OIR: 2324/862

Request for Information under the Local Government Official Information and Meetings Act 1987 (the Act) (the LGOIMA)

Appendix one

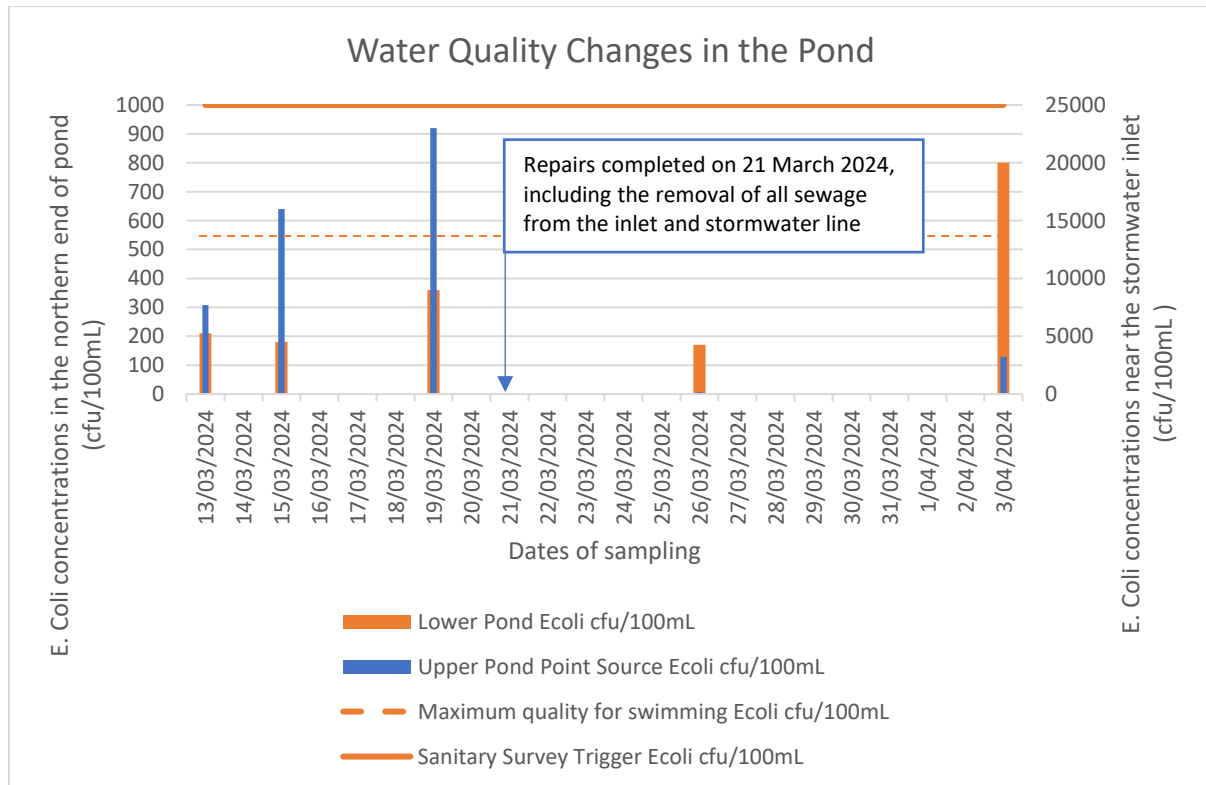
If you look at the sample results from the recent sampling in Appendix One, note the difference in E. Coli between the inlet and the northern end of the pond. Despite untreated sewage in the pond, the E.Coli never exceeded the trigger for sanitary survey (to track the source of the contamination).

We are currently sampling and assessing the pond weekly. Please see the results in Appendix One.
