OIR: 2324/809

**Request for Information under the Local Government Official Information and Meetings Act 1987 (the Act) (the LGOIMA)**

## Section Inspection - 8/07/2022 - KSWP003634

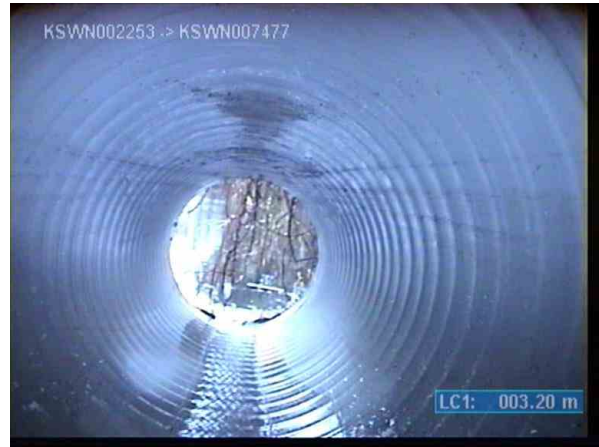
KSWP003634\_23266daf-560e-4aaf-960b-442abe849b0c\_20220708\_155222\_076.jpg, 00:01:17, 3.20m  
Material change / Bosspipe

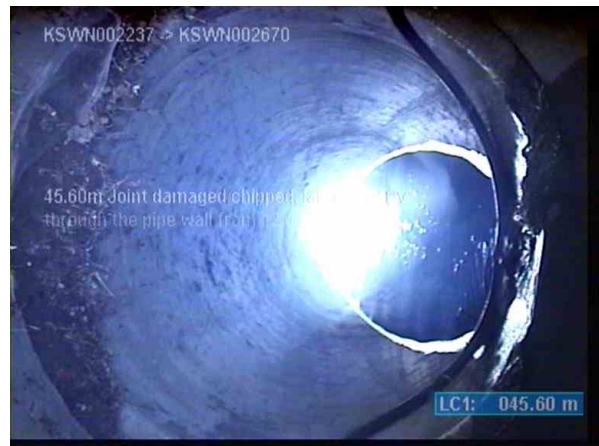
<table><tr> <td style="width: 10%;">0.10</td> <td style="width: 5%;">IS</td> <td style="width: 45%;">Inspection start, node reference: KSWN002237</td> <td style="width: 10%;">00:00:10</td> <td style="width: 10%;">KSWP003 713_8fcae d6d-e316-</td> <td style="width: 15%;"></td> </tr><tr> <td>45.60</td> <td>JFDL</td> <td>Joint damaged/chipped, large, clearly through the pipe wall from 12 o'clock to 12 o'clock</td> <td>00:04:25</td> <td>KSWP003 713_bdd9 7187-9c4c</td> <td>17</td> </tr></table>

KSWP003713\_bdd97187-9c4c-4e12-97c5-650296e93888\_20220811\_132048\_371.jpg, 00:04:25, 45.60m (2.60m)  
Joint damaged/chipped, large, clearly through the pipe wall from 12 o'clock to 12 o'clock

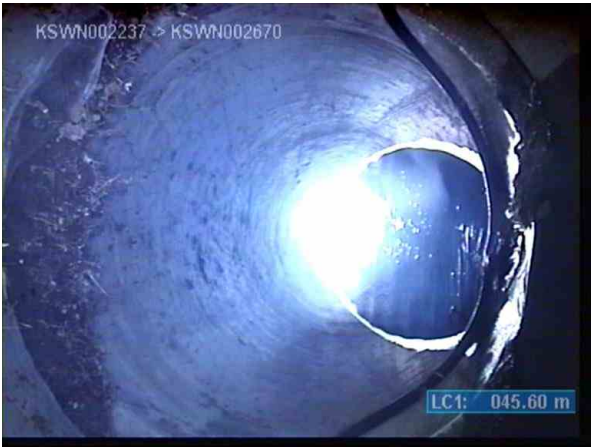
<table><tr> <td style="width: 10%;">0.10</td> <td style="width: 5%;">IS</td> <td style="width: 45%;">Inspection start, node reference: KSWN002237</td> <td style="width: 10%;">00:00:10</td> <td style="width: 10%;">KSWP003 713_8fcae d6d-e316-</td> <td style="width: 15%;"></td> </tr><tr> <td>45.60</td> <td>DIS</td> <td>Gap separation width 20mm</td> <td>00:04:31</td> <td>KSWP003 713_4a77 d837-2bba</td> <td>36</td> </tr></table>

KSWP003713\_4a77d837-2bba-4c40-a44b-a017512c4149\_20220811\_132102\_186.jpg, 00:04:31, 45.60m (2.60m)  
Gap separation width 20mm

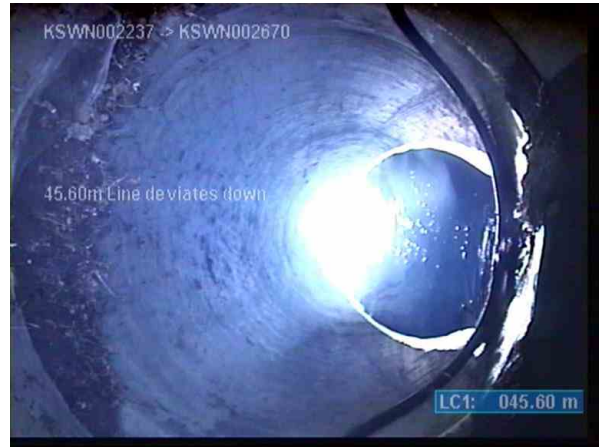
<table><tr> <td style="width: 10%;">0.10</td> <td style="width: 5%;">IS</td> <td style="width: 45%;">Inspection start, node reference: KSWN002237</td> <td style="width: 10%;">00:00:10</td> <td style="width: 10%;">KSWP003 713_8fcae d6d-e316-</td> <td style="width: 15%;"></td> </tr><tr> <td>45.60</td> <td>LD</td> <td>Line deviates down</td> <td>00:04:37</td> <td>KSWP003 713_71c9e dd4-90be-</td> <td></td> </tr></table>

KSWP003713\_71c9edd4-90be-4488-97db-24646cada9ca\_20220811\_132110\_921.jpg, 00:04:37, 45.60m (2.60m)  
Line deviates down

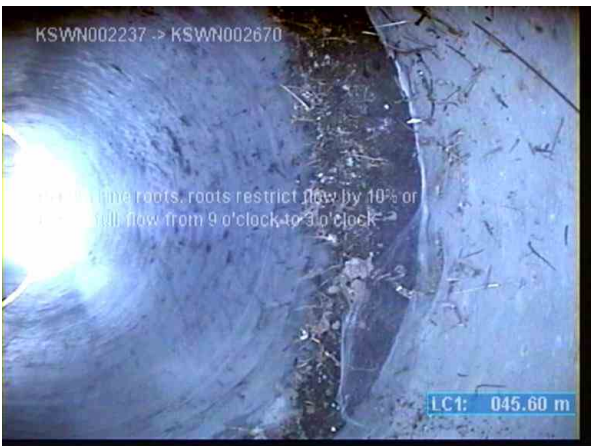
<table><tr> <td style="width: 10%;">0.10</td> <td style="width: 5%;">IS</td> <td style="width: 45%;">Inspection start, node reference: KSWN002237</td> <td style="width: 10%;">00:00:10</td> <td style="width: 10%;">KSWP003 713_8fcae d6d-e316-</td> <td style="width: 15%;"></td> </tr><tr> <td>45.60</td> <td>RIFS</td> <td>Fine roots, roots restrict flow by 10% or less of full flow from 9 o'clock to 3 o'clock</td> <td>00:04:52</td> <td>KSWP003 713_9041 9e6e-c99a</td> <td>3</td> </tr></table>

KSWP003713\_90419e6e-c99a-4298-a253-86fee32cceed\_20220811\_132134\_875.jpg, 00:04:52, 45.60m (2.60m)  
Fine roots, roots restrict flow by 10% or less of full flow from 9 o'clock to 3 o'clock

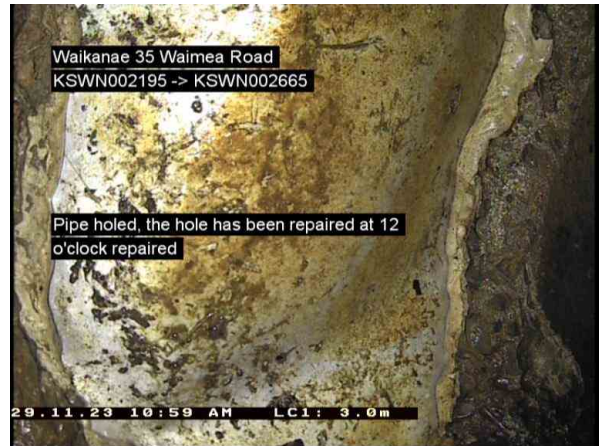
42\_KSWP003751\_196.jpg, 00:02:26, 3.00m (12.40m)  
Pipe holed, the hole has been repaired at 12 o'clock / repaired

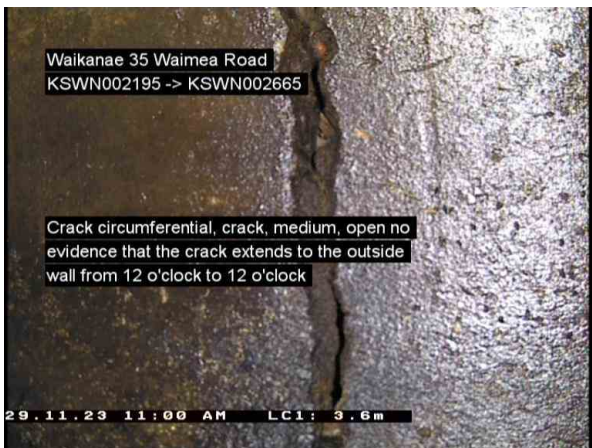
42\_KSWP003751\_197.jpg, 00:02:53, 3.60m (11.80m)  
Crack circumferential, crack, medium, open no evidence that the crack extends to the outside wall from 12 o'clock to 12 o'clock

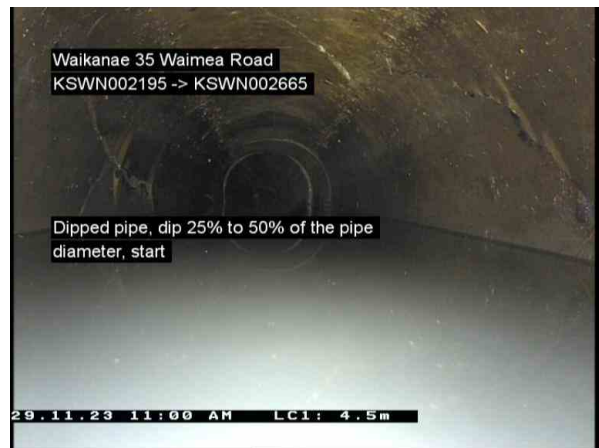
42\_KSWP003751\_198.jpg, 00:03:10, 4.50m (10.90m)  
Dipped pipe, dip 25% to 50% of the pipe diameter, start

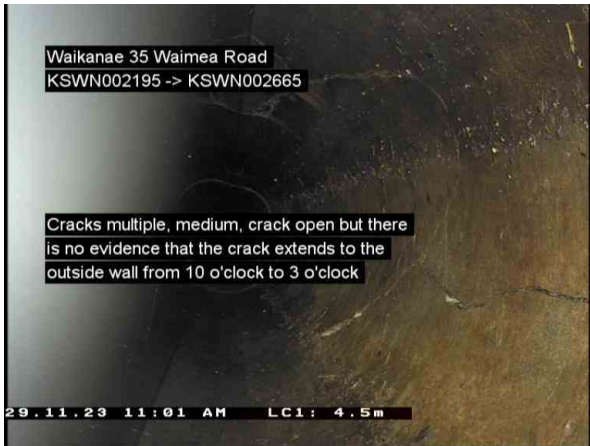
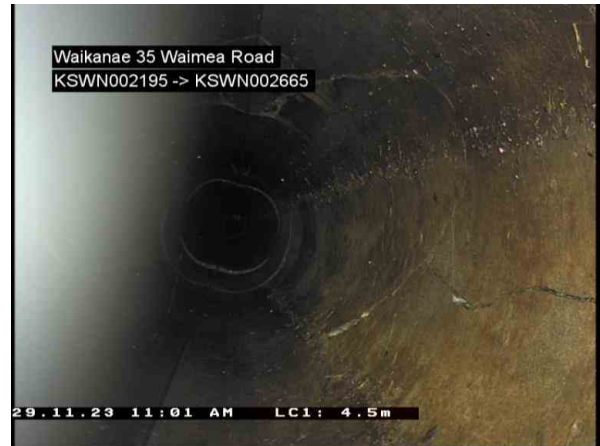
42\_KSWP003751\_199.jpg, 00:03:25, 4.50m (10.90m)  
Cracks multiple, medium, crack open but there is no evidence that the crack extends to the outside wall from 10 o'clock to 3 o'clock

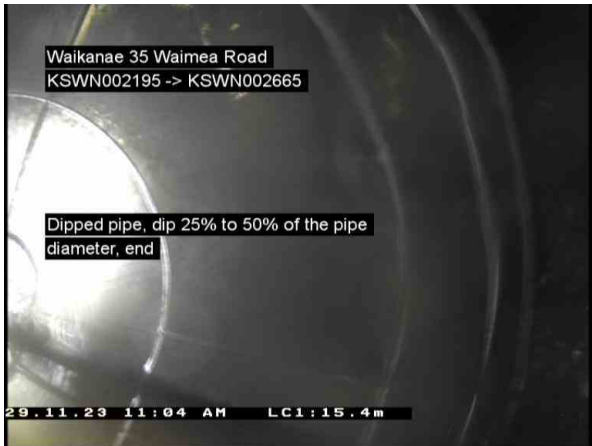
42\_KSWP003751\_203.jpg, 00:06:36, 15.40m (0.00m)  
Dipped pipe, dip 25% to 50% of the pipe diameter, end

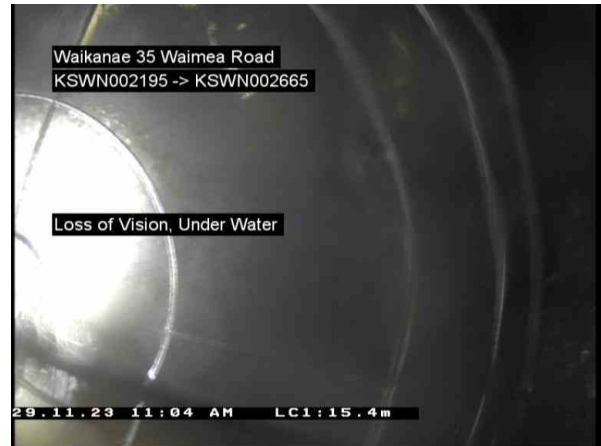
42\_KSWP003751\_204.jpg, 00:06:39, 15.40m (0.00m)  
Loss of Vision, Under Water

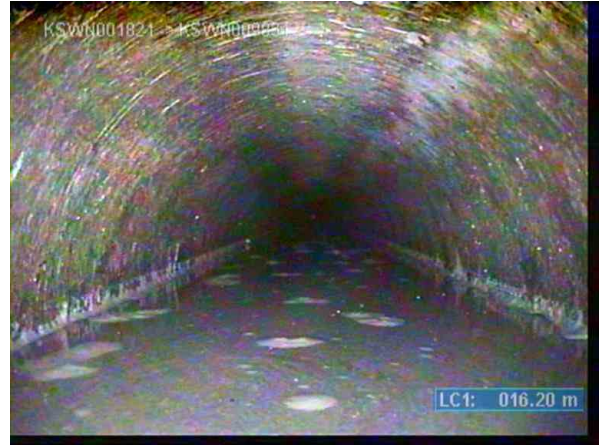
KSWP003815\_6490fce0-0345-4d25-ac2c-1e2e453b3bc3\_20220701\_135213\_247.jpg, 00:03:52, 16.20m  
General comment / High water level going to creek

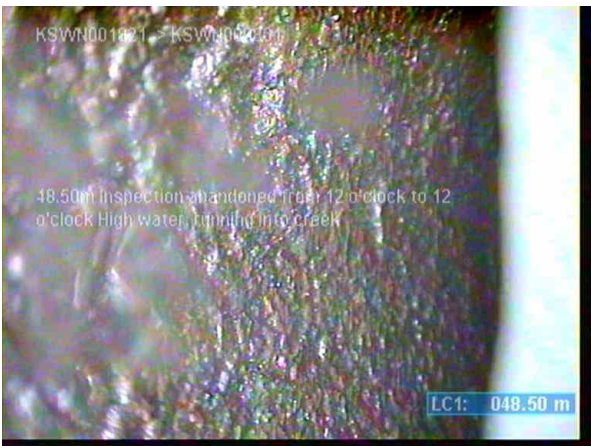
KSWP003815\_c7aa7907-fc96-4a78-b240-7bb6f4c7ad22\_20220701\_140011\_875.jpg, 00:11:27, 48.50m  
Inspection abandoned from 12 o'clock to 12 o'clock / High water, running into creek

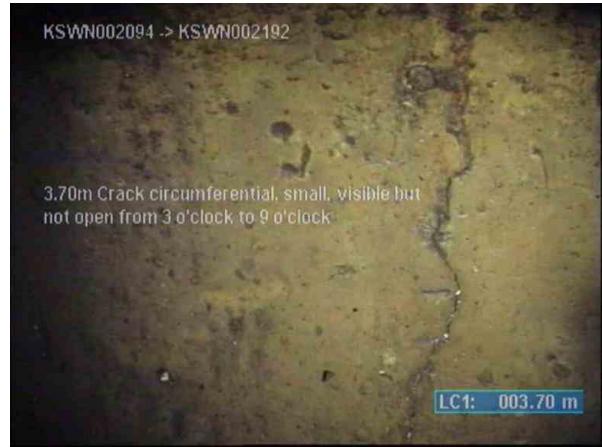
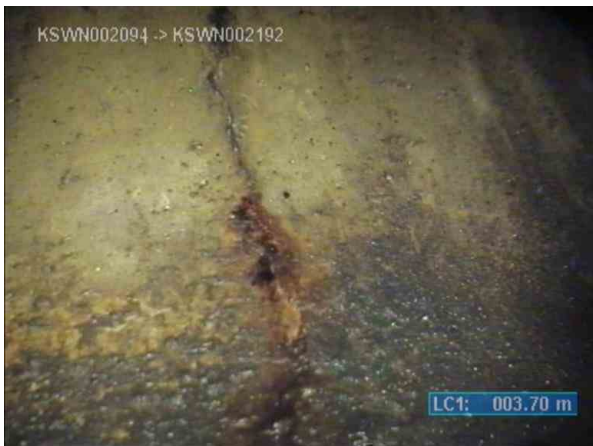
KSWP003817\_06475611-4031-46c4-9258-8a08b54254d5\_20220812\_112909\_255.jpg, 00:01:29, 3.70m (52.30m)  
Crack circumferential, small, visible but not open from 3 o'clock to 9 o'clock

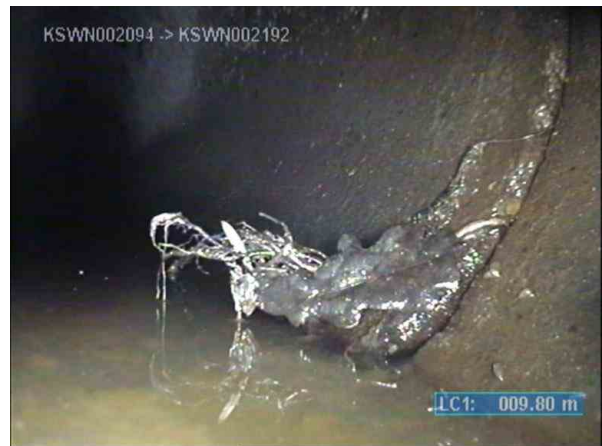
KSWP003817\_35b78b62-6938-4352-9f91-7300c8ca4902\_20220812\_113006\_929.jpg, 00:02:18, 9.80m (46.20m)  
Joint damaged/chipped, large, clearly through the pipe wall from 4 o'clock to 6 o'clock / Roots

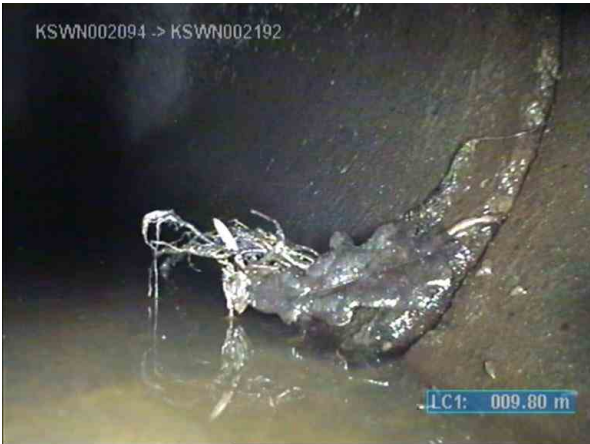
KSWP003817\_c21fe9cd-398c-42ed-b7fb-1d5d78366c5d\_20220812\_113017\_759.jpg, 00:02:25, 9.80m (46.20m)  
Fine roots, roots restrict flow by 10% or less of full flow from 4 o'clock to 6 o'clock

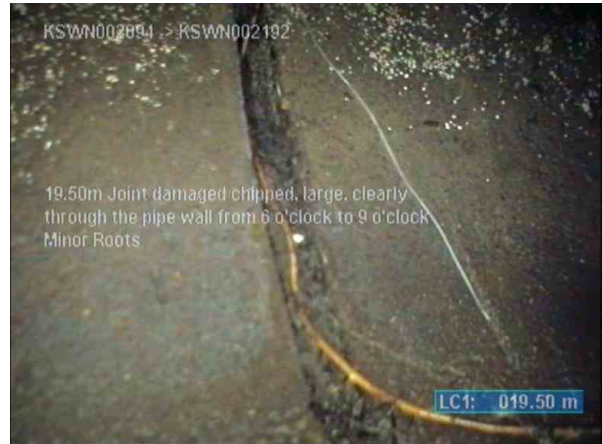
19.50	JFDL	Joint damaged/chipped, large, clearly through the pipe wall from 6 o'clock to 9 o'clock / Minor Roots	00:03:54	KSWP003 817_36c32 fb4-a4dc-4	17

KSWP003817\_36c32fb4-a4dc-41d3-aa9c-aab22b83395a\_20220812\_113157\_910.jpg, 00:03:54, 19.50m (36.50m)  
Joint damaged/chipped, large, clearly through the pipe wall from 6 o'clock to 9 o'clock / Minor Roots

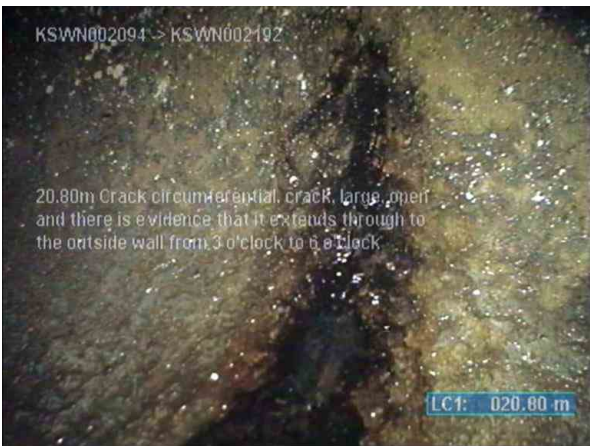
20.80	CCL	Crack circumferential, crack, large, open and there is evidence that it extends through to the outside wall from 3 o'clock to 6 o'clock	00:04:32	KSWP003 817_db4cb f4f-896b-4	12

KSWP003817\_db4cbf4f-896b-4697-8544-55b7a58b3b42\_20220812\_113238\_708.jpg, 00:04:32, 20.80m (35.20m)  
Crack circumferential, crack, large, open and there is evidence that it extends through to the outside wall from 3 o'clock to 6 o'clock

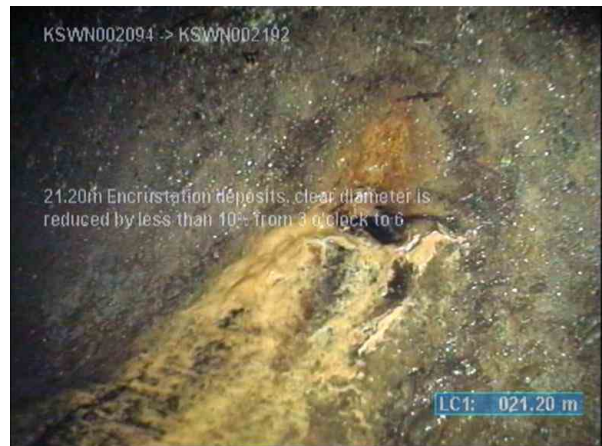
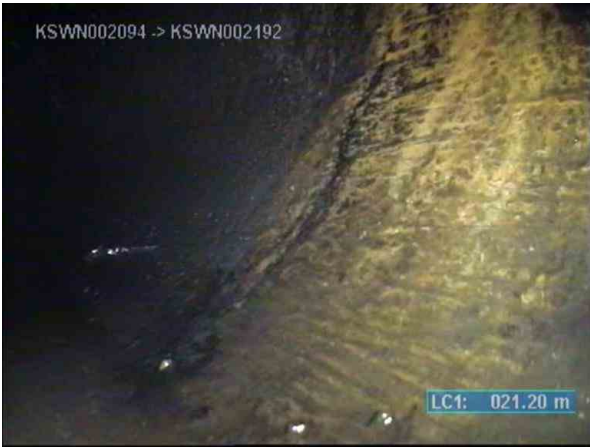
KSWP003817\_c9bedc18-acc9-4587-be8a-7ff7d5d63b6e\_20220812\_113306\_569.jpg, 00:04:55, 21.20m (34.80m)  
Encrustation deposits, clear diameter is reduced by less than 10% from 3 o'clock to 6 o'clock

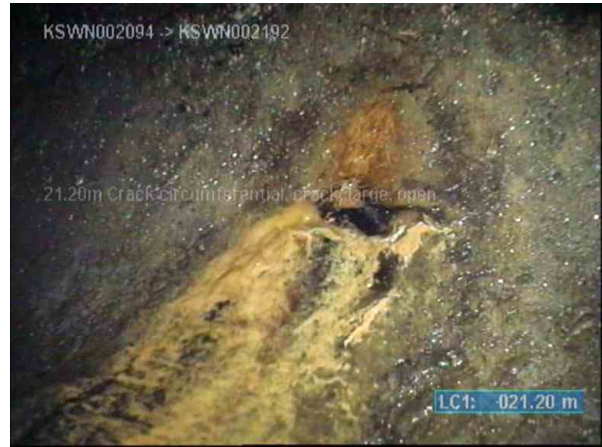
KSWP003817\_17864e24-11e9-4cd5-acf6-a256721788ba\_20220812\_113319\_750.jpg, 00:05:04, 21.20m (34.80m)  
Crack circumferential, crack, large, open and there is evidence that it extends through to the outside wall from 3 o'clock to 6 o'clock

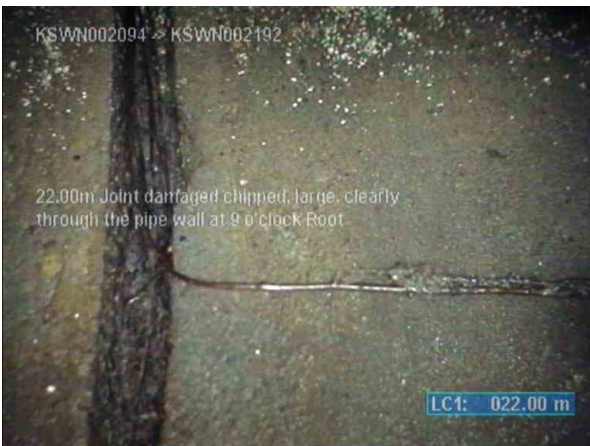
KSWP003817\_bf9a678e-ebf6-4e9e-a17c-8ff011637ce3\_20220812\_113348\_222.jpg, 00:05:24, 22.00m (34.00m)  
Joint damaged/chipped, large, clearly through the pipe wall at 9 o'clock / Root

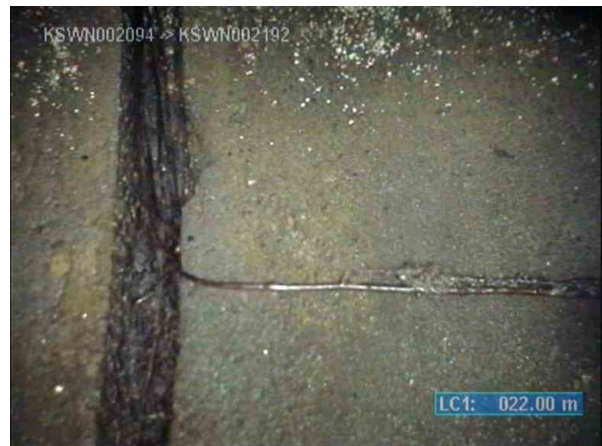
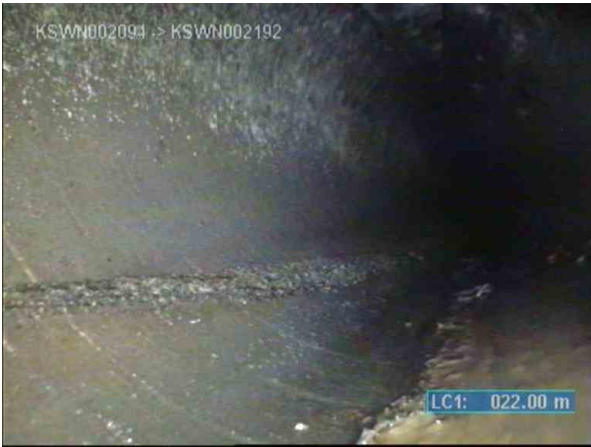
KSWP003817\_da90fc7a-621a-40ac-8dd4-68883b6b4d57\_20220812\_113358\_896.jpg, 00:05:30, 22.00m (34.00m)  
Fine roots, roots restrict flow by 10% or less of full flow at 9 o'clock

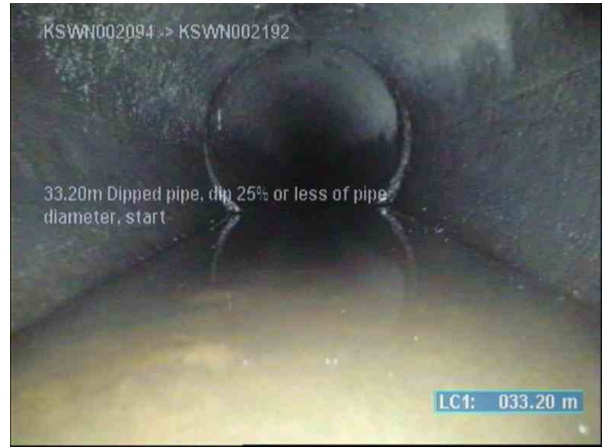
KSWP003817\_c346b211-c8d1-4778-881d-df197c90eed6\_20220812\_113525\_551.jpg, 00:06:53, 33.20m (22.80m)  
Dipped pipe, dip 25% or less of pipe diameter, start

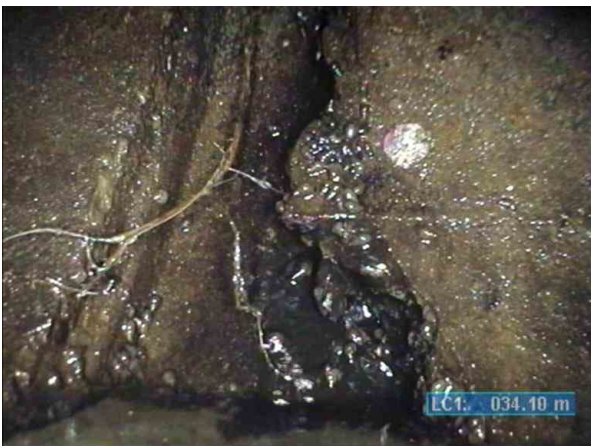
KSWP003817\_700bbb4a-d05f-4d20-bcb1-caed32b5e03b\_20220812\_113613\_212.jpg, 00:07:24, 34.10m (21.90m)  
Joint damaged/chipped, large, clearly through the pipe wall from 3 o'clock to 9 o'clock / Infiltration and broken

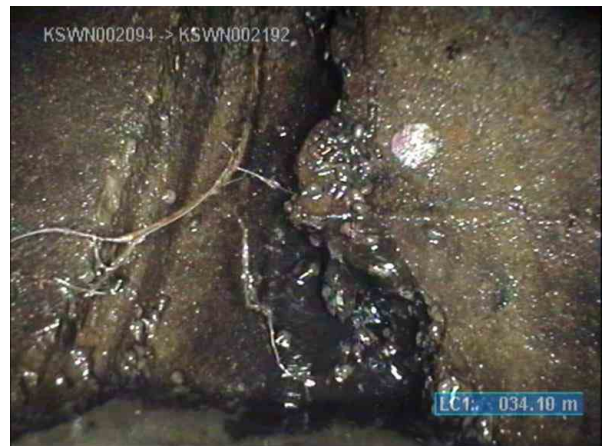
34.10	IPM	Infiltration, running (visibly moving) flow from 3 o'clock to 6 o'clock	00:07:30	KSWP003 817_adfc3 087-874e-	10 / 21			
	34.40	S02 DES	Debris silt, small, clear diameter reduced by less than 10%, start	00:07:47	KSWP003 817_87cce dcd-31e1-	15

KSWP003817\_adfc3087-874e-45aa-86b4-190dc5edbc04\_20220812\_113624\_055.jpg, 00:07:30, 34.10m (21.90m)  
Infiltration, running (visibly moving) flow from 3 o'clock to 6 o'clock

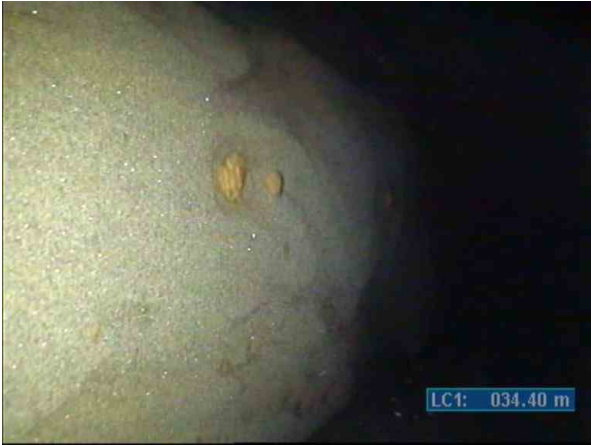
KSWP003817\_87ccedcd-31e1-4b81-b037-d14fae2386ca\_20220812\_113645\_304.jpg, 00:07:47, 34.40m (21.60m)  
Debris silt, small, clear diameter reduced by less than 10%, start

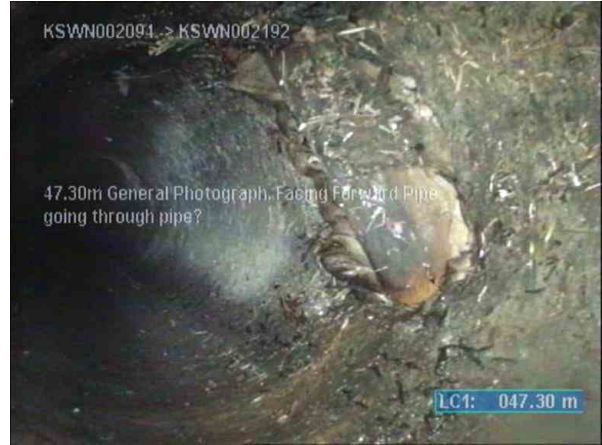
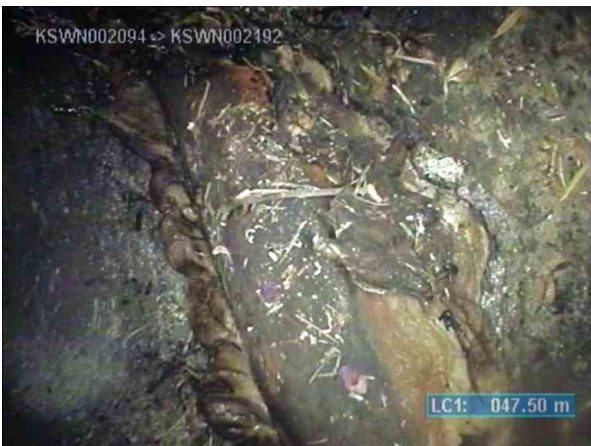
KSWP003817\_571327f2-f20b-48b4-873b-7e7518a073fb\_20220812\_113946\_888.jpg, 00:10:25, 47.30m (8.70m)  
General Photograph, Facing Forward / Pipe going through pipe?

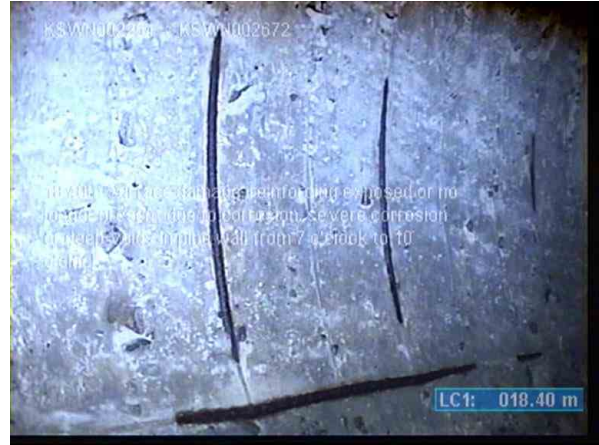
KSWP004512\_0244a32f-c0b6-44dc-be00-d1b417667dd6\_20220711\_125619\_066.jpg, 00:02:44, 18.40m  
Surface damage, reinforcing exposed or no longer present due to corrosion, severe corrosion or deep voids in pipe wall from 7 o'clock to 10 o'clock

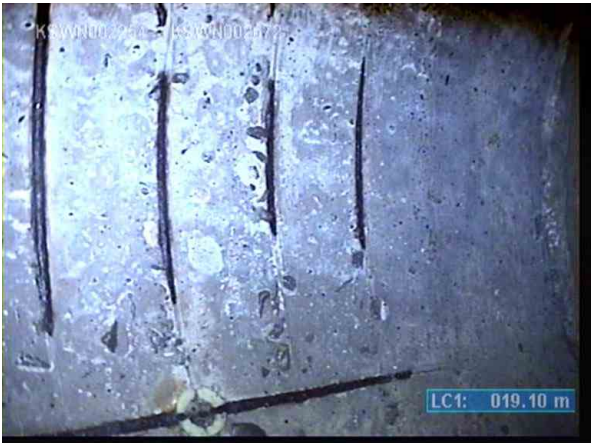
KSWP004512\_060d03ac-41e2-4c53-bf61-835357fe24d4\_20220711\_125640\_322.jpg, 00:03:03, 19.10m  
Surface damage, reinforcing exposed or no longer present due to corrosion, severe corrosion or deep voids in pipe wall from 7 o'clock to 10 o'clock

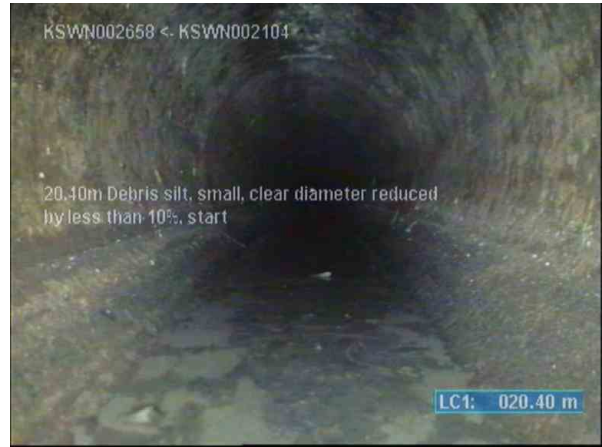
KSWP004528\_3ffb6422-f8c1-4fb4-8ea1-b66669cf51d5\_20220809\_112312\_556.jpg, 00:04:14, 20.40m (28.30m)  
Debris silt, small, clear diameter reduced by less than 10%, start

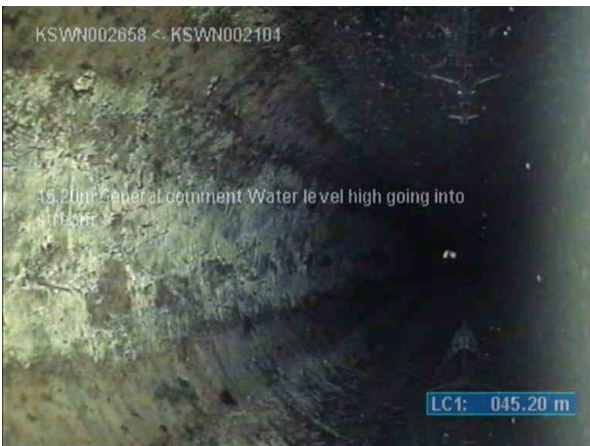
KSWP004528\_519b205c-9559-4adf-97c9-13e5ab0f0c8c\_20220809\_112722\_172.jpg, 00:08:11, 45.20m (3.50m)  
General comment / Water level high going into stream
