Arboricultural & Environmental Consultants

### SECTION 92 RESPONSE FOR 160 KAPITI RD, PARAPARUMU

PREPARED FOR:	Kurt Gibbons, Kapiti Retail Holdings Ltd
cc:	Kay Panther Knight, Forme Planning
BY:	Simon Miller
DATE:	20.8.21

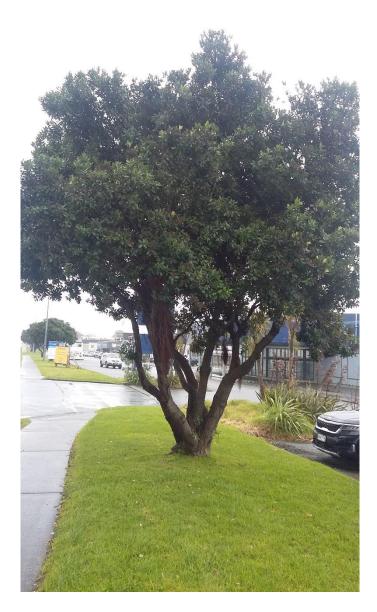
Tree 1

Tree No.	Species	Height (m)	DBH (cm)	Crown Spread Radius (m)	Condition	Age	Remarks
1	Pohutukawa Metrosideros excelsa	6	42 (based on 7 stems)	2.9	Good	SM	Good vigour and foliar density. Areas of new shoot-tip growth noted – 5cm+. Some areas of mechanical damage noted on stems, footpath side of tree. GIS maps indicate stormwater services located within root zone of tree.
2	Pohutukawa <i>Metrosideros</i> <i>excelsa</i>	7	45 (based on 10 stems)	3.8	Good	SM	Good vigour and foliar density. Areas of new shoot-tip growth noted – 5cm+. Some areas of mechanical damage noted on stems, footpath side of tree. Lamp post standing within root zone of tree. GIS maps indicate stormwater services located within root zone of tree.

DBH DBH/3 Replacement \$	42 cm 14 x 508			
Total Value	\$7112			
3.3 Tree 2				
DBH DBH/3 Replacement \$	45 cm 15 x 508			
Total Value	\$7620

From an arboricultural perspective the transplantation of the trees is not warranted due to the costs involved. While the trees are good specimens that contribute positively to the existing urban forest in the area they are not significant in terms of species, age or form.

Resources might be better allocated to the planting of a number (e.g. 4 - 6) new larger grade - 160 litre - Pohutukawa trees within the existing road reserve. The new planting pits for these trees could likely work around existing services that may be in situ.
