# Resource Consent Application – 35 Kaitawa Crescent, Paraparaumu

Housing New Zealand

Date: June 2019  
Reference: N-H0060.00  
Status: Final Issue

# Application for Resource Consent Form

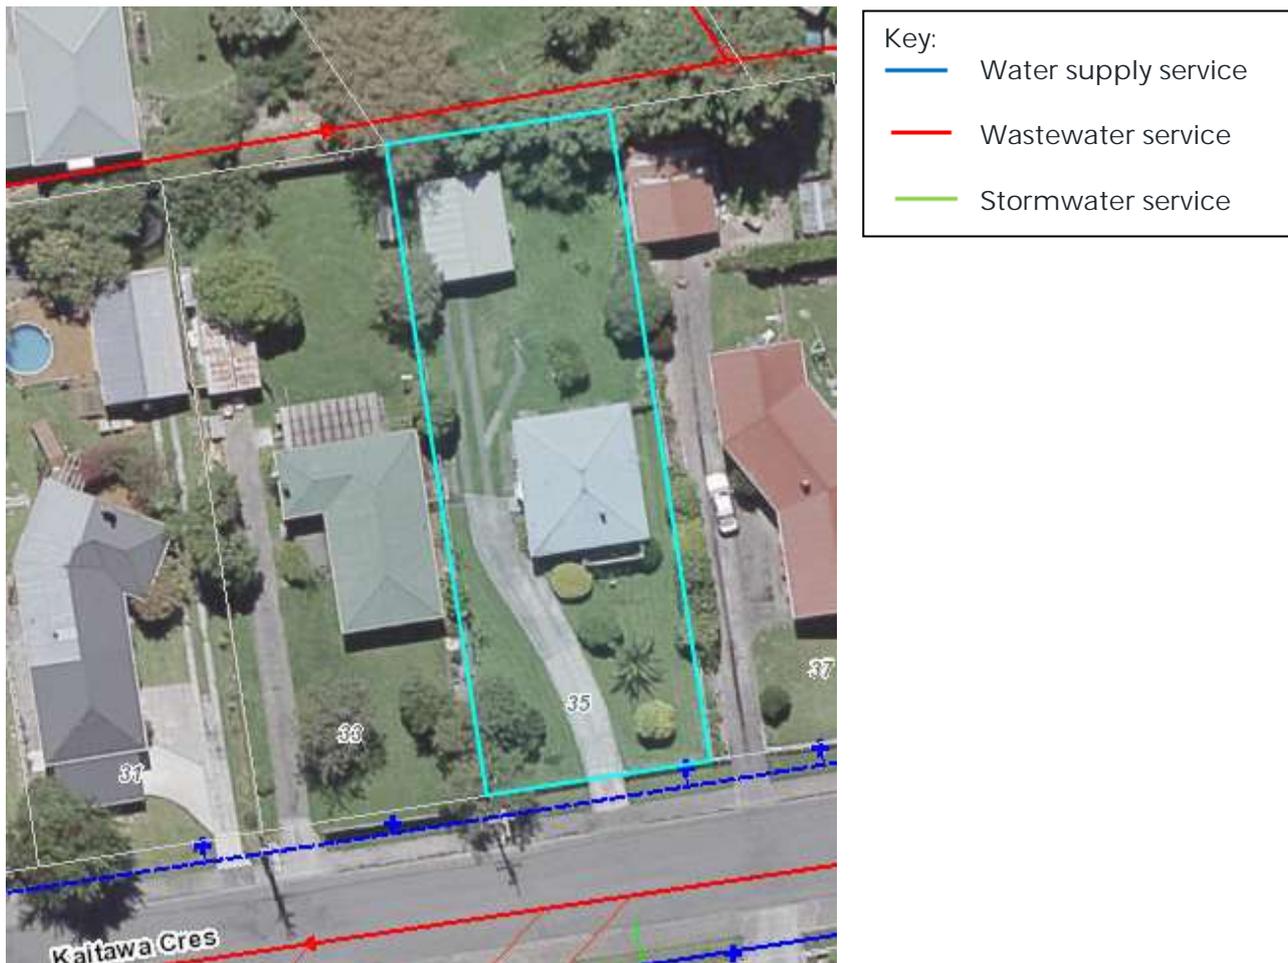
Figure 3: Existing water services (KCDC GIS maps).

A new water supply and wastewater connection will be provided to each of the new units in proposed Lots 1 and 2. The new connections will be provided as per the site drawing (Appendix C).

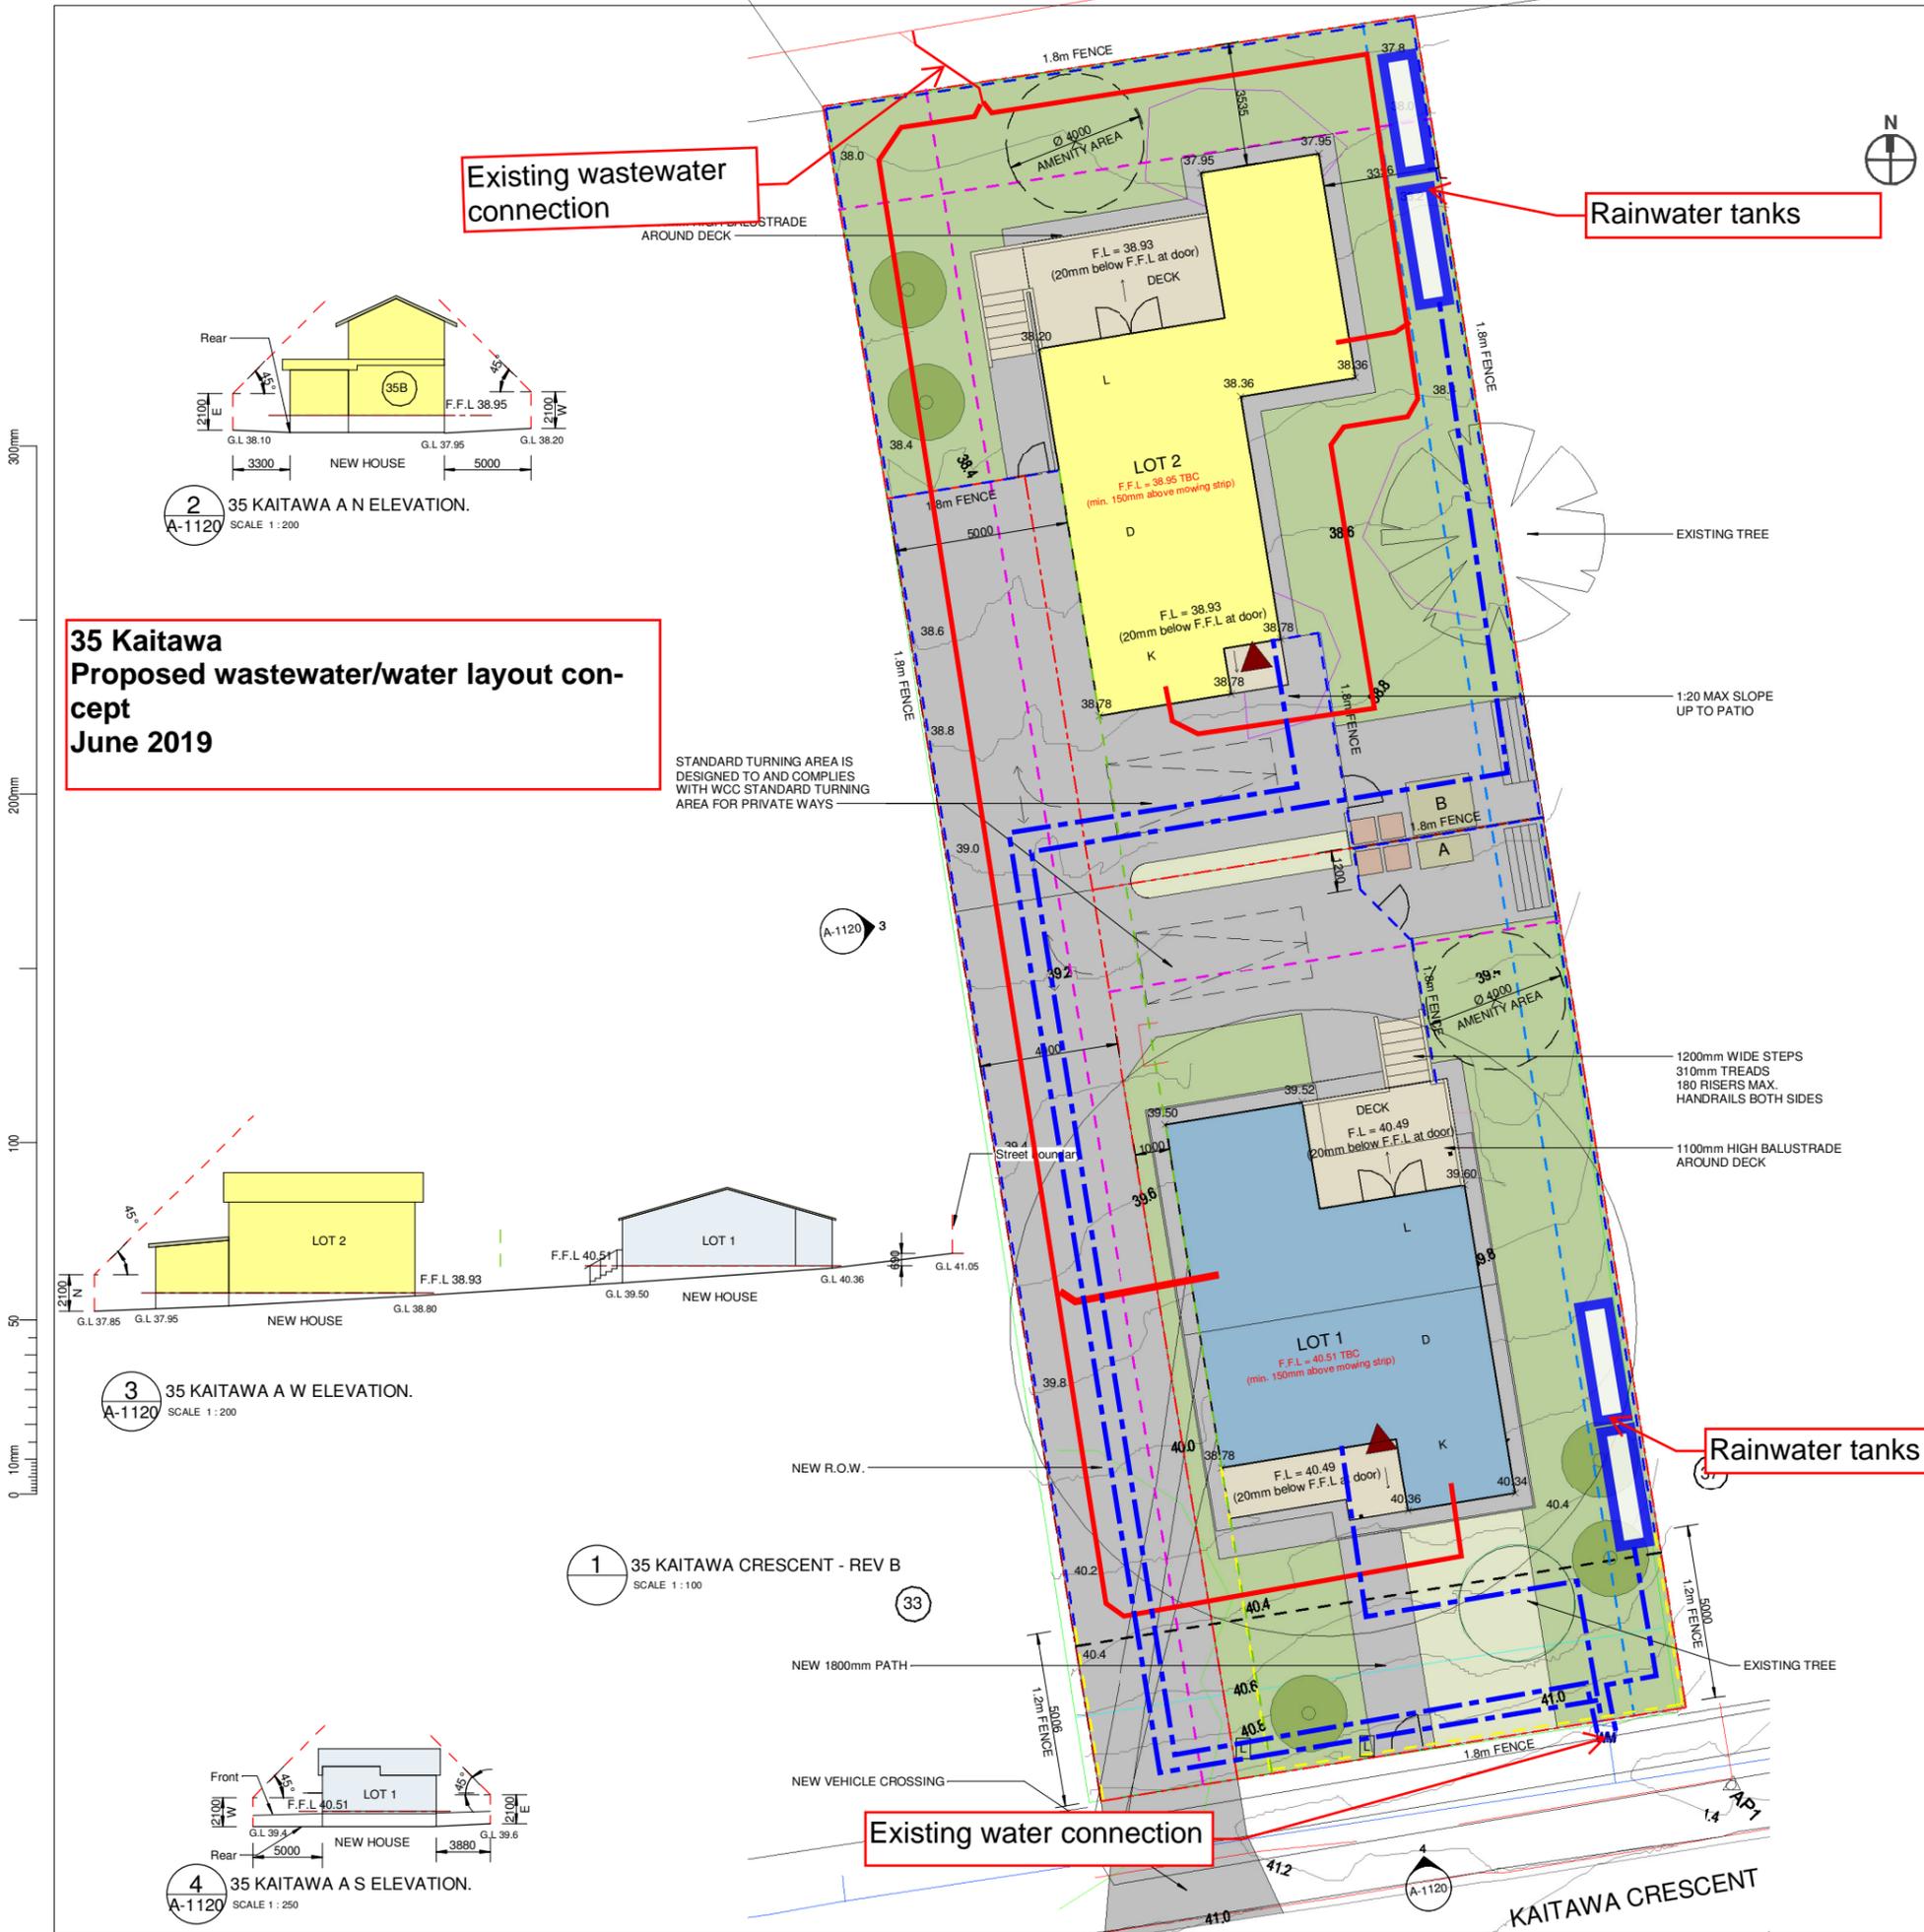
**35 Kaitawa  
Proposed wastewater/water layout concept  
June 2019**

**CONSTRUCTION MANAGEMENT ZONE**  
CONSTRUCTION MANAGEMENT ZONE IS INDICATED BY THE COLOURED AREA ON THE PLAN.

**GEOTECHNICAL NOTES**  
1. SOFT SPOTS - CONTRACTOR TO CONFIRM THE EXTENT OF ANY SOFT SPOTS WITH PROJECT MANAGER. WHERE REQUIRED THESE ARE TO BE REMOVED AND REPLACED WITH GEOTEXTILE AND COMPACTED GRANULAR FILL AS NOTED BELOW.

2. HOUSE FOUNDING EXCAVATIONS - LOT 1 AND 2 ARE TO BE EXCAVATED DOWN TO 800mm  
THE UPPER 800mm OF SOIL FOR LOTS 1 & 2 SHALL BE REMOVED AND REPLACED WITH COMPACTED GRANULAR FILL TO CREATE A STABLE BUILDING PLATFORM. THE GRANULAR FILL SHALL BE COMPACTED IN ACCORDANCE WITH NZS4431:1989 WITH APPROPRIATE ON-SITE QUALITY CONTROL. A LAYER OF GEOTEXTILE SHOULD BE PLACED BETWEEN SUBGRADE AND THE COMPACTED GRANULAR FILL.  
PLEASE NOTE THAT A GEOTECHNICAL ENGINEER IS TO INSPECT THE UNDERCUT AND THE FOUNDING MATERIAL AT A DEPTH OF 0.9m FOR LOTS 1 & 2. IT MAY BE NECESSARY TO CARRY OUT FUTURE INSTU TESTING AT THE TIME OF CONSTRUCTION TO DETERMINE THE EXTENT OF SOFT SPOTS AND CONFIRM FOUNDING MATERIAL.

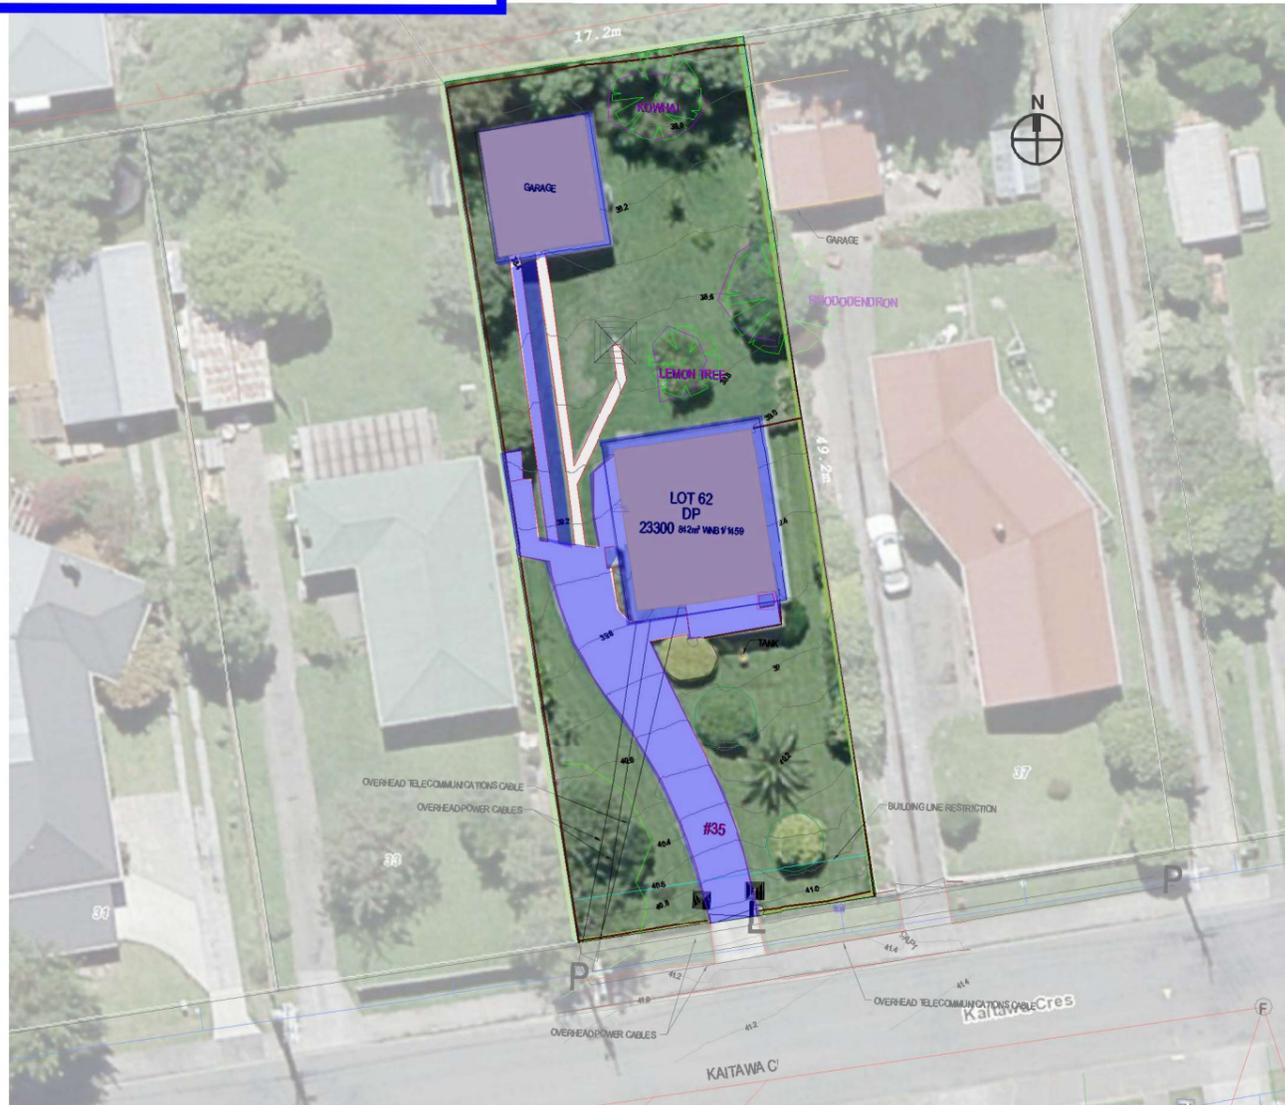
**1** 35 KAITAWA CRESCENT - EXISTING  
SCALE 1:200

**SW CONCEPT DESIGN -MAY 2019 FIGURE 1 OF 3 DEVELOPED AREAS**

**Existing -35 Kaitawa Crescent**  
 Area Measurements for SW Design (from pdf)  
 (from pdf, scale 1mm = 0.4m)

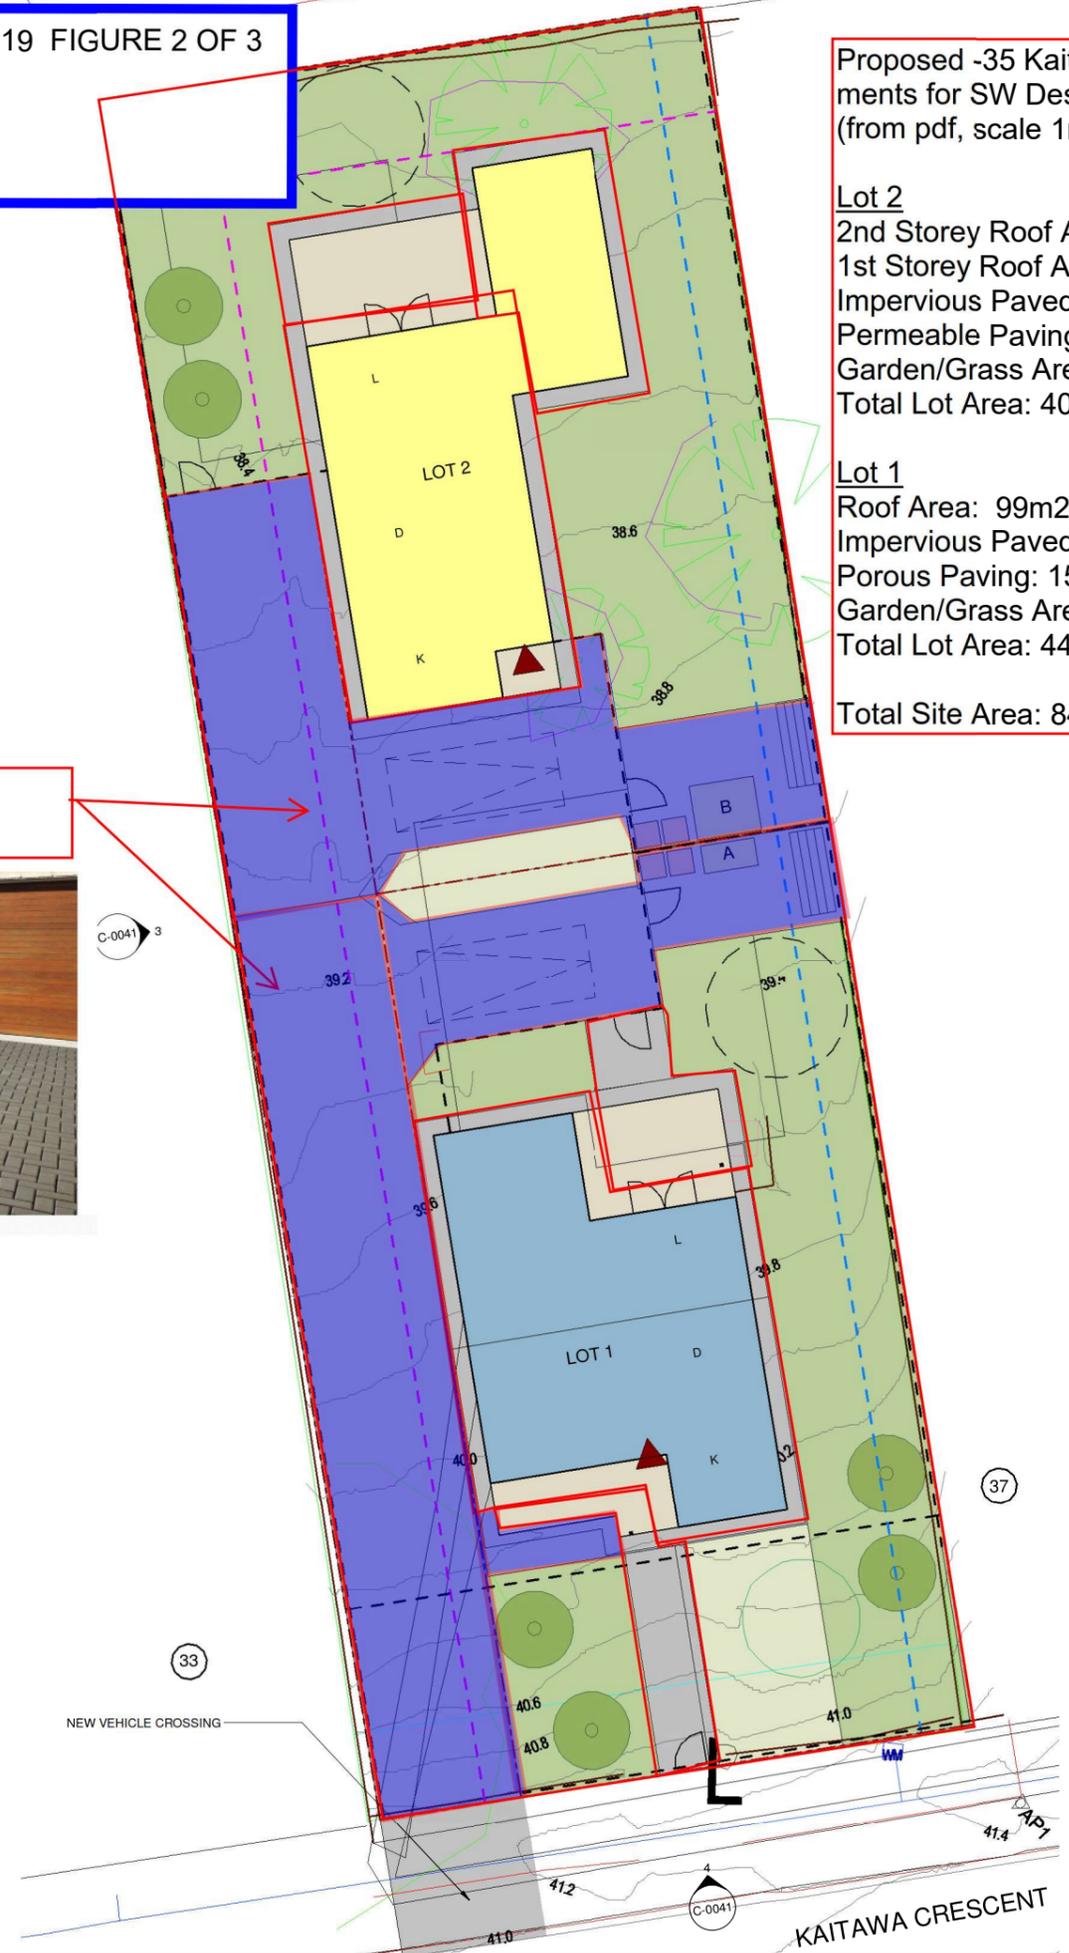
① 35 KAITAWA CRESCENT - REV B  
SCALE 1:100

**SW CONCEPT DESIGN -MAY 2019 FIGURE 3 OF 3 PROPOSED STORMWATER SYSTEM**

Attenuated flows will be discharged to soakholes sized to NZBC Clause E1 for storms of 10% AEP. These soakholes will only be used in the event that the pumps are not operational. As the soils are not well suited to soakage, soakholes have been based on a soakage rate of 0mm/hr as presented in Table 7. On-site soakage rates were found to be a maximum of 120 mm/hr with no groundwater encountered down to 1.0m depth (WSP Opus Geotechnical Assessment 2019).

- The pumps will be shared with the water re-use system. This will ensure that pump failure is immediately obvious as the toilet will then stop filling, therefore notifying the residence that maintenance is required.
- The pumped discharge will be controlled utilising a solenoid valve and tethered float system. The system will be made as simple as possible, with readily-available components.
- The pump will discharge to a standard kerb outlet chamber and discharge pipe. This will ensure the flows 'well up' for a gentle discharge to the kerb.

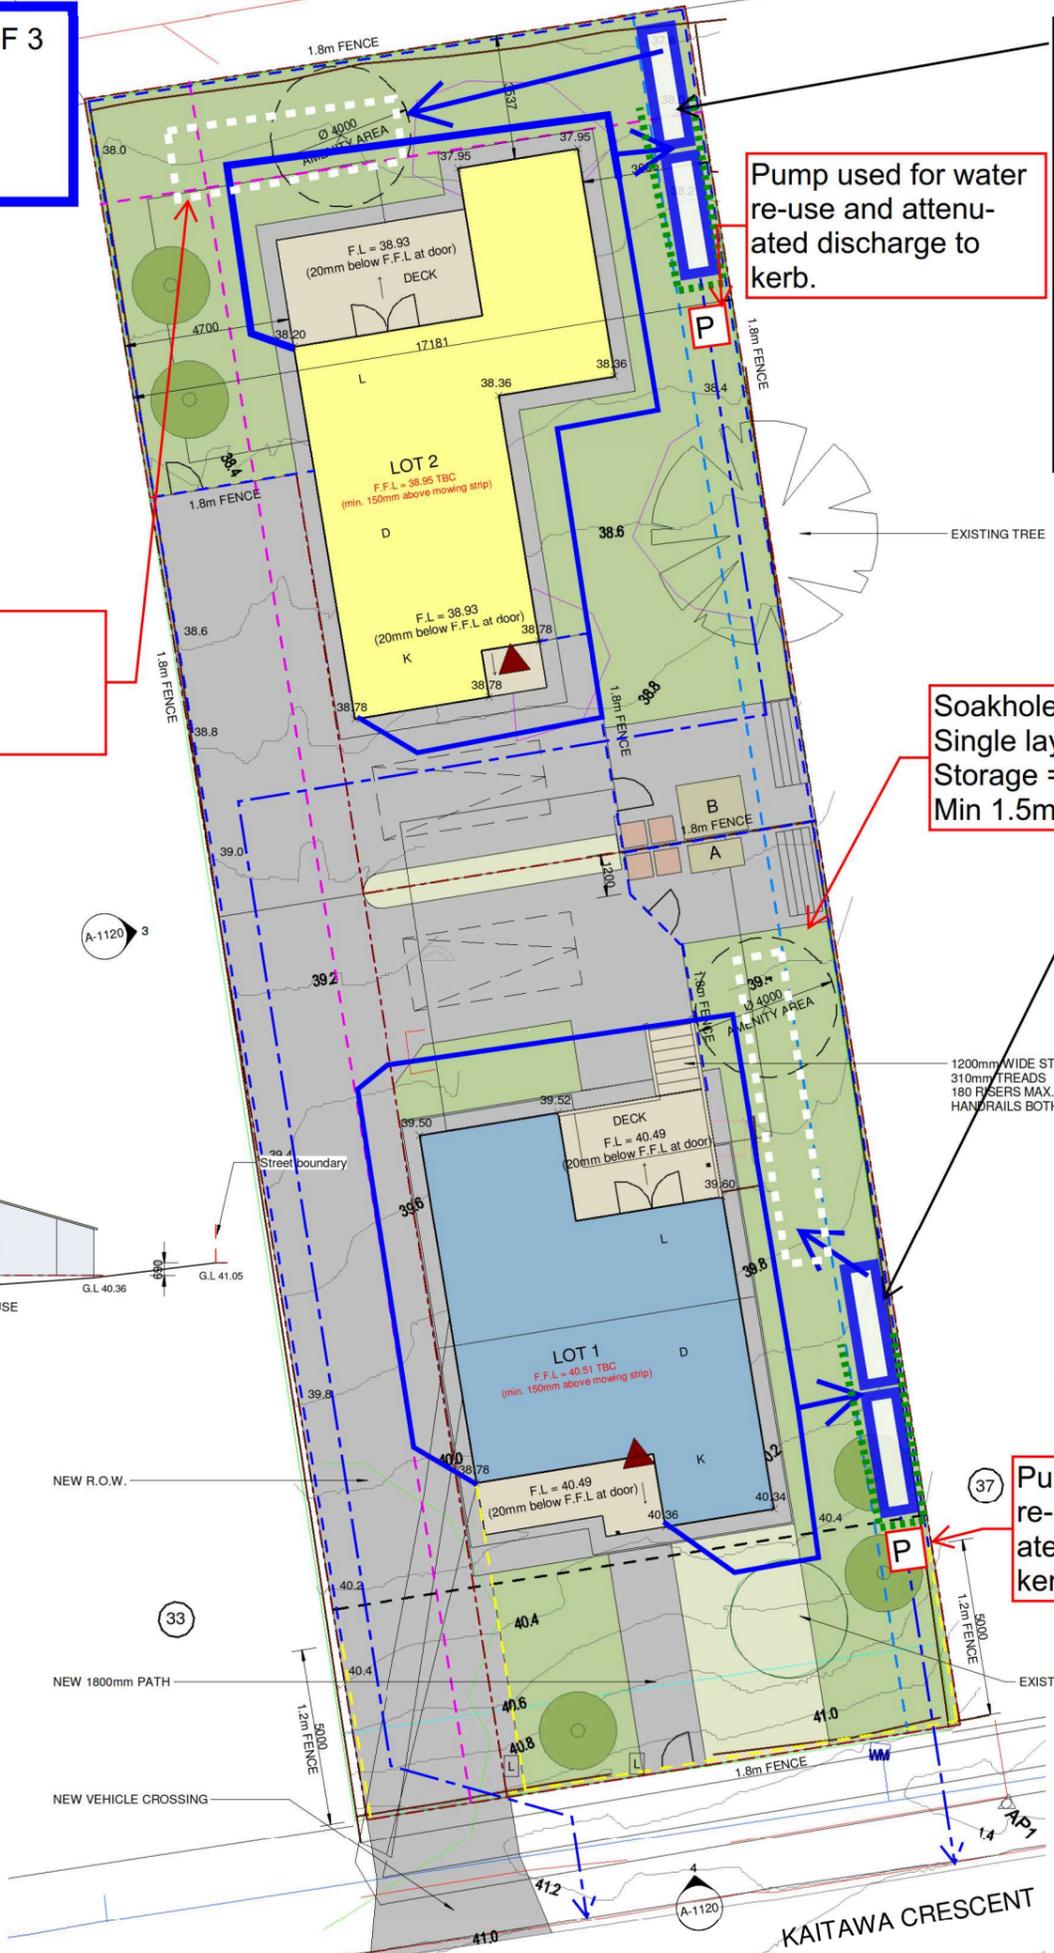
Slimline Corrugated Steel Tanks, 6000L x 2 on concrete slab with timber edging.  
Dimensions (WxLxH): 1150x3700x1600  
Tank base 38.1m  
Tank top 39.7m  
20mm orifice at 38.8m with discharge to soakhole

Attenuation Storage 3380L  
Pumped Storage 2625L  
Permanent Storage 5358L  
Pump Discharge 0.3 L/s

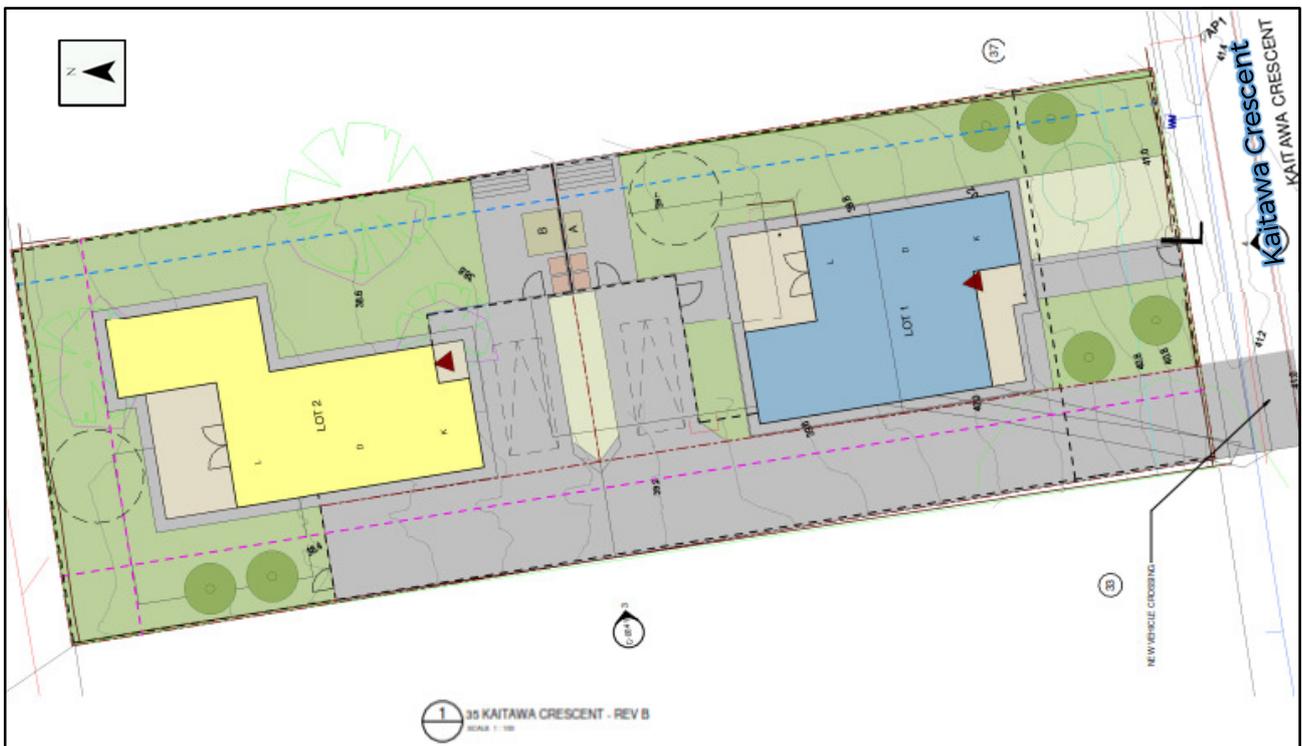
Figure 2-1 : Site Development Plan

We understand the development of the site will include the construction of two lightweight timber framed buildings as per NZS3604:2011 (NZS, 2011). The existing building on the property will be demolished. The proposed development layout is shown in Figure 2-1.

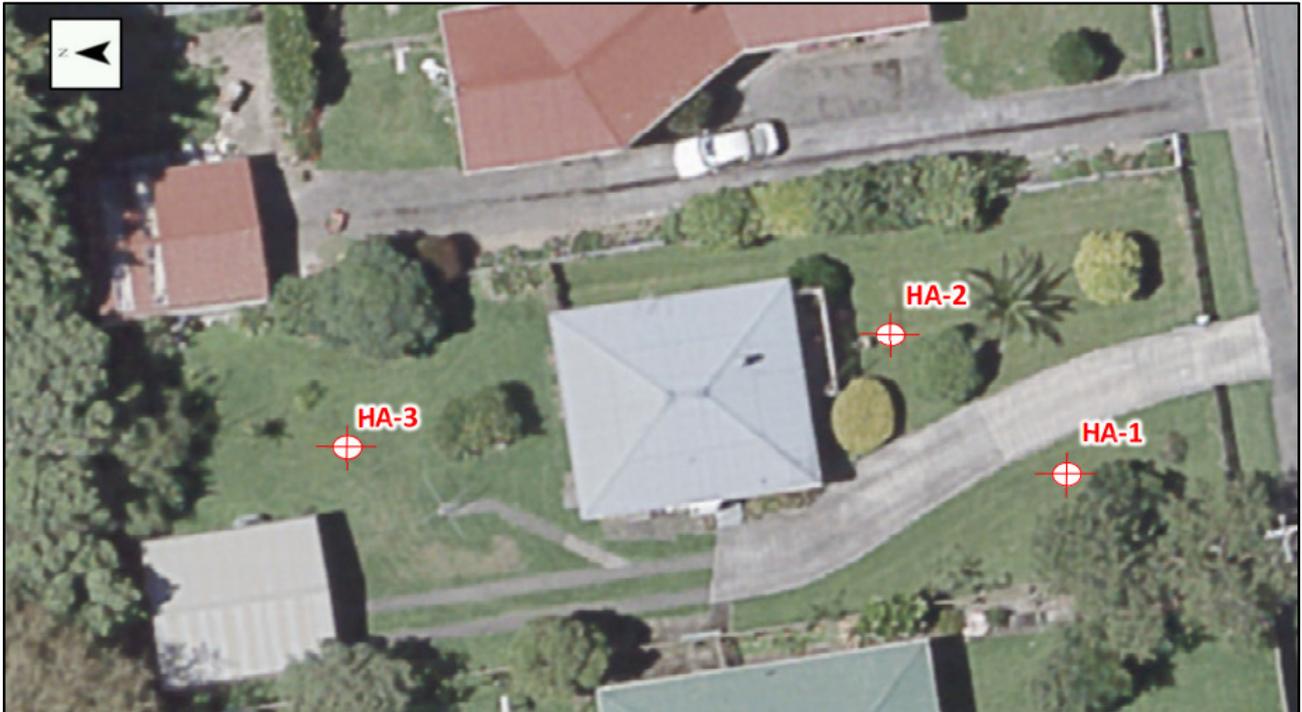
Figure 6-1 : Site Investigation Plan

One soakage test was conducted at 1.0m bgl in HA-3 to determine the soakage rate of the site. The soakage test was in accordance with Low Impact Urban Design and Development (LIUDD) stormwater guideline.

A site investigation location plan is presented below, the hand auger and Scala penetrometer logs are presented in Appendix A.

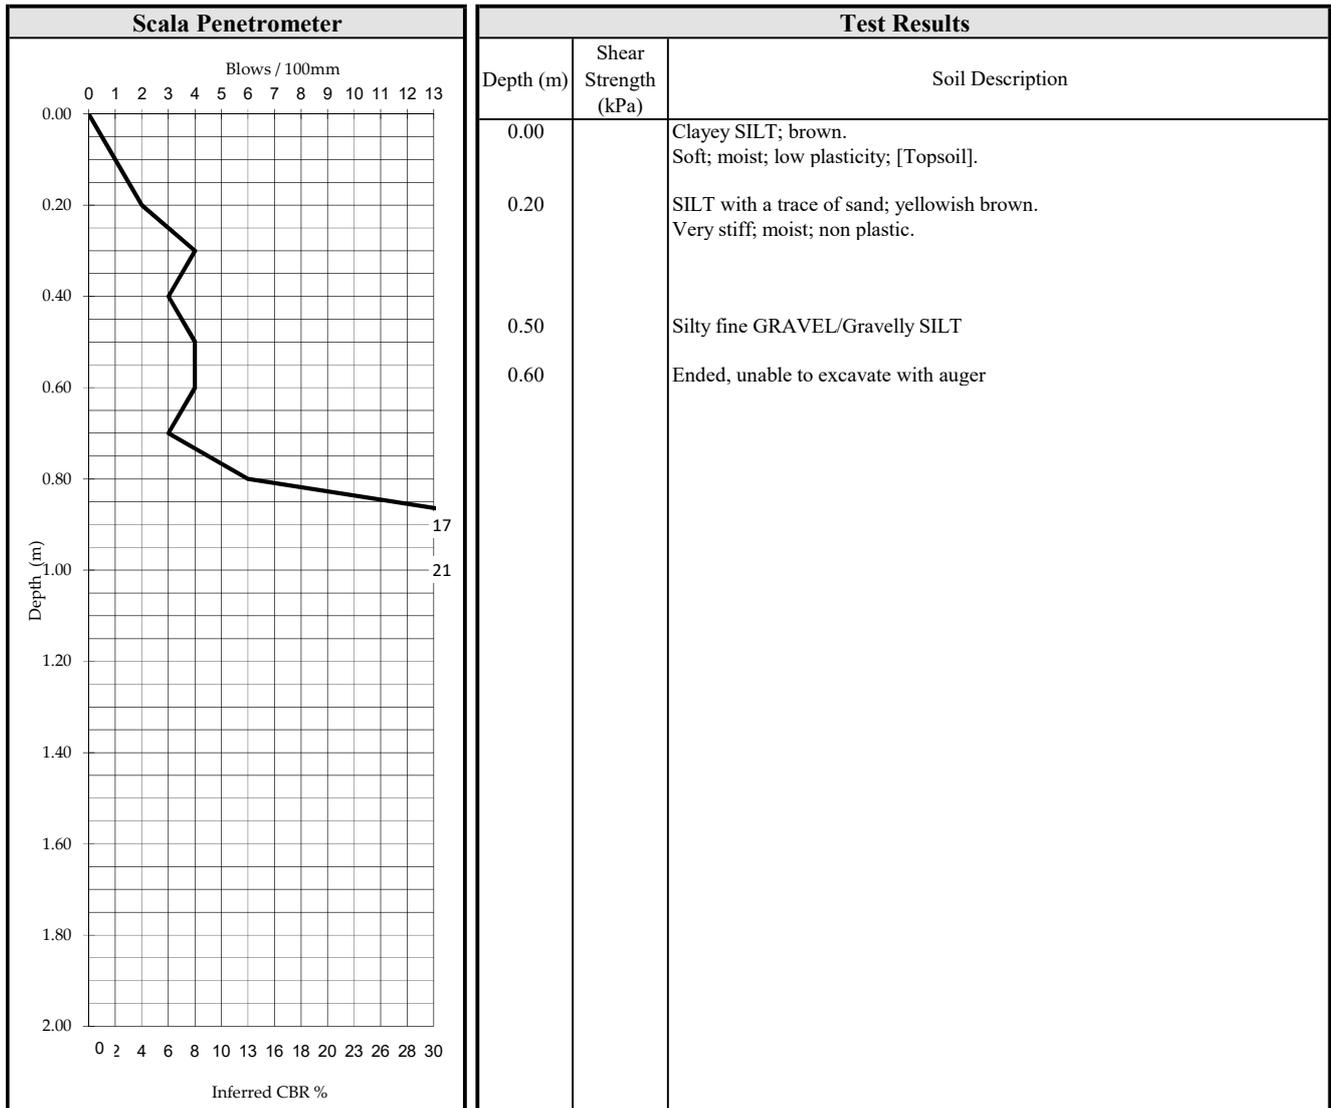
**Project No : N-H0060.03**  
**Lab Ref No : WA484.4**  
**Client Ref No :**

Test Methods	
Determination of Penetration Resistance of a Soil, NZS 4402 : 1988, Test 6.5.2 Inferred CBR values taken from Austroads Pavement Design Manual 2004	Field Descriptions of Soils and Rocks by NZ Geotechnical Society Dec 2005 and Inferred CBR values are not IANZ accredited.

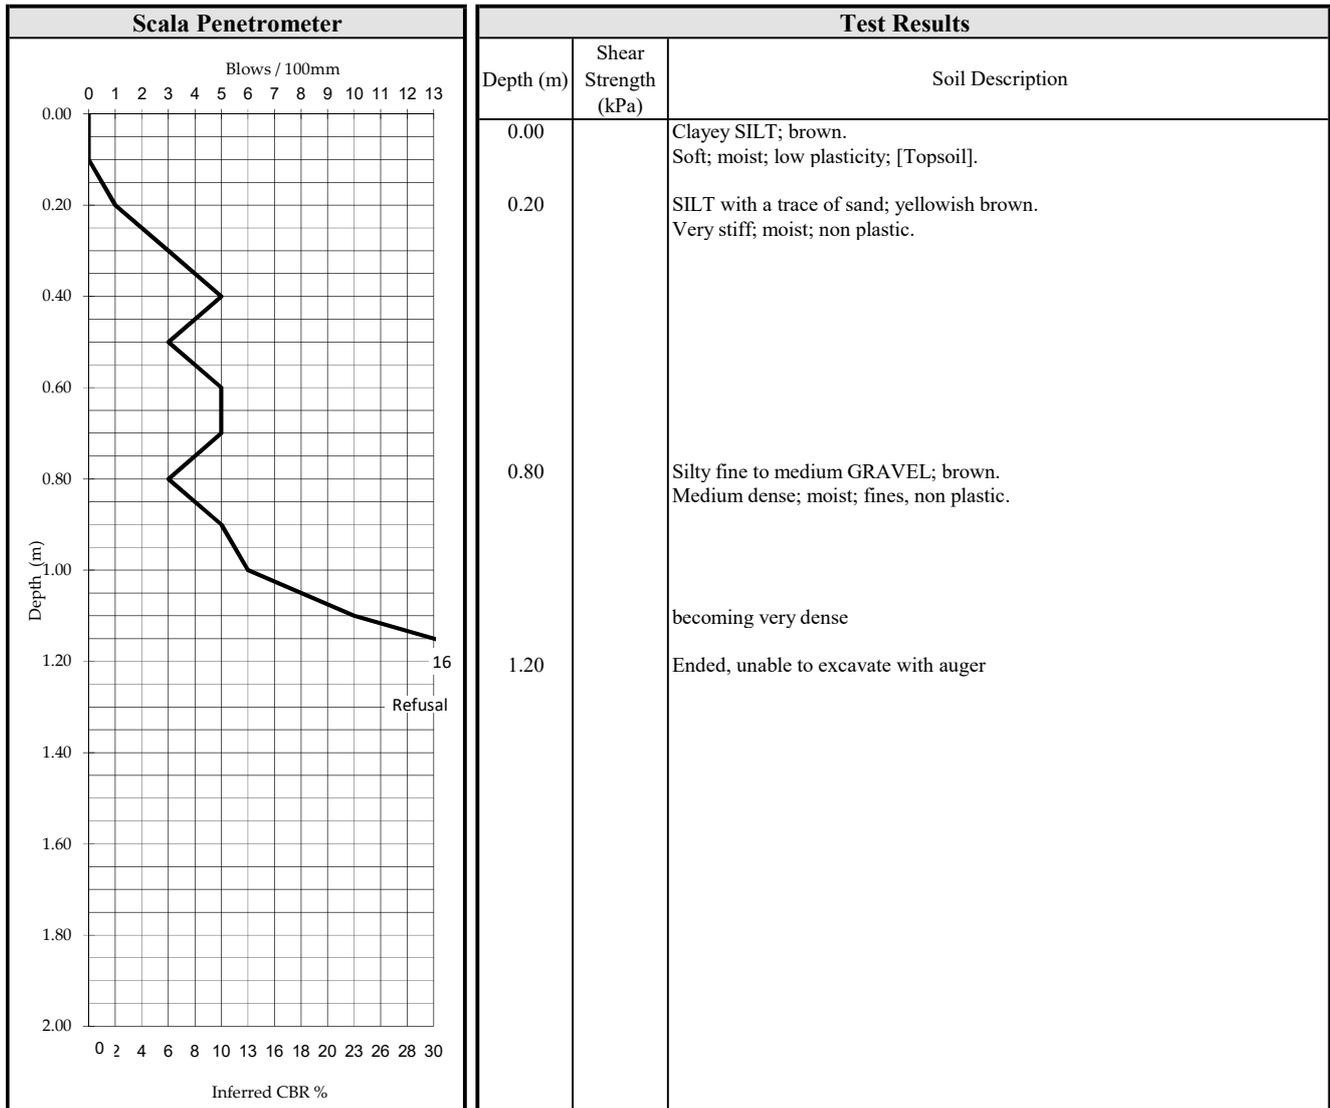
**Project No : N-H0060.03**  
**Lab Ref No : WA484.5**  
**Client Ref No :**

Test Methods	
Determination of Penetration Resistance of a Soil, NZS 4402 : 1988, Test 6.5.2 Inferred CBR values taken from Austroads Pavement Design Manual 2004	Field Descriptions of Soils and Rocks by NZ Geotechnical Society Dec 2005 and Inferred CBR values are not IANZ accredited.

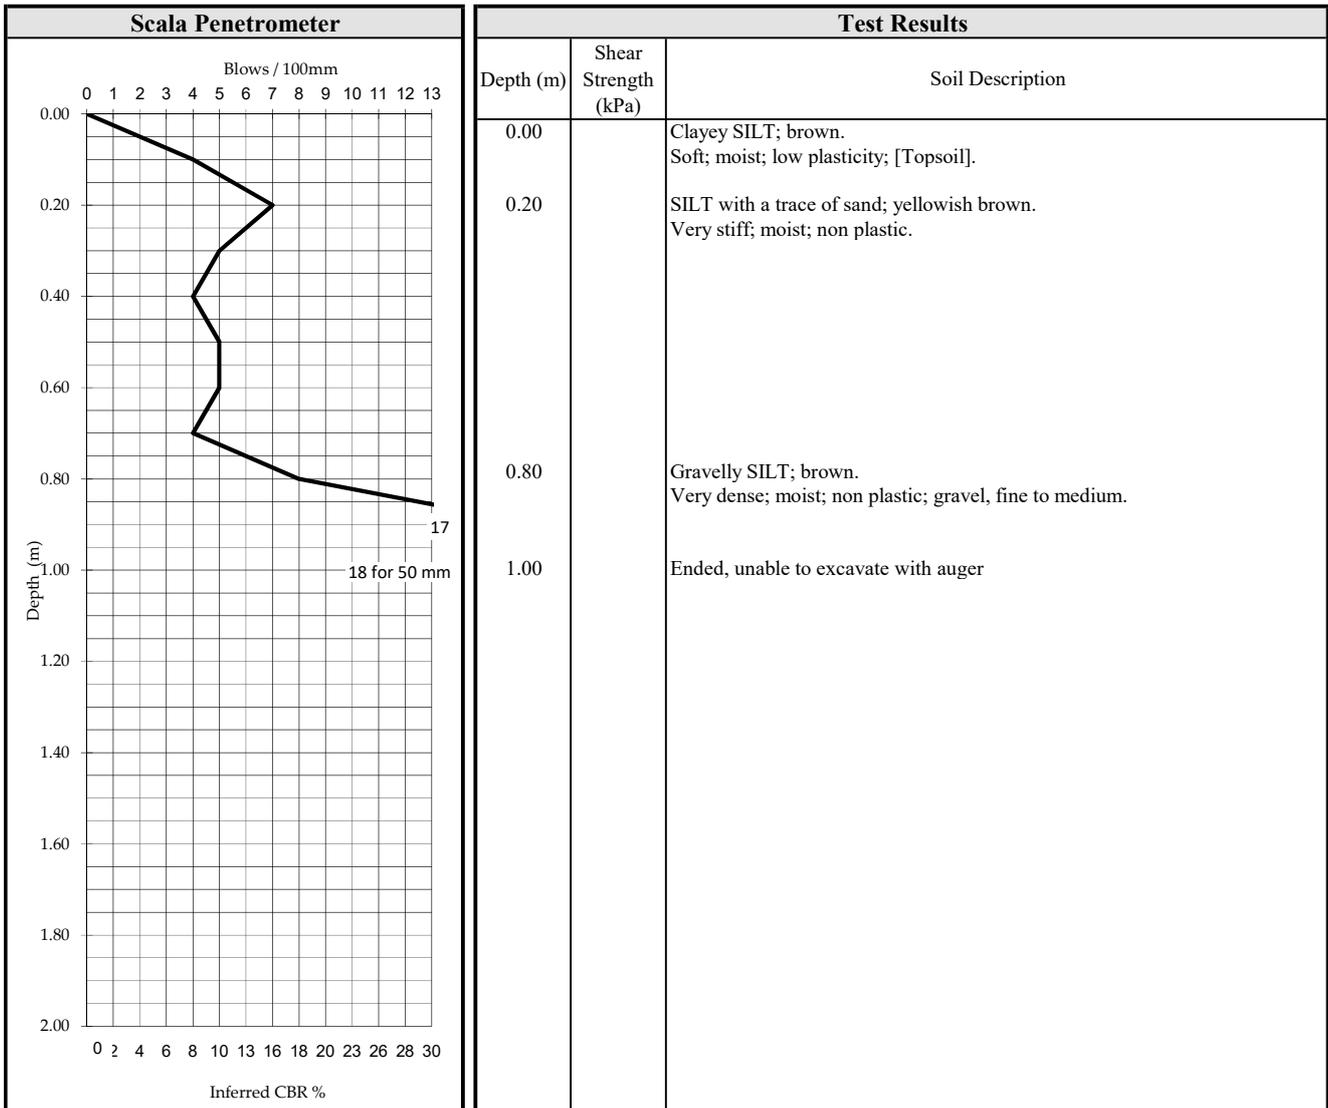
**Project No : N-H0060.03**  
**Lab Ref No : WA484.6**  
**Client Ref No :**

Test Methods	
Determination of Penetration Resistance of a Soil, NZS 4402 : 1988, Test 6.5.2 Inferred CBR values taken from Austroads Pavement Design Manual 2004	Field Descriptions of Soils and Rocks by NZ Geotechnical Society Dec 2005 and Inferred CBR values are not IANZ accredited.

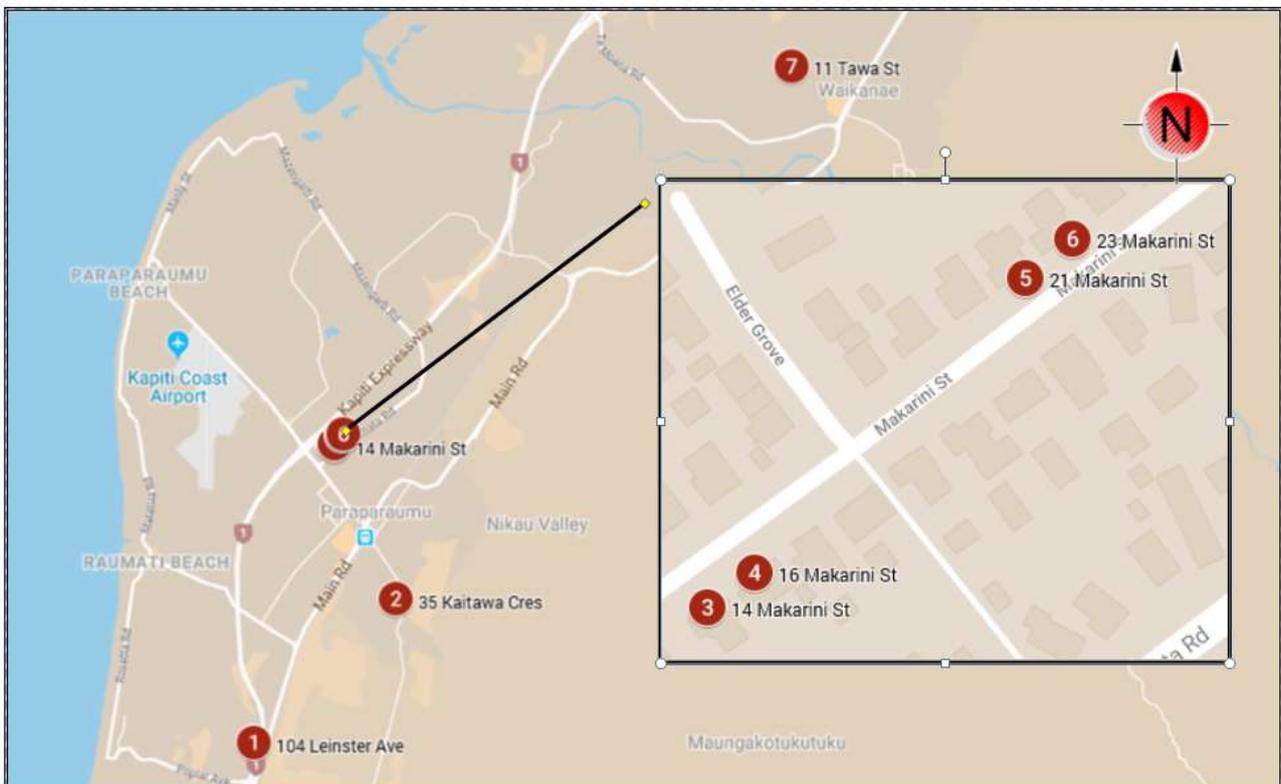
The sampling plan including sequence and regional location of properties is provided in Figure 1 below.

Figure 1: Housing NZ Site investigation locations and sampling sequence.

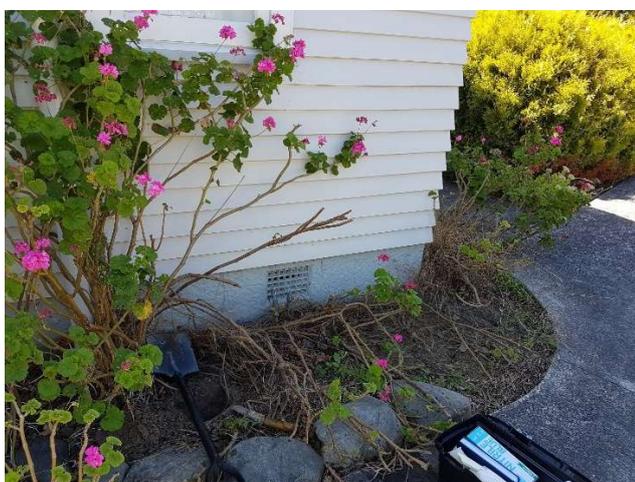
Photo 7: Test Pit 6 location 35 Kaitawa Crescent. Site of lead contaminated soil sample

A detailed site investigation (DSI) has been carried out by WSP-Opus by Senior Public Health Scientist Scott Rostron in February 2019 (see Appendix G). Two surface soil samples were collected for asbestos analysis and four near surface samples were collected for lead analysis, within 1m of the existing unit. The samples were assessed against the National Environmental Standard Soil Contaminant Standards for Health (SCS<sub>(Health)</sub>) based on the Ministry for the Environment's Contaminated Land Management Guidelines - Methodology for Deriving Standards for Contaminants to Protect Human Health for Residential 10% produce land use (Table 2, Appendix G).
