Appendix I Geotechnical Assessment

Prepared by Torlesse

Geotechnical Assessment Report

160 Mazengarb Road

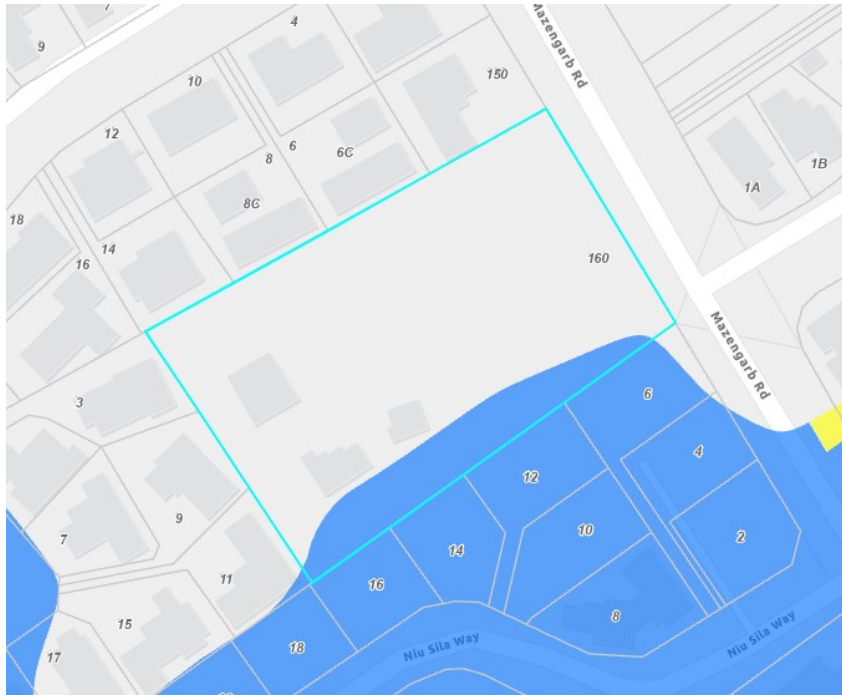
Figure 1: KCDC flood hazard map—Ponding

Source	Source Description	Data Description	Notes
GNS	NZ Geological Webmap (1:50,000)	Holocene windblown deposits	Inactive dunes.
	NZ Active Fault Database	Ohariu Fault ~ 3.5km southeast Gibbs Fault—4.7km southeast	Dextral, RI II >2,000 to <= 3,500 years, slip rate moderate. Dextral, RI III >3,500 to <= 5,000 years, slip rate low.
GWRC	Mapped Hazard	Combined Hazard Ground Shaking Liquefaction Slope	Moderate to high Moderate High Low
KCDC	Flood Hazards	Ponding on site GWRC Flood Hazard Webmap notes a 1%AEP.	Stream corridor shown 120m south-east of the property.
	Historical Aerial Imagery	1940s—One building existing on site 1991—Two buildings added to property.	No major changes to site between 1991 and 2021.
Retrolens	Historical Aerial Images	1942—Single building present on the property. 1964—Small structure added to north end of site. 1966—Northern structure no longer present. 1991—Building added to south end of property, near the existing driveway

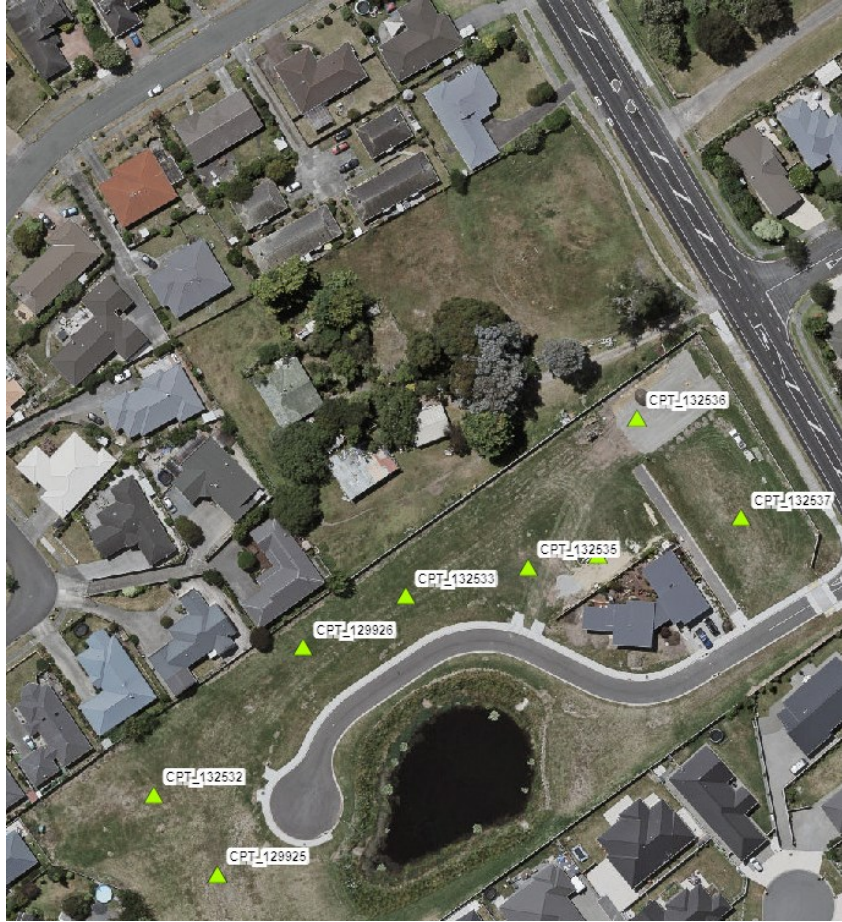
Figure 2: NZGD test locations

NZGD	Nearby Investigation Records	18 CPTs and 5 hand auger logs have been completed within 300m of the site.	Logs generally indicated sands with gradually increasing soil strength.

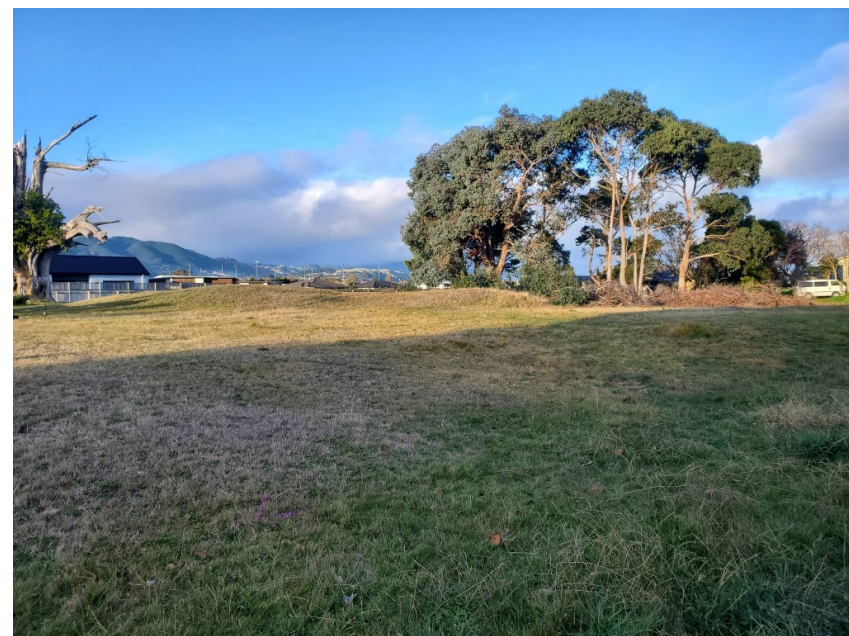
Figure 3: Photo near CPT02, looking South

Element	Description
Date of Visit	4 and 8 July 2024
Vegetation and topography	The property is vegetated with several large trees and grass. The north area of the property has a higher elevation than the south area (up to 2m difference in places), with generally undulating topography.
Site structures (buildings, walls, etc)	There is currently an existing dwelling and garage located on the property. In terms of foundations, the garage has a concrete slab while the dwelling is on piles.
Underground and overhead services	All services are underground on this property.
Soil/ rock exposures	No soil or rock exposures were observed on the property,
Water/ Drainage	No drainage features were observed.

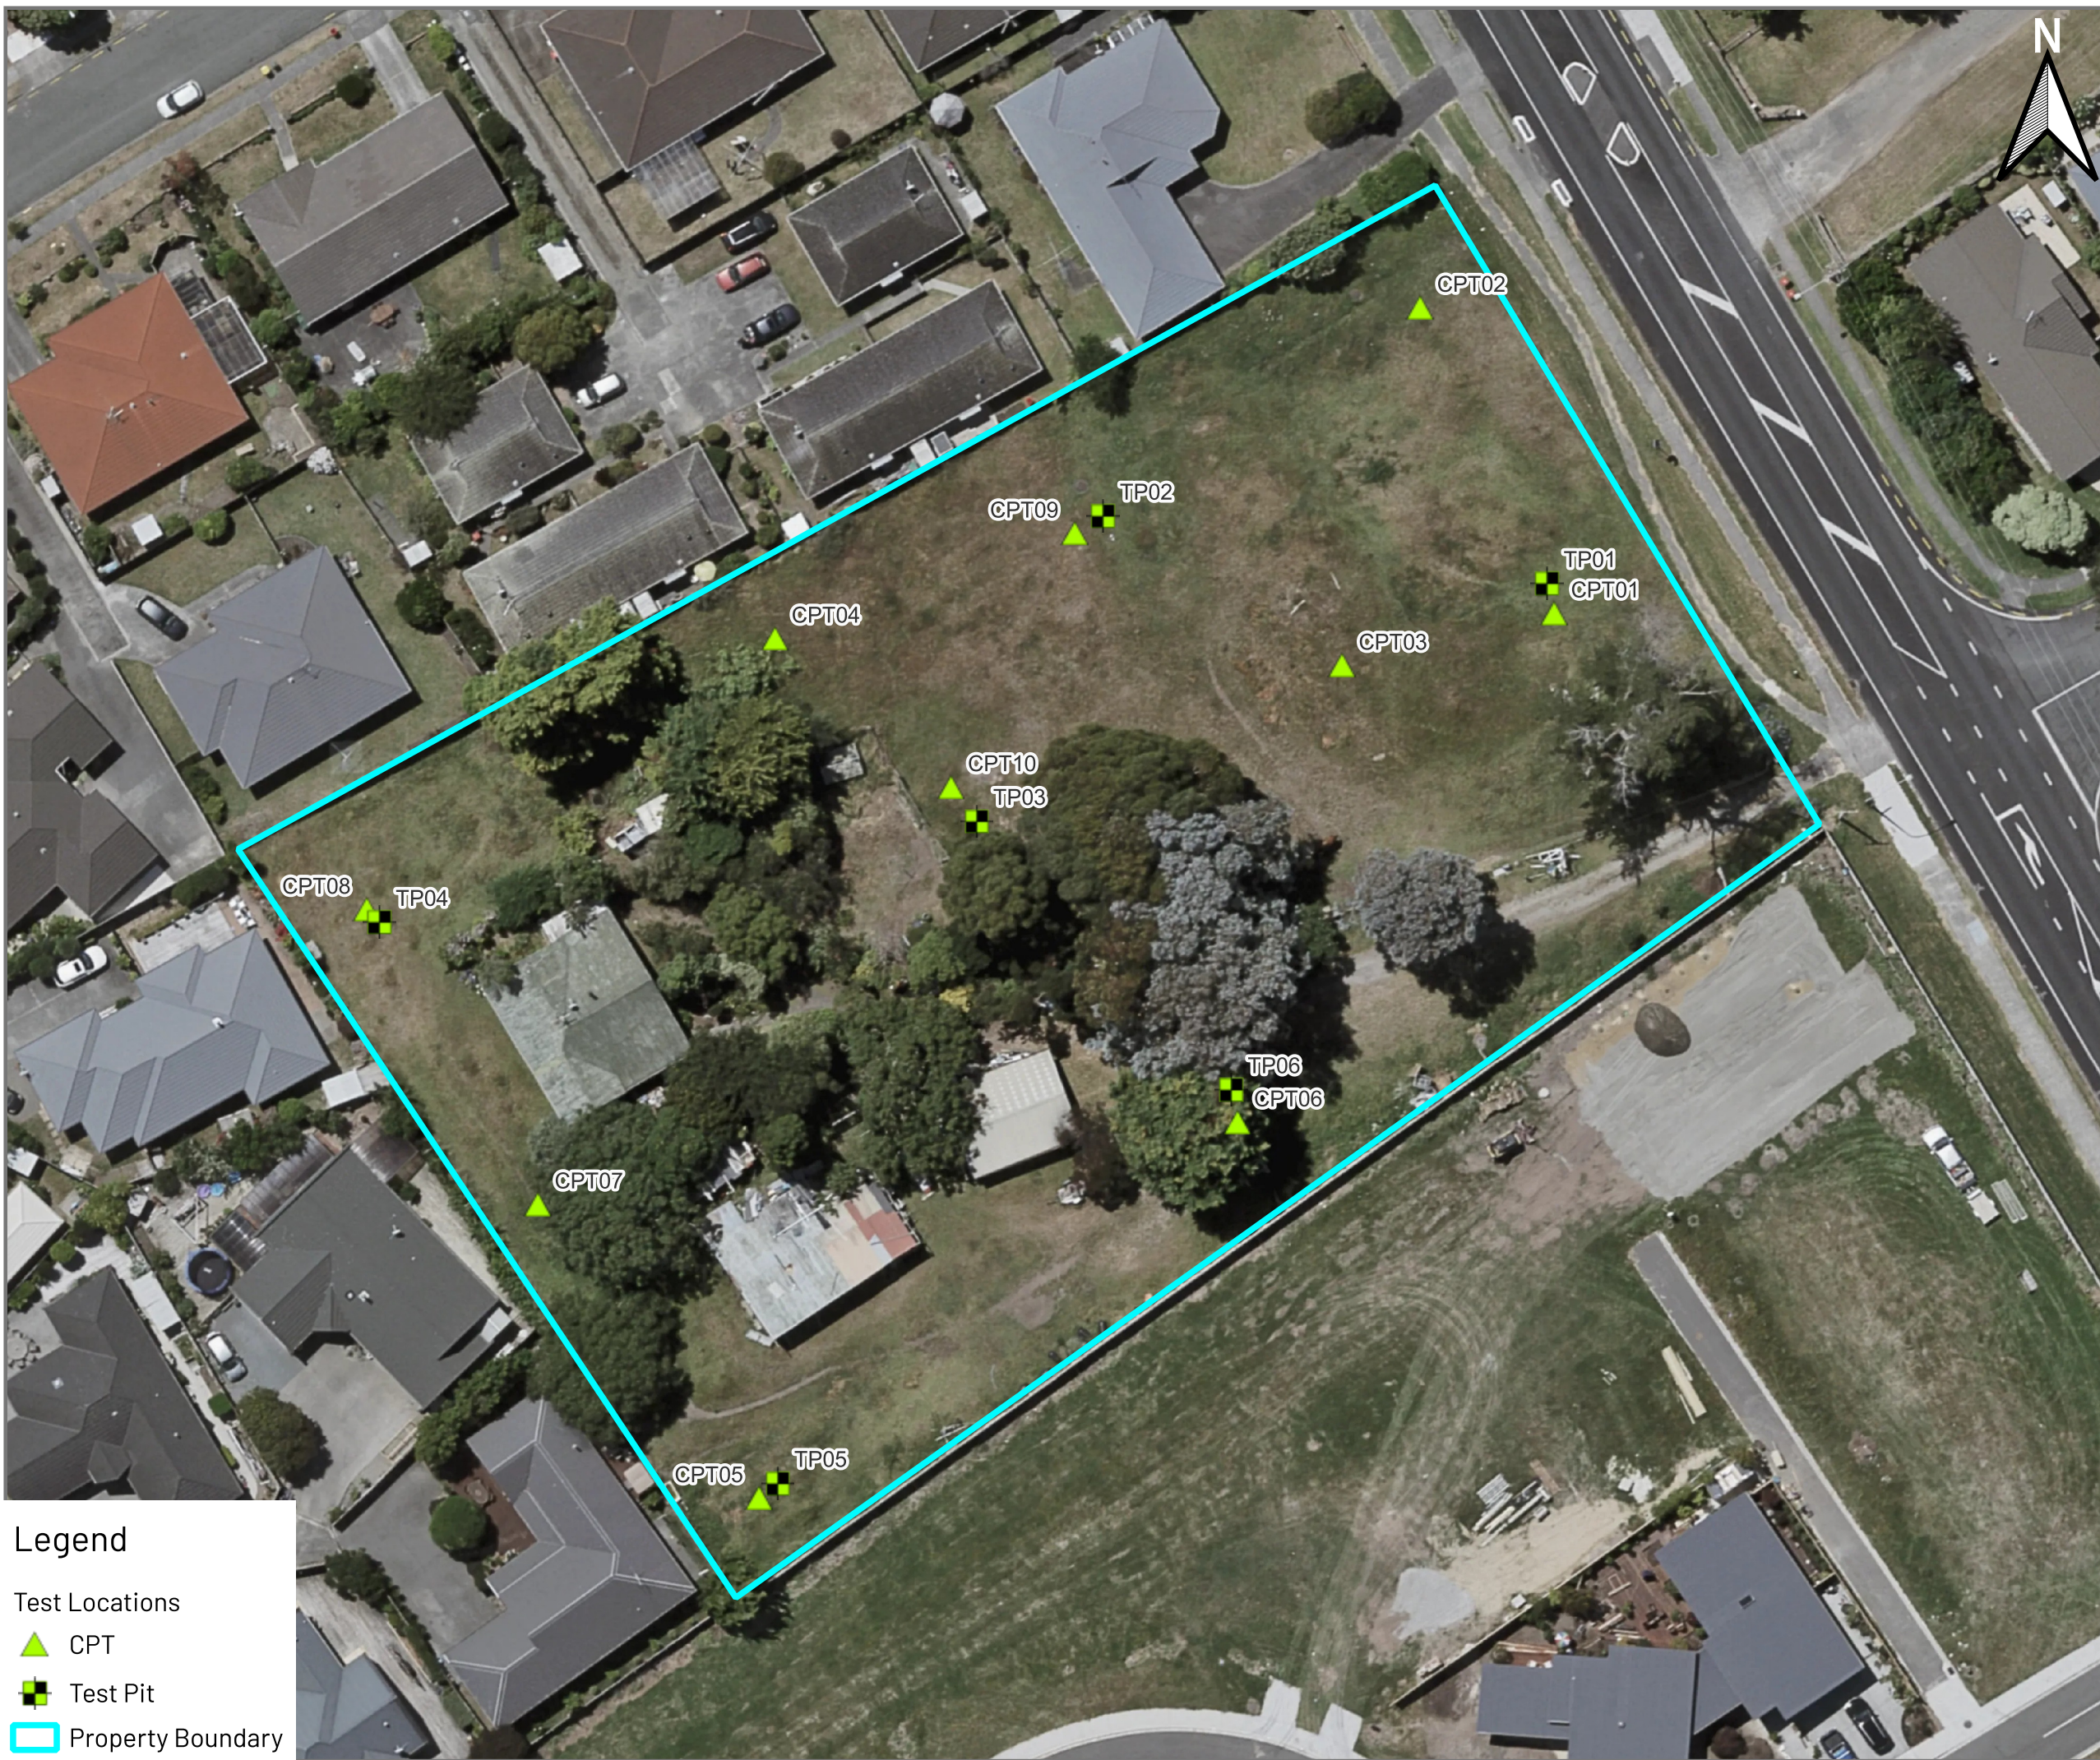
Sketch Title:
Test Location Plan

A geotechnical investigation was completed between the 4 and 8 July 2024 and consisted of 6 No. Test Pits to a maximum depth of 3.2m below existing ground level and 10 CPTs to a maximum depth of 15m where refusal was encountered.

- CPT05 was repeated due to early refusal with the second test achieving 12m.
- A DCP was undertaken at each pit location to refusal.
- The test locations are shown on Sketch 1 in Appendix A.
- A full copy of the Test Pit and CPT logs are included in Appendix C.

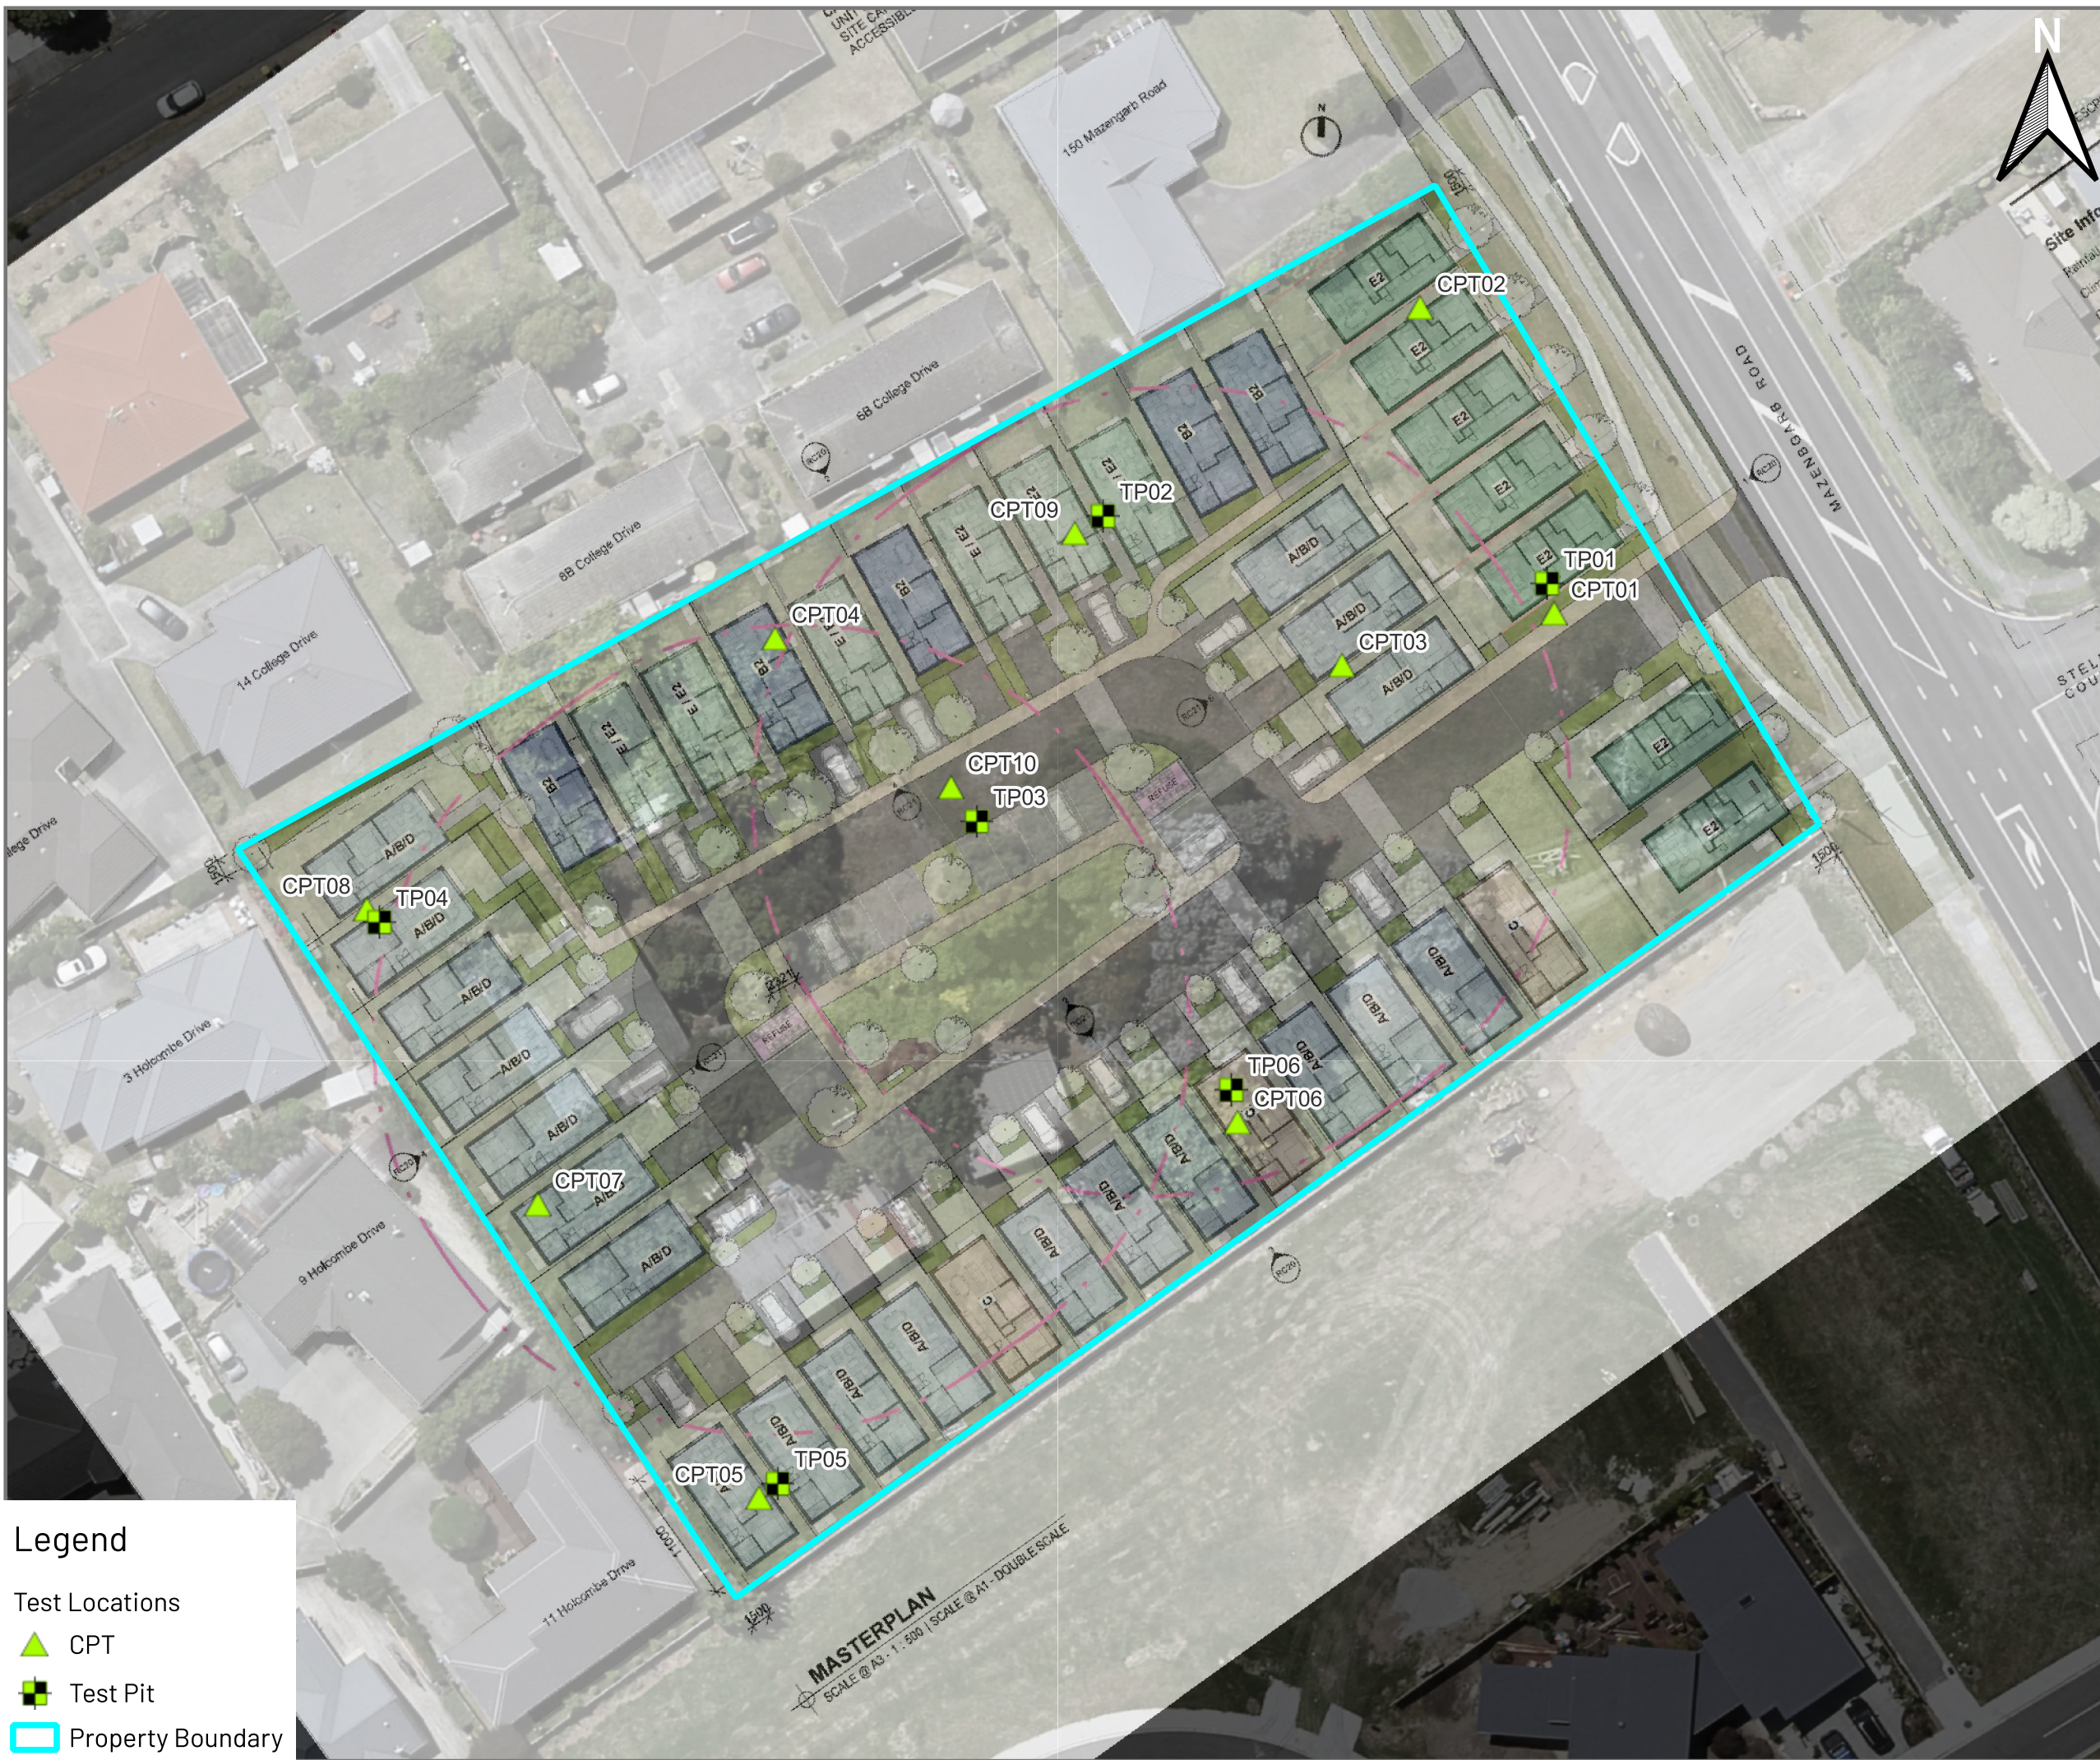
Sketch Title:
Proposed Development Plan

A copy of the proposed layout is included in Appendix B, while Sketch 2 in Appendix A shows the testing locations overlaid on the proposed development.

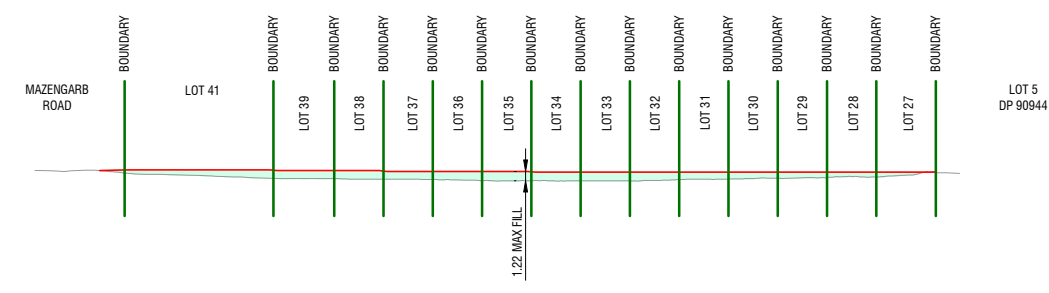
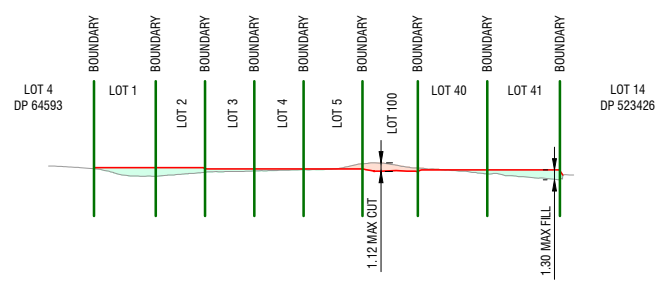
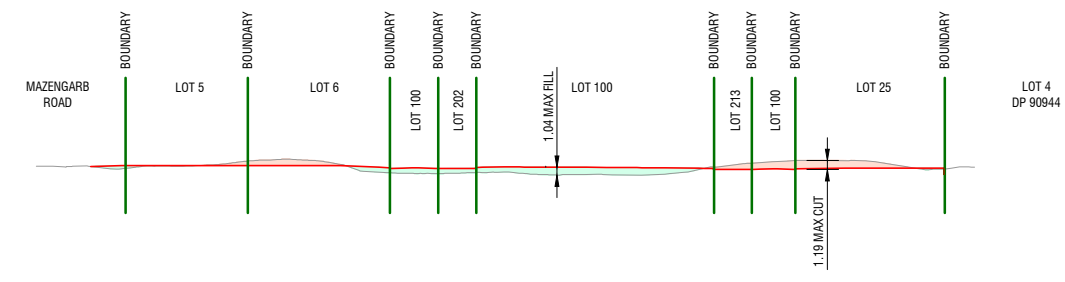
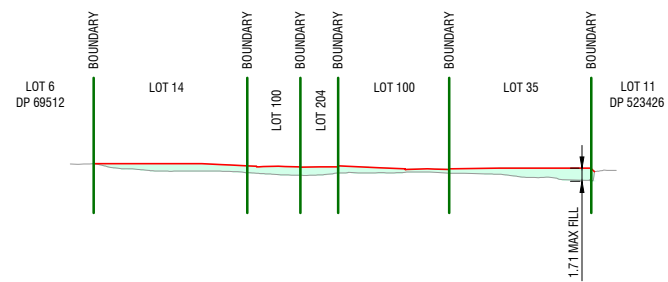
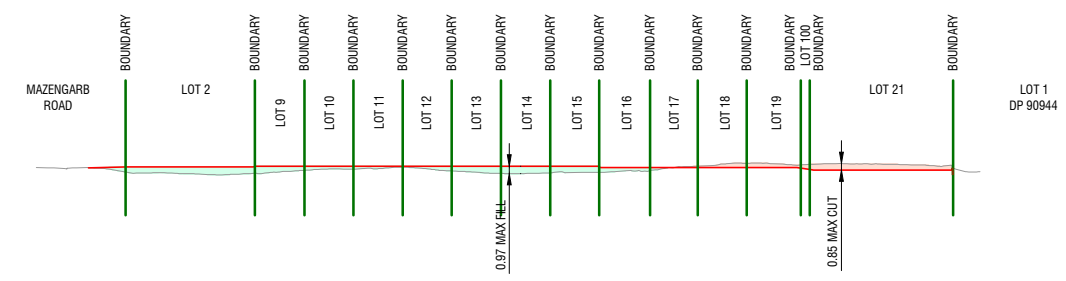
- Increasing site levels by up to 2.0m to create a near level building platform between 5.8m RL and 6.5m RL.
- A total of 41 individual units are proposed consisting of 1 and 2 storey structures.
- The units are a mix of 1, 2 and 3 bedroom units.
- The units are proposed to be timber framed with the use of light weight construction material.
- The development also includes a driveway and associated parking.

CUT = 1300m³ (MEASURED SOLID)
 FILL = 3300m³ (MEASURED SOLID)
 BALANCE = 2000m³ (MEASURED SOLID)

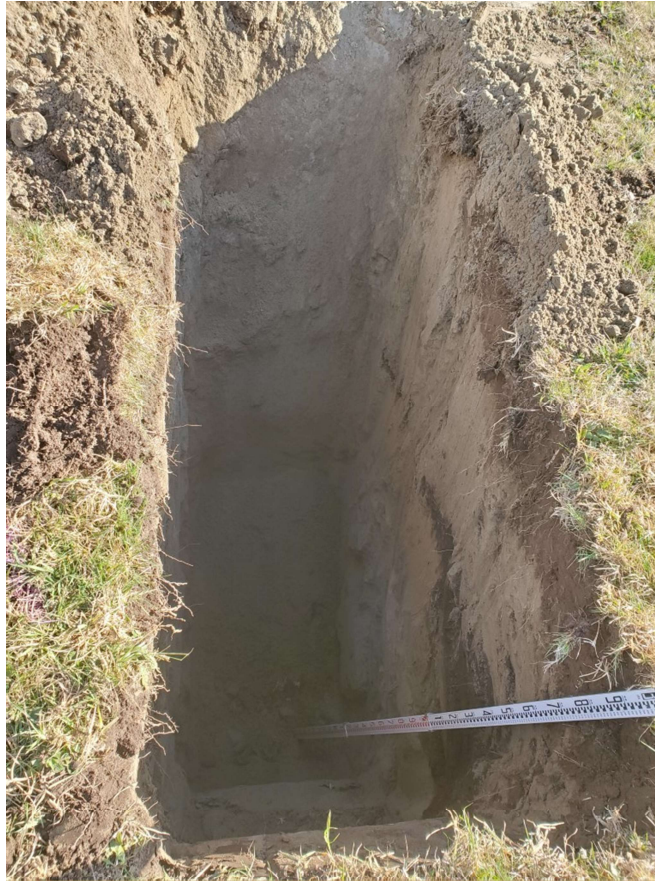
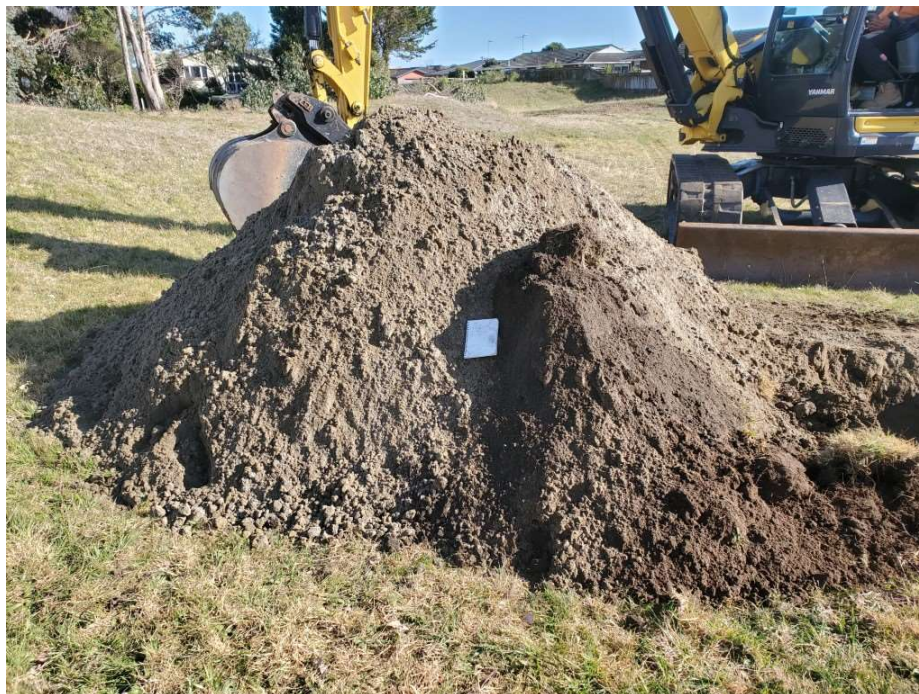
TP01 Pit

Depth Scale	Lithologic Description	Symbol	Samples	Vane Shear Test (Su)	Pocket Penetrometer	Manual DCP	Comments / Additional Notes
0	Ground Surface						
0	TOPSOIL						
	Fine to coarse SAND Light brown, loose, moist.						
	Fine to medium SAND With trace silt. Dark brown, loose to medium dense, moist. Silt is non-plastic.						
	Fine SAND Light brown, medium dense, moist.						
	Fine to medium SAND Grey, medium dense, moist.						
2	From 2.2m bgl - Medium dense to dense.						
	From 2.5m bgl - Dense.						
3	Test Hole Terminated at 3 m - Target depth.						
4							
5

Coordinates obtained from mobile phone GPS.
Elevation estimated from Cuttriss Consultants Topographic Survey.
Groundwater was not encountered.

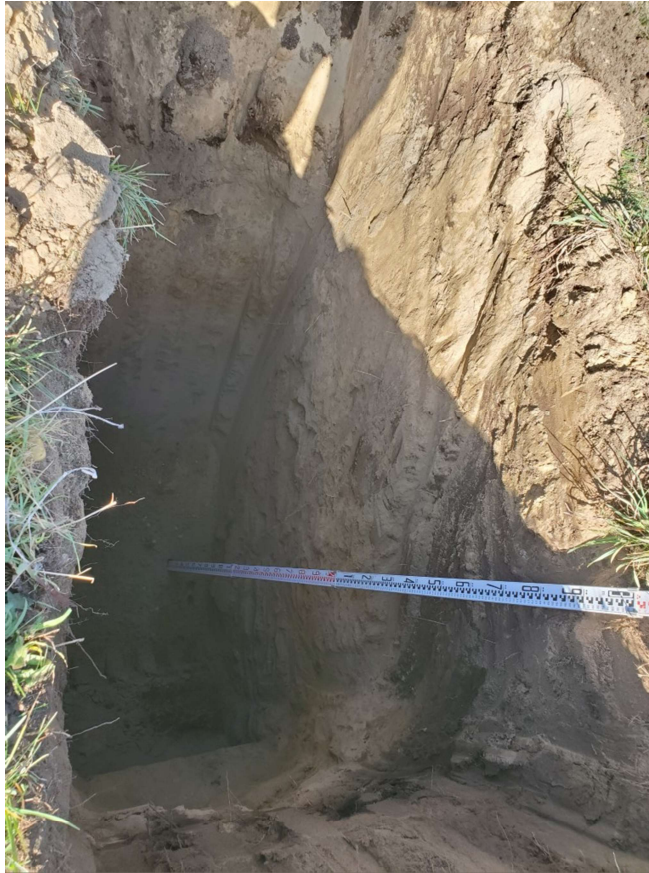
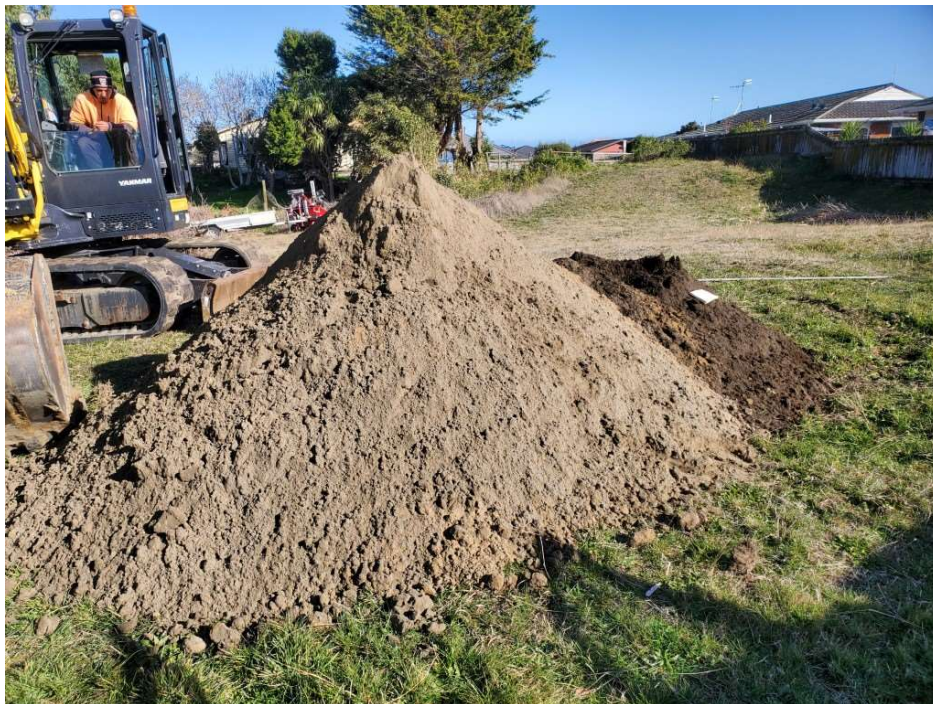
TP02 Pit

Depth Scale	Lithologic Description	Symbol	Samples	Vane Shear Test (Su)	Pocket Penetrometer	Manual DCP	Comments / Additional Notes
						0 5 10 15 20	
Ground Surface							
0	TOPSOIL						
	Fine to medium SAND With trace gravel. Dark brown, loose, dry to moist. Gravels are fine to medium, sub-round. (FILL?).						
	Fine to medium SAND With trace rootlets. Brown, loose, dry to moist.						
	Fine SAND Light brown, medium dense, dry to moist.						
	Fine to coarse SAND Grey brown, medium dense to dense, moist. From 2.1m bgl - Dense.						
	Test Hole Terminated at 3.1 m - Target depth.						
5

Coordinates obtained from mobile phone GPS.
Elevation estimated from Cuttriss Consultants Topographic Survey.
Groundwater was not encountered.

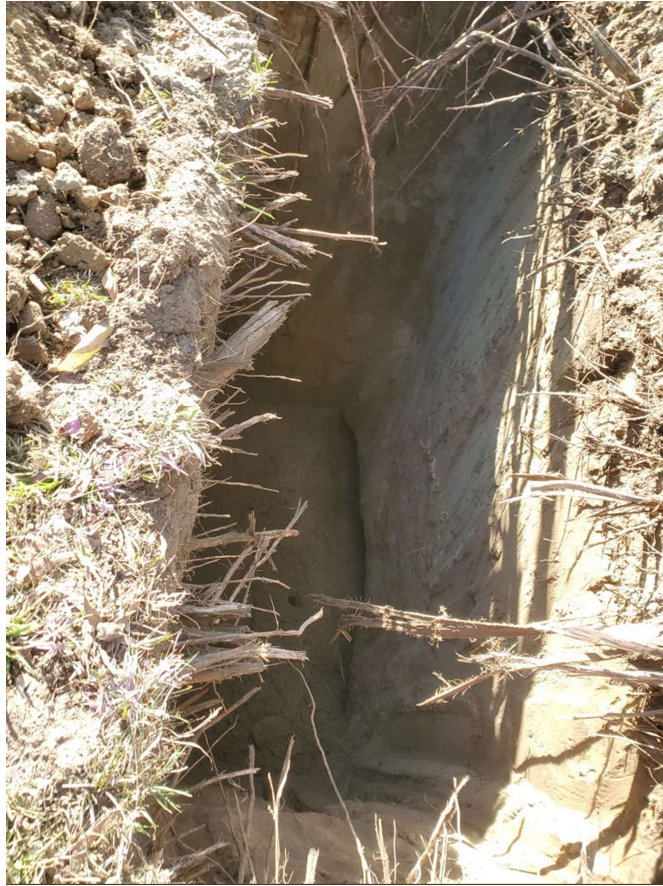
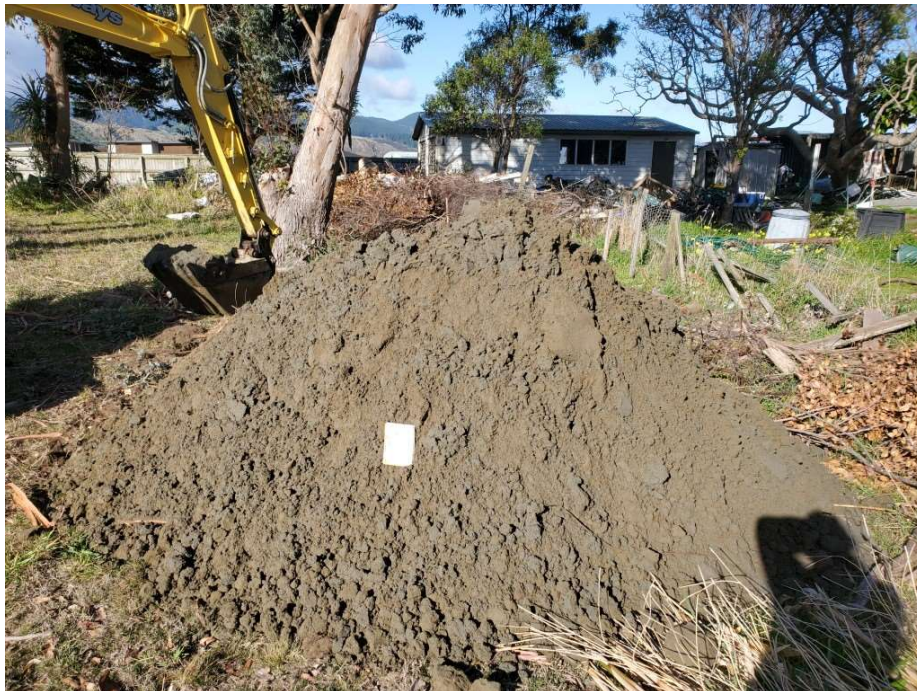
TP03 Pit

Depth Scale	Lithologic Description	Symbol	Samples	Vane Shear Test (Su)	Pocket Penetrometer	Manual DCP	Comments / Additional Notes
0	Ground Surface						
0	TOPSOIL						
0	Fine SAND With minor tree roots. Brown, loose to medium dense, dry.						
0	Fine to coarse SAND With trace rootlets. Light brown, medium dense, dry to moist.						
1	From 1.2m bgl - Medium dense to dense.						
2	From 1.8m bgl - Dense.						
2	From 2.0m bgl - Moist.						
3	Fine to coarse SAND Grey, dense, moist to wet.						
3	Test Hole Terminated at 3.2 m - Target depth and pit wall collapse.						
4							
5

Coordinates obtained from mobile phone GPS.
Elevation estimated from Cuttriss Consultants Topographic Survey.
Groundwater was not encountered.

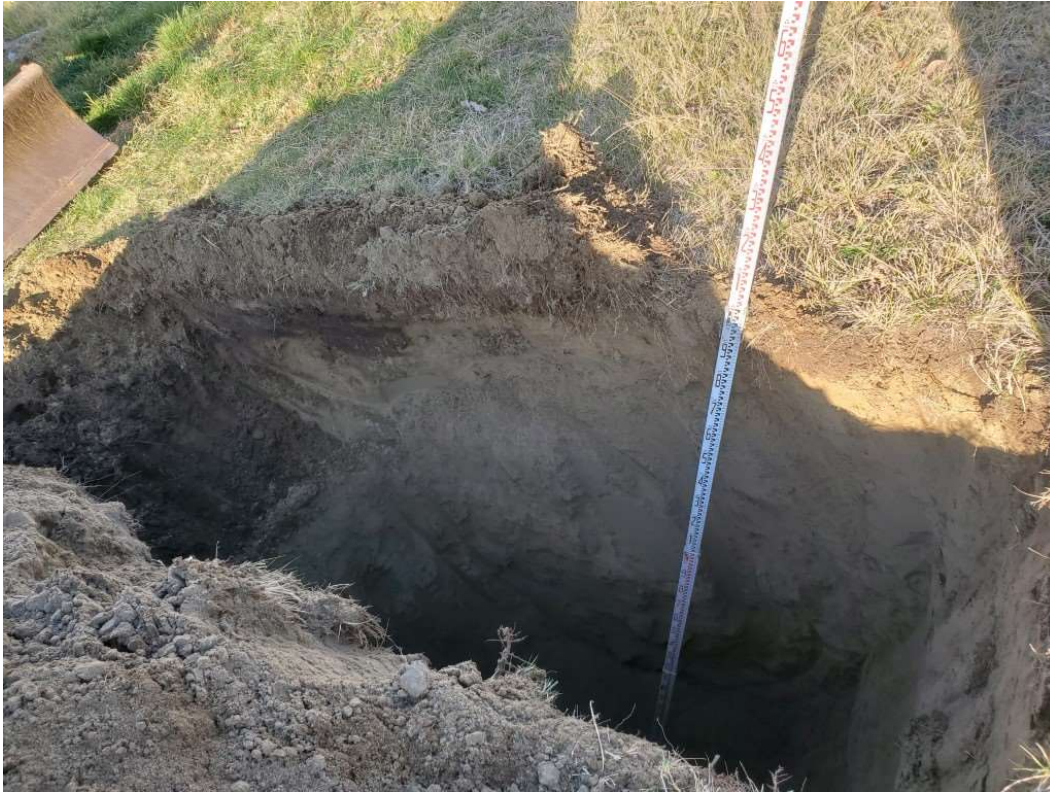
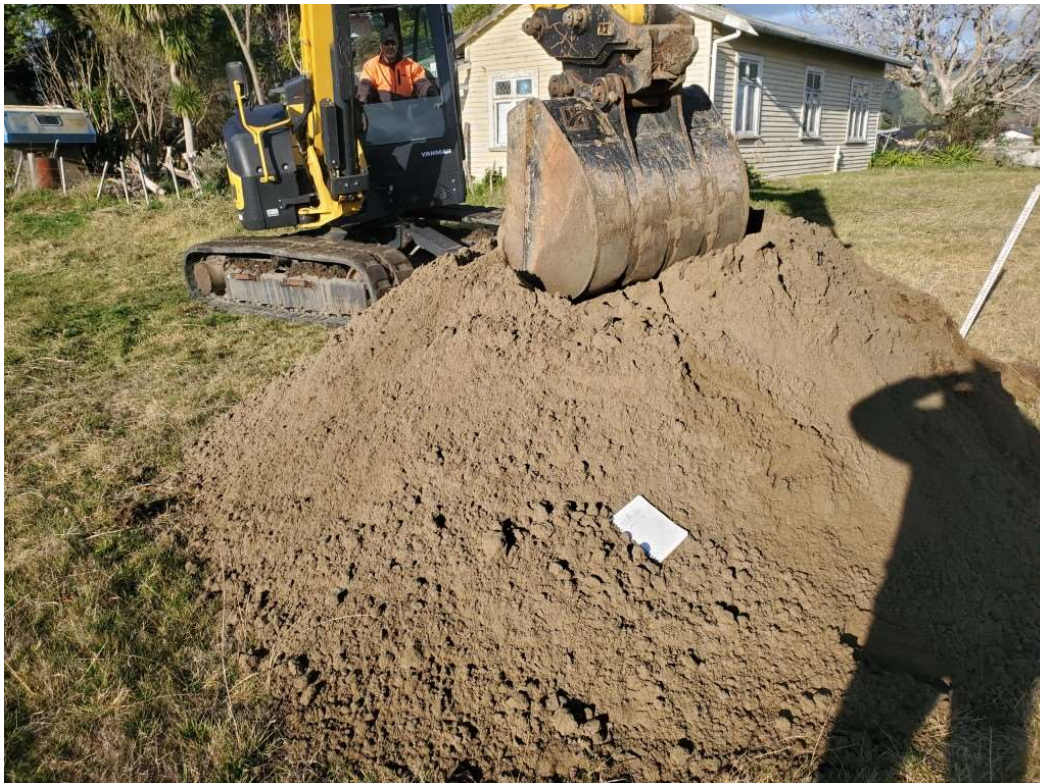
TP04 Pit

Depth Scale	Lithologic Description	Symbol	Samples	Vane Shear Test (Su)	Pocket Penetrometer	Manual DCP	Comments / Additional Notes
0	Ground Surface						
0	TOPSOIL						
	Fine to medium SAND Light brown, loose to medium dense, moist.						
	Fine to coarse SAND Light brown, loose, moist.						
1	From 1.1m bgl - Medium dense.						
2	From 2.0m bgl - Dense.						
3	Test Hole Terminated at 3 m - Target depth.						
4							
5

Coordinates obtained from mobile phone GPS.
Elevation estimated from Cuttriss Consultants Topographic Survey.
Groundwater was not encountered.

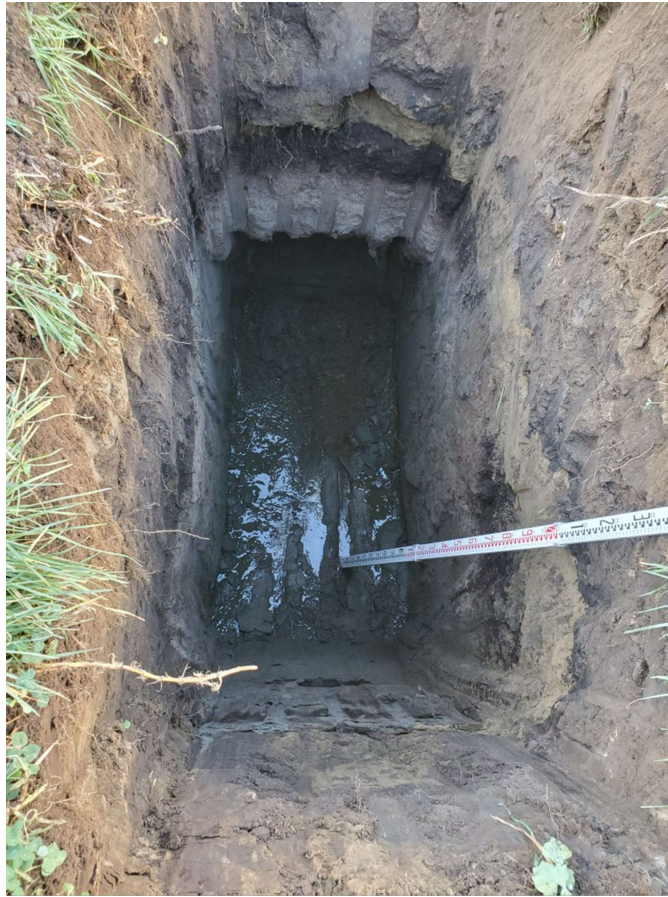
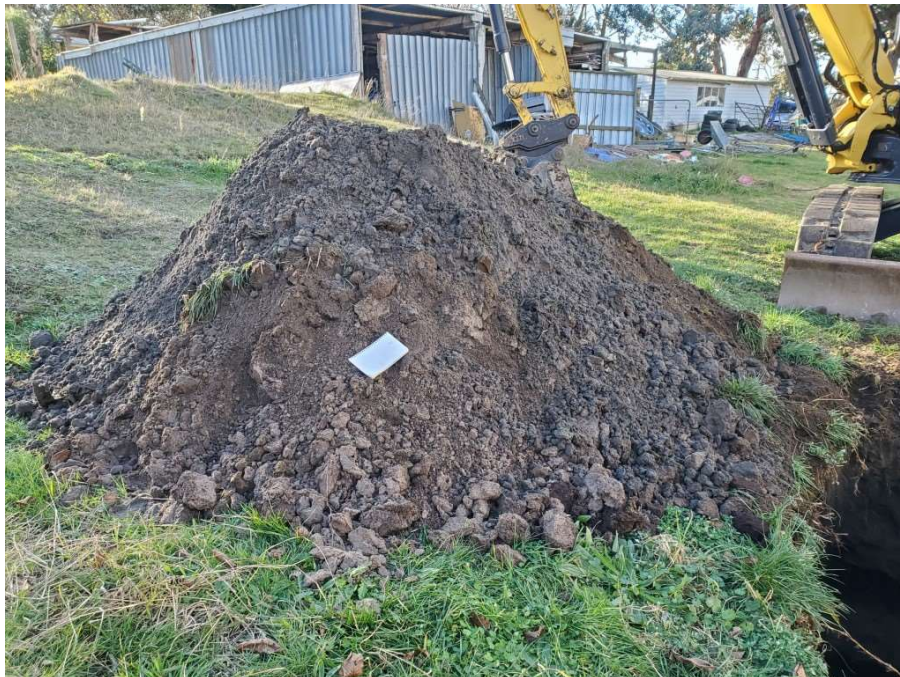
TP05 Pit

Depth Scale	Lithologic Description	Symbol	Samples	Vane Shear Test (Su)	Pocket Penetrometer	Manual DCP	Comments / Additional Notes
0	Ground Surface						
0	TOPSOIL						
	Fine to coarse SAND Light brown, loose, moist.						
	Sandy SILT With trace gravel and rootlets. Dark brown, stiff, moist. Non-plastic. Sand is fine to medium. Gravels are fine, sub-angular.						
	Fine to medium SAND Dark brown, medium dense, moist.						
1	Silty fine SAND Grey, moist. Silt has low plasticity.						
	Fine to coarse SAND Grey, medium dense, moist.						
	From 1.8m bgl - Strong organic smell.						
2	From 2.5m bgl - Saturated. Organics in base of pit (bark).						
3	Test Hole Terminated at 2.6 m - Refusal on organic material (possible log).						
08 Jul 2024							
3							
4							
5

Coordinates obtained from mobile phone GPS.
 Elevation estimated from Cuttriss Consultants Topographic Survey.

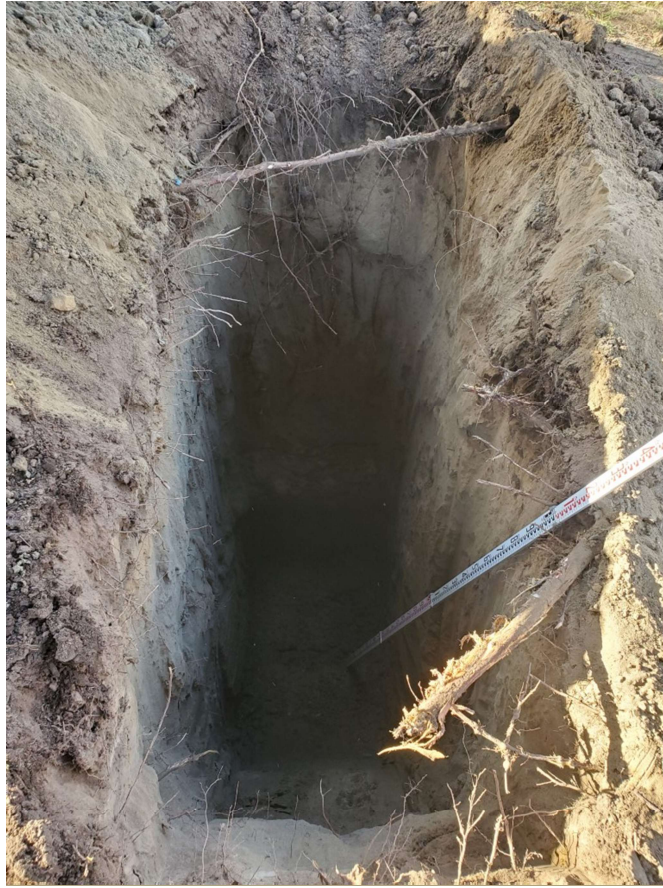
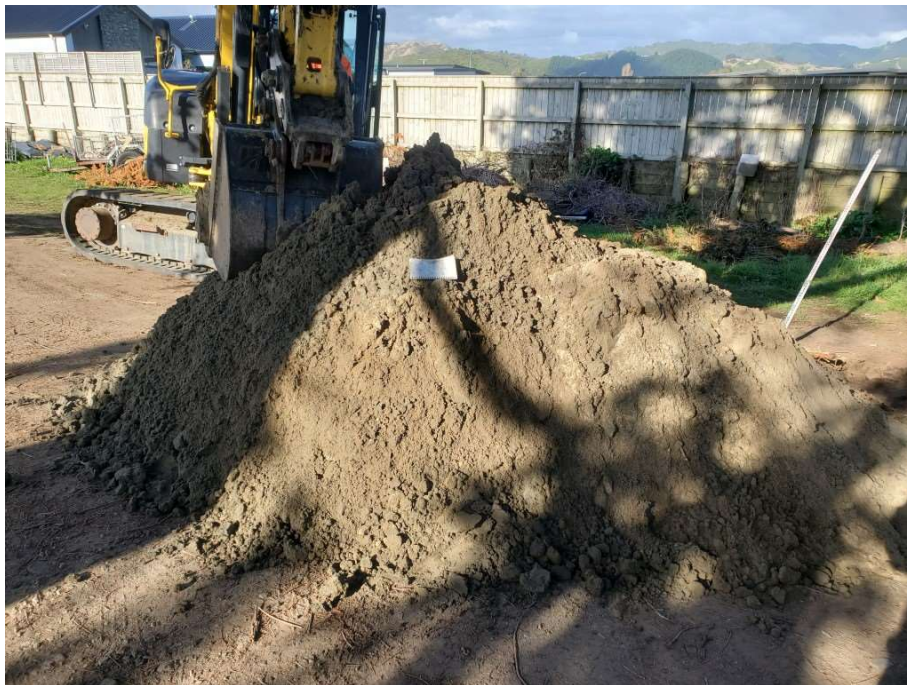
TP06 Pit

Depth Scale	Lithologic Description	Symbol	Samples	Vane Shear Test (Su)	Pocket Penetrometer	Manual DCP	Comments / Additional Notes
0	Ground Surface						
0	Fine SAND With trace tree roots. Grey brown, loose to medium dense, dry.	[Symbol]					
	Fine SAND Light brown, medium dense to dense, dry.	[Symbol]					
1	From 1.1m bgl - Dense.	[Symbol]					
2	Fine to coarse SAND Grey, dense, moist.	[Symbol]					
3	From 3.0m bgl - Wet.	[Symbol]					
	Test Hole Terminated at 3.1 m - Target depth and pit wall collapse.						
4							
5

Coordinates obtained from mobile phone GPS.
 Elevation estimated from Cuttriss Consultants Topographic Survey.
 Groundwater was not encountered, however some seepage was observed in the base of the pit.
