Appendix I Geotechnical Assessment

Prepared by Torlesse

Geotechnical Assessment Report

160 Mazengarb Road

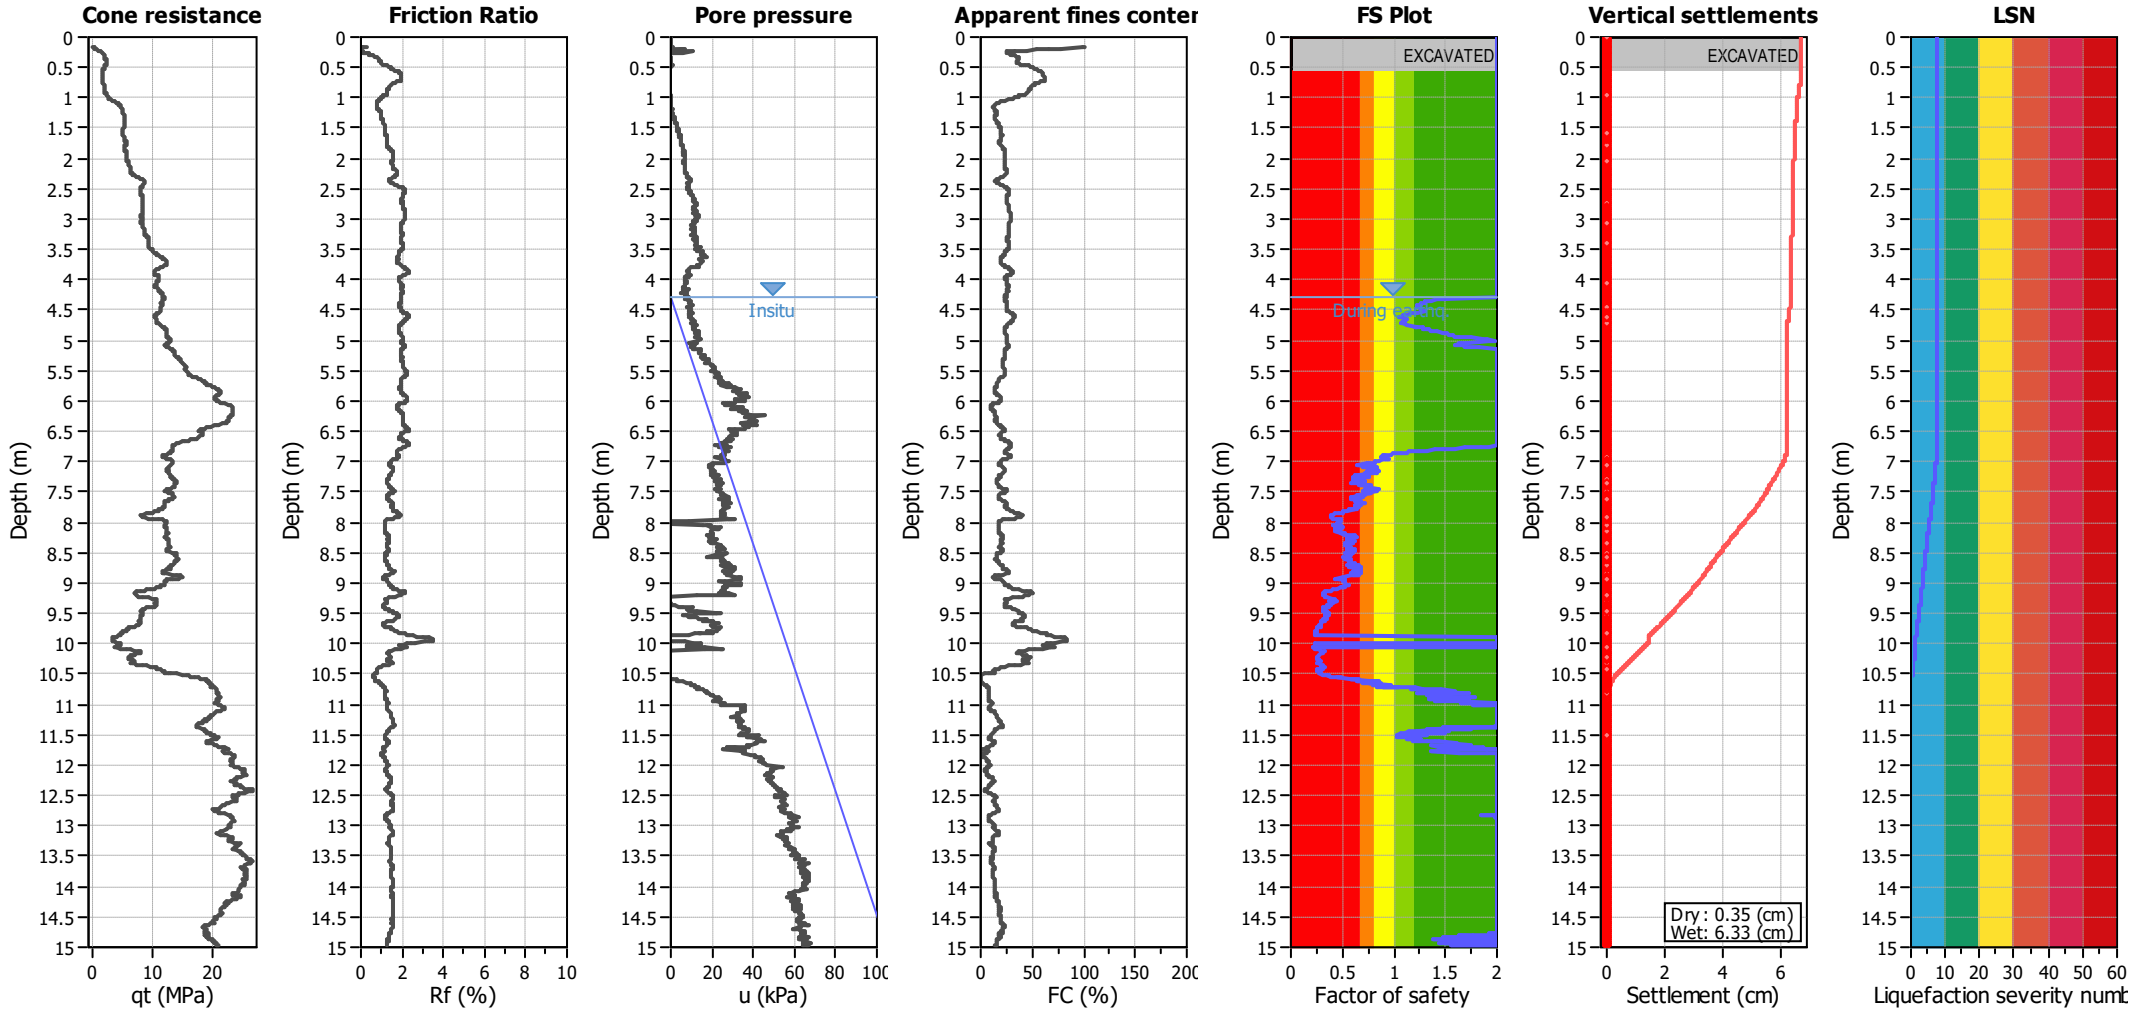
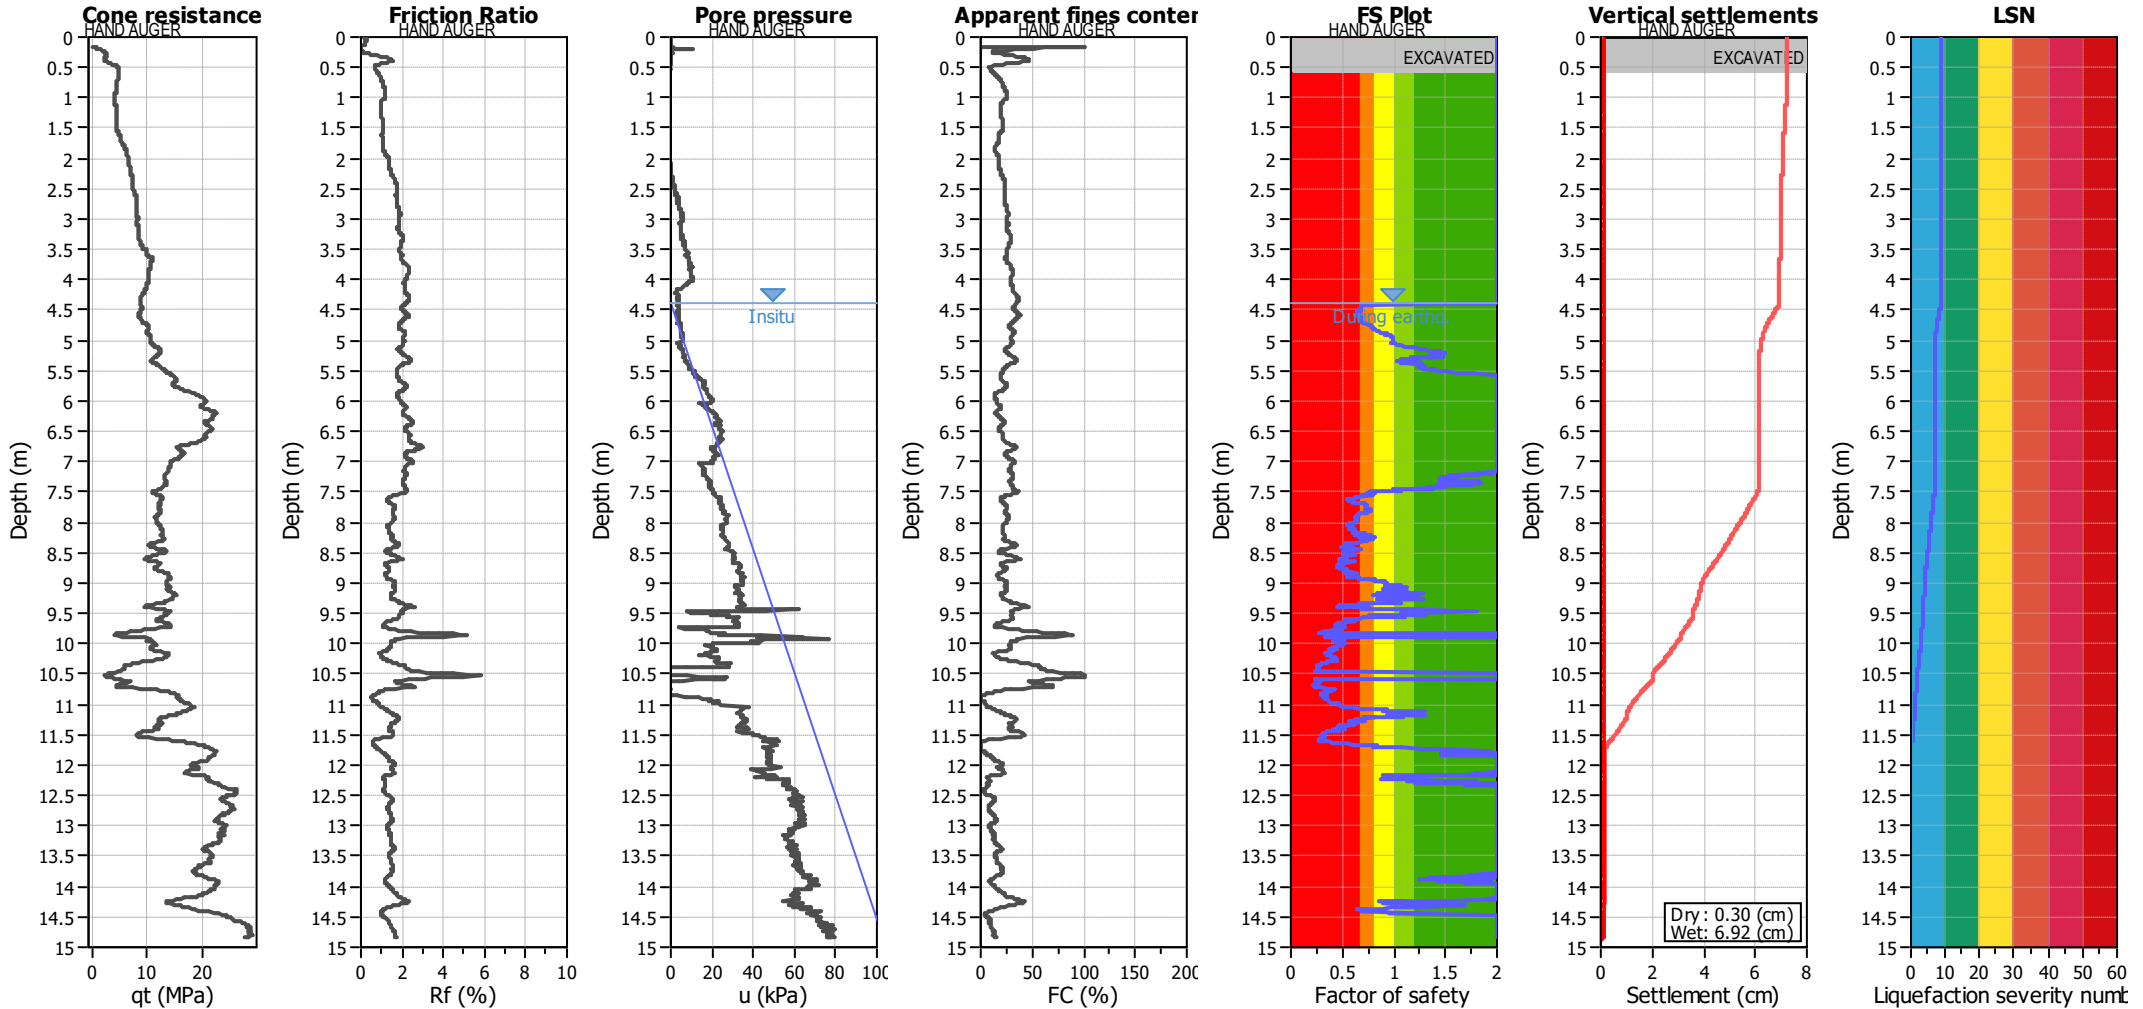
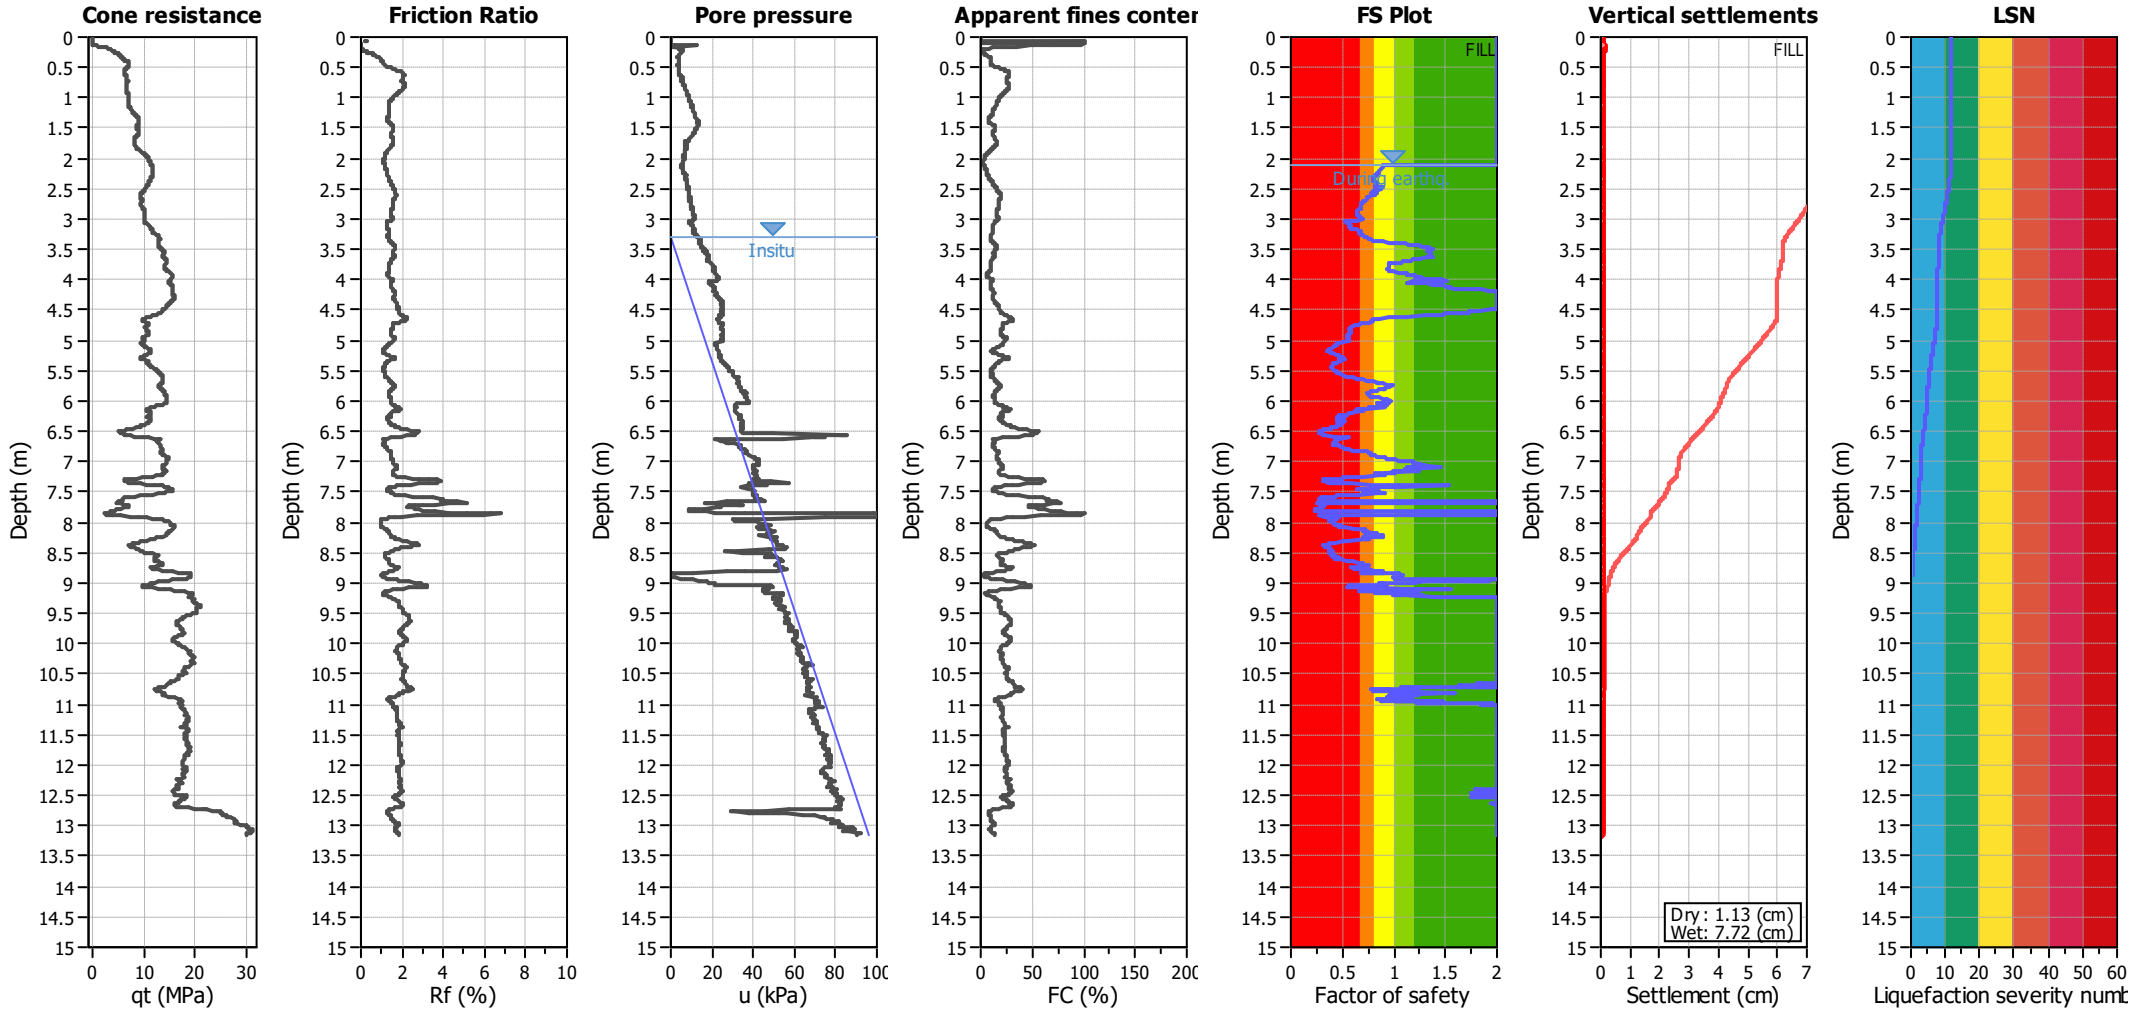
Analysis method:	B&I (2014)	G.W.T. (in-situ):	3.90 m	Use fill:	Yes	Clay like behavior
Fines correction method:	B&I (2014)	G.W.T. (earthq.):	3.90 m	Fill height:	0.05 m	applied:
Points to test:	Based on Ic value	Average results interval:	3	Fill weight:	19.00 kN/m ³	Limit depth applied:
Earthquake magnitude M_w :	7.70	Ic cut-off value:	2.60	Trans. detect. applied:	No	No
Peak ground acceleration:	0.68	Unit weight calculation:	Based on SBT	K_σ applied:	No	N/A
						MSF method: Method based

Analysis method:	B&I (2014)	G.W.T. (in-situ):	3.90 m	Use fill:	Yes	Clay like behavior
Fines correction method:	B&I (2014)	G.W.T. (earthq.):	3.90 m	Fill height:	0.90 m	applied:
Points to test:	Based on Ic value	Average results interval:	3	Fill weight:	19.00 kN/m ³	Limit depth applied:
Earthquake magnitude M_w :	7.70	Ic cut-off value:	2.60	Trans. detect. applied:	No	No
Peak ground acceleration:	0.68	Unit weight calculation:	Based on SBT	K_σ applied:	No	N/A
						MSF method: Method based

Analysis method:	B&I (2014)	G.W.T. (in-situ):	4.30 m	Excavation:	Yes	Clay like behavior	
Fines correction method:	B&I (2014)	G.W.T. (earthq.):	4.30 m	Excavation depth:	0.55 m	applied:	
Points to test:	Based on Ic value	Average results interval:	3	Footing load:	10.00 kPa	Limit depth applied:	No
Earthquake magnitude M_w :	7.70	Ic cut-off value:	2.60	Trans. detect. applied:	No	Limit depth:	N/A
Peak ground acceleration:	0.68	Unit weight calculation:	Based on SBT	K_σ applied:	No	MSF method:	Method based

Analysis method:	B&I (2014)	G.W.T. (in-situ):	4.40 m	Excavation:	Yes	Clay like behavior	
Fines correction method:	B&I (2014)	G.W.T. (earthq.):	4.40 m	Excavation depth:	0.60 m	applied:	
Points to test:	Based on Ic value	Average results interval:	3	Footing load:	10.00 kPa	Limit depth applied:	No
Earthquake magnitude M_w :	7.70	Ic cut-off value:	2.60	Trans. detect. applied:	No	Limit depth:	N/A
Peak ground acceleration:	0.68	Unit weight calculation:	Based on SBT	K_σ applied:	No	MSF method:	Method based

Analysis method:	B&I (2014)	G.W.T. (in-situ):	3.30 m	Use fill:	Yes	Clay like behavior
Fines correction method:	B&I (2014)	G.W.T. (earthq.):	3.30 m	Fill height:	1.20 m	applied:
Points to test:	Based on Ic value	Average results interval:	3	Fill weight:	19.00 kN/m ³	Limit depth applied:
Earthquake magnitude M_w :	7.70	Ic cut-off value:	2.60	Trans. detect. applied:	No	No
Peak ground acceleration:	0.68	Unit weight calculation:	Based on SBT	K_{σ} applied:	No	N/A
						MSF method: Method based

- The site does not meet NZS 3604 conditions due to some low DCP blow counts and presence of liquefaction at the site.
- The proposed 3.3m to 4.0m crust at the site will reduce the impact of liquefaction during a ULS seismic event.

The site is generally level lying and underlain by sand. The proposed 3.3m+ crust at the site will significantly mitigate the risk of liquefaction induced ejecta at the surface and also the impact of settlement on the proposed structures.
