Client: Sussex Trust			
Project Name: Geotechnical Assessment Report			
Site Location: 160 Mazengarb Road, Paraparaumu			
Sheet Title: Liquefaction Assessment			
Project/Report No: T0399/02			
Sheet No: 4 of 4			
Author:	L Heaton/N Clendon	Initials:	LH/NC
Reviewed By:	J Spinks	Initials:	JS
Rev.	Date:	Description	Initials
A	17/07/2024	RC and BC	NC
B	24/07/2024	RC and BC	NC
C	18/09/2024	RC and BC	JS

Project Name:  
Geotechnical Assessment Report

Site Location:  
160 Mazengarb Road, Paraparaumu

Project/Report No:  
T0399/02

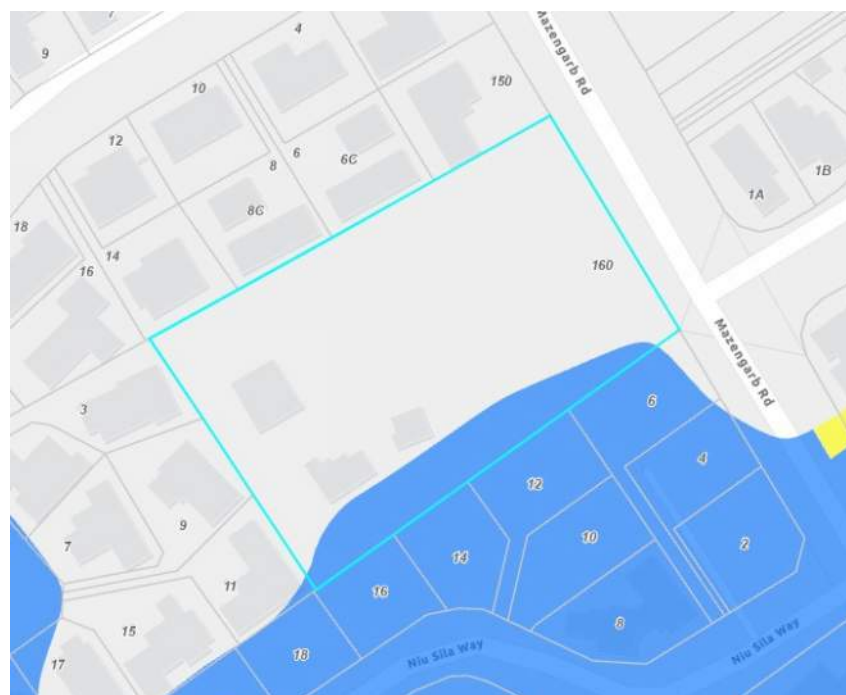
Figure 1: KCDC flood hazard map—Ponding

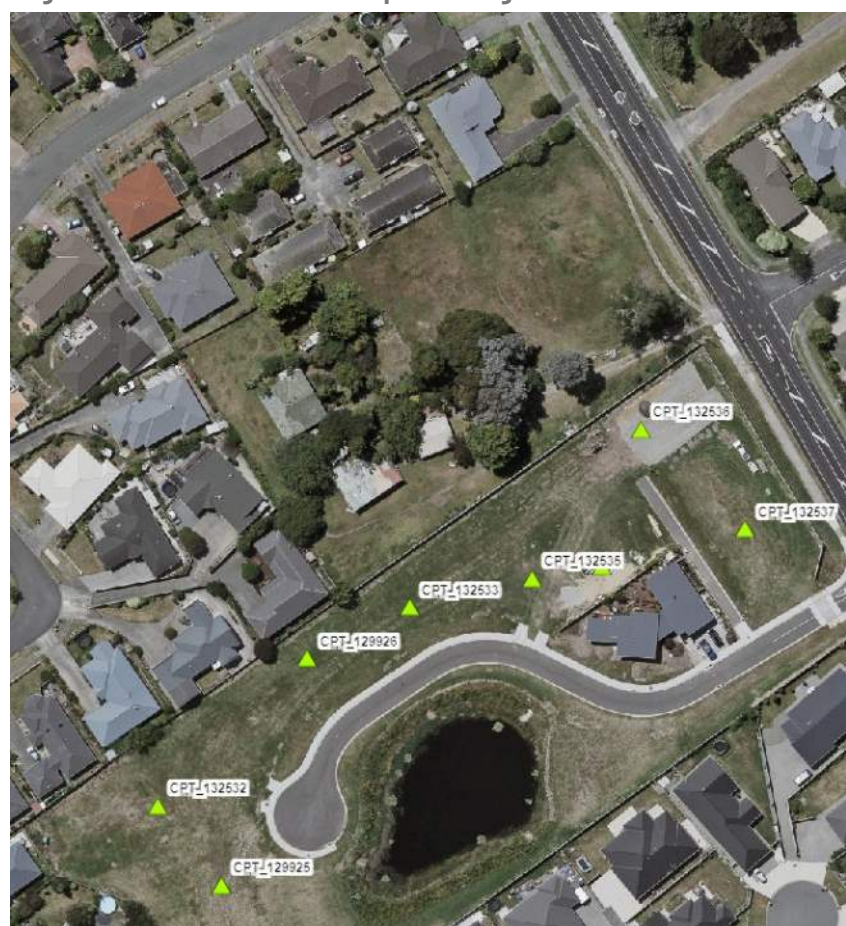
<b>NZGD</b>	Nearby Investigation Records	18 CPTs and 5 hand auger logs have been completed within 300m of the site.	Logs generally indicated sands with gradually increasing soil strength.

Figure 2: NZGD test locations

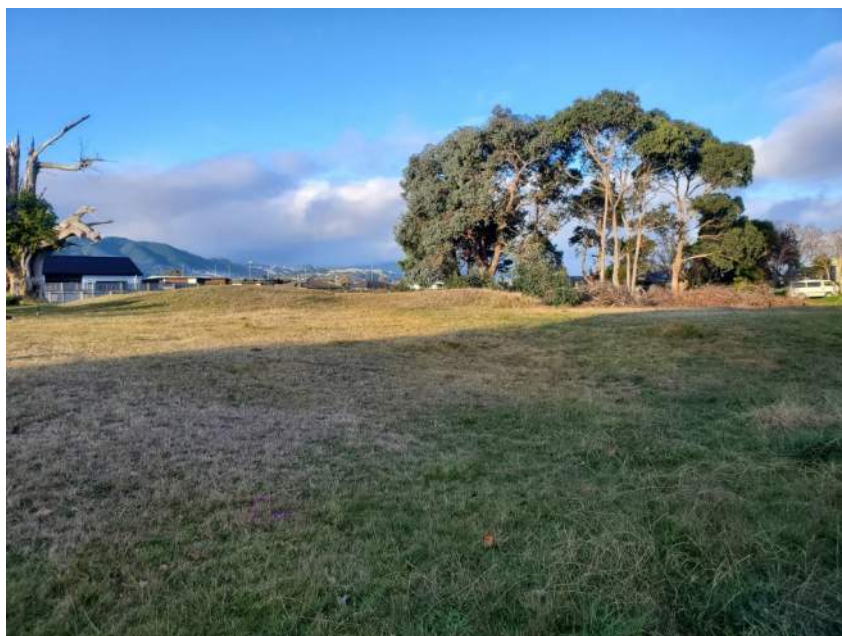
Figure 3: Photo near CPT02, looking South

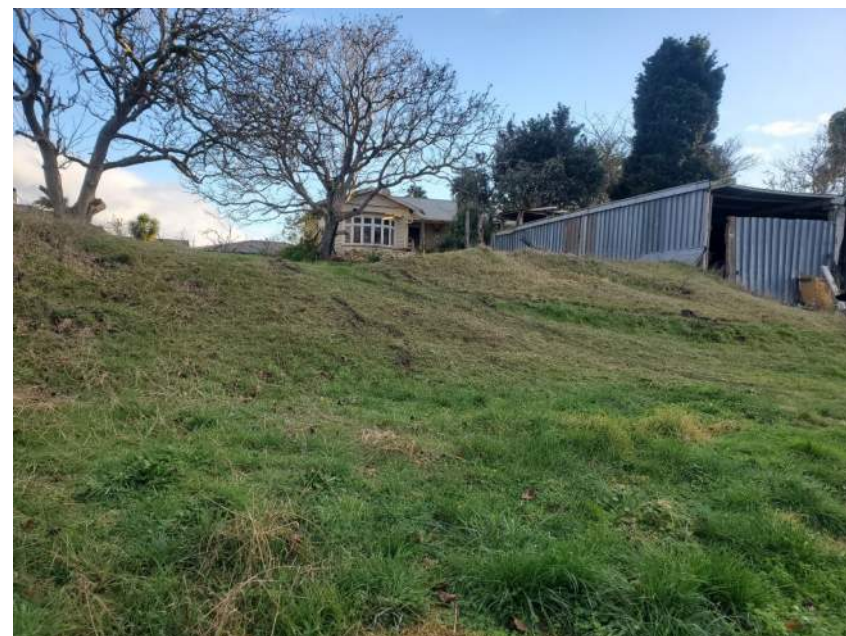
Figure 4: Photo near TP05, looking North

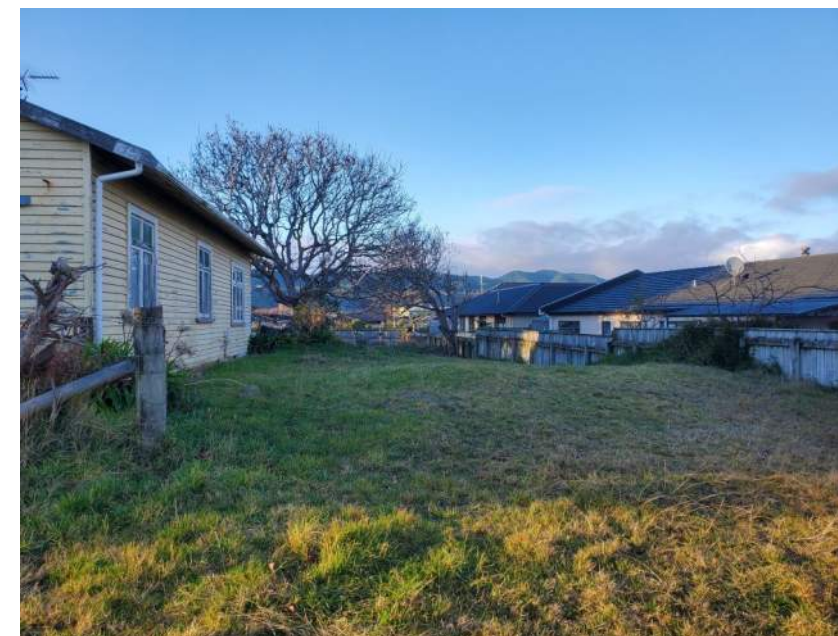
Figure 5: Photo near TP04, looking Southeast

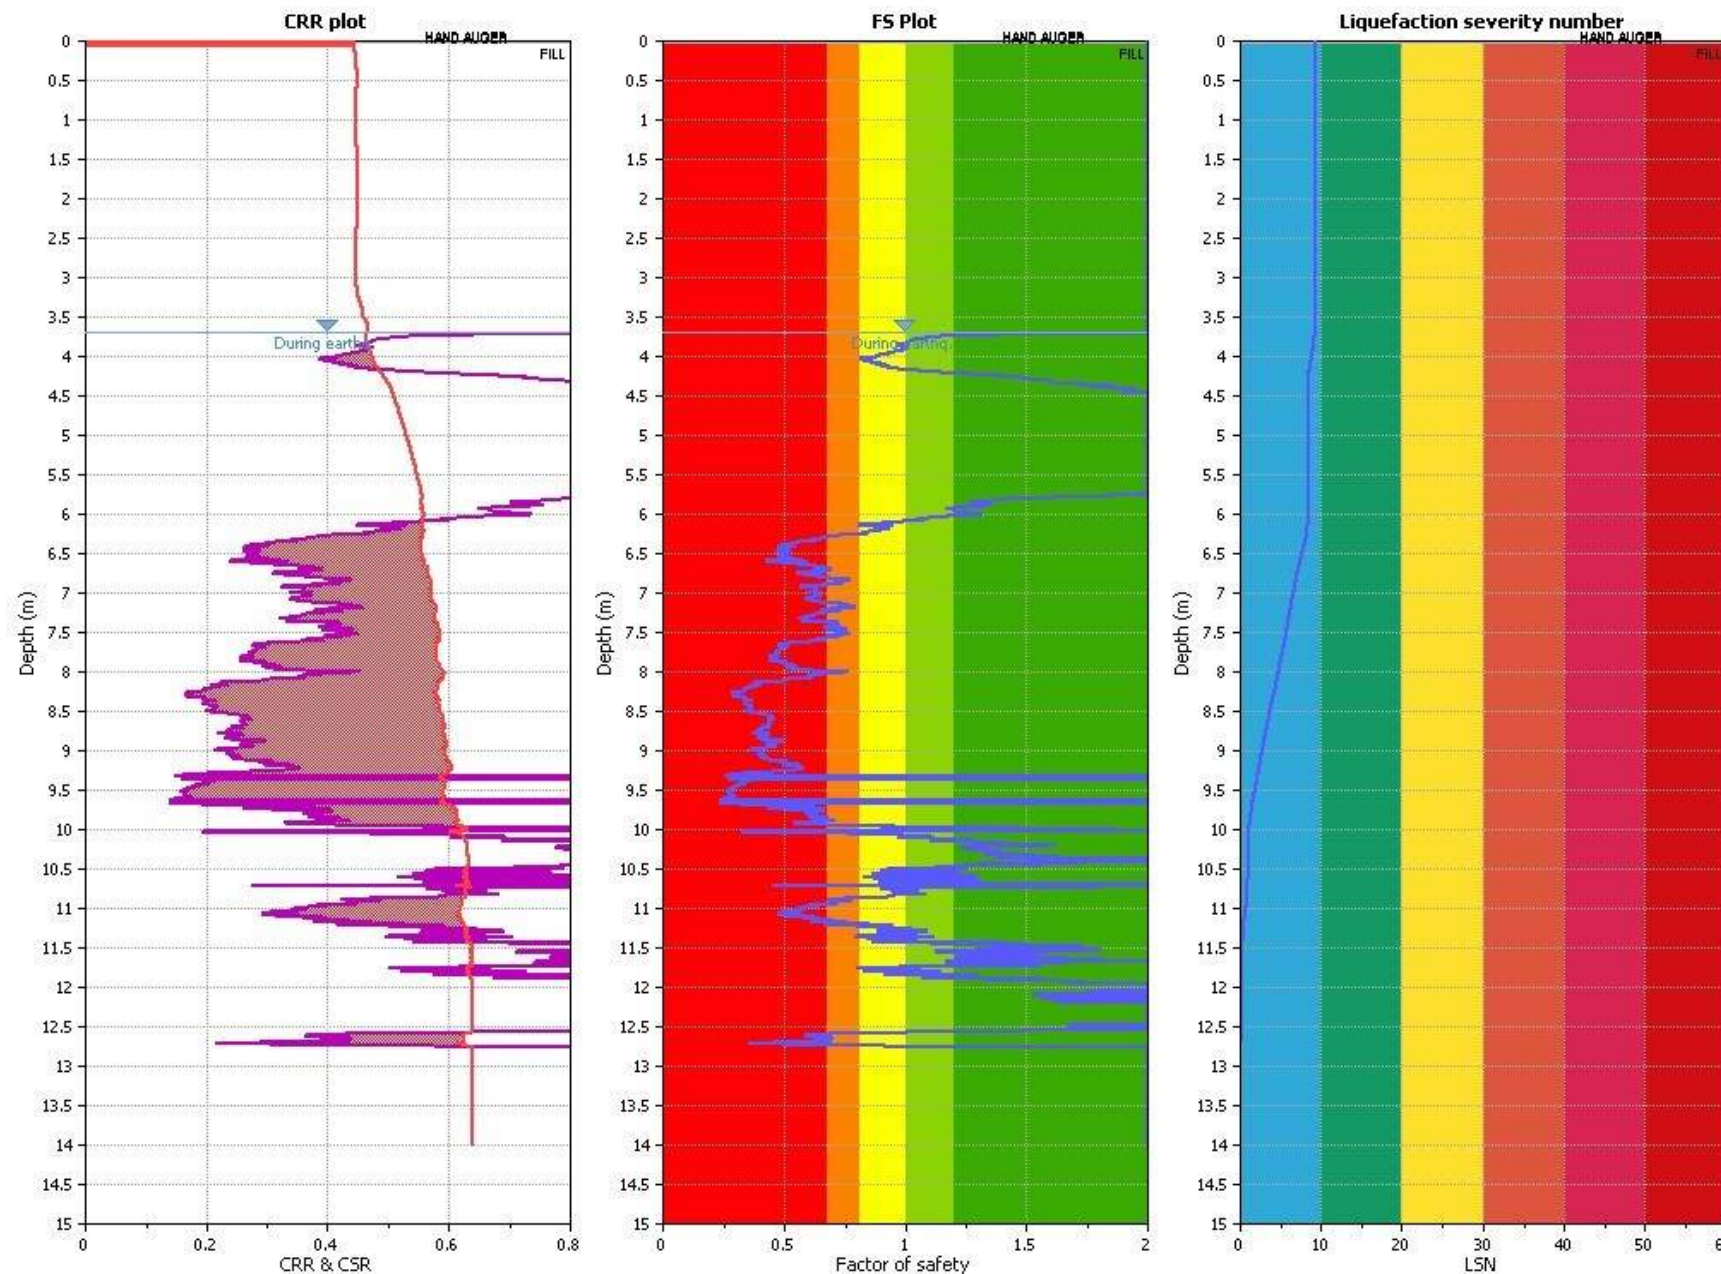
- Under ULS earthquake conditions, the majority of the liquefaction is occurring between 6 and 11m below proposed site levels. With more variable levels of liquefaction occurring between 4 and 6m below proposed site levels.

- Overall the liquefaction hazard is considered to be moderate due to the proposed crust thickness and the typically increasing density of the ground profile with depth.

Figure 5: Liquefaction Assessment CPT01

Test ID	Current mRL	Proposed Fill Thickness (m)	Depth to Groundwater (mbgl)	ULS loading condition			
				Free Field Settlement (mm)	LPI (ISH)	LSN	Performance level
CPT01	6.2	0.05	3.90	90	3	9	Moderate/High
CPT02	5.5	0.90	3.90	120	7	10	High
CPT03	6.8	-0.55	3.75	70	3	8	Moderate
CPT04	6.9	-0.60	3.80	80	2	9	Moderate
CPT05 part 2	4.6	1.20	3.30	110	11	15	High
CPT06	4.7	1.20	3.30	90	6	12	Moderate
CPT07	6.0	-0.10	3.40	80	4	7	Moderate
CPT08	6.5	-0.50	3.5	85	3	7	High
CPT09	6.2	0.30	4.0	80	5	8	Moderate
CPT10	4.9	1.1	3.5	45	2	4	Mild

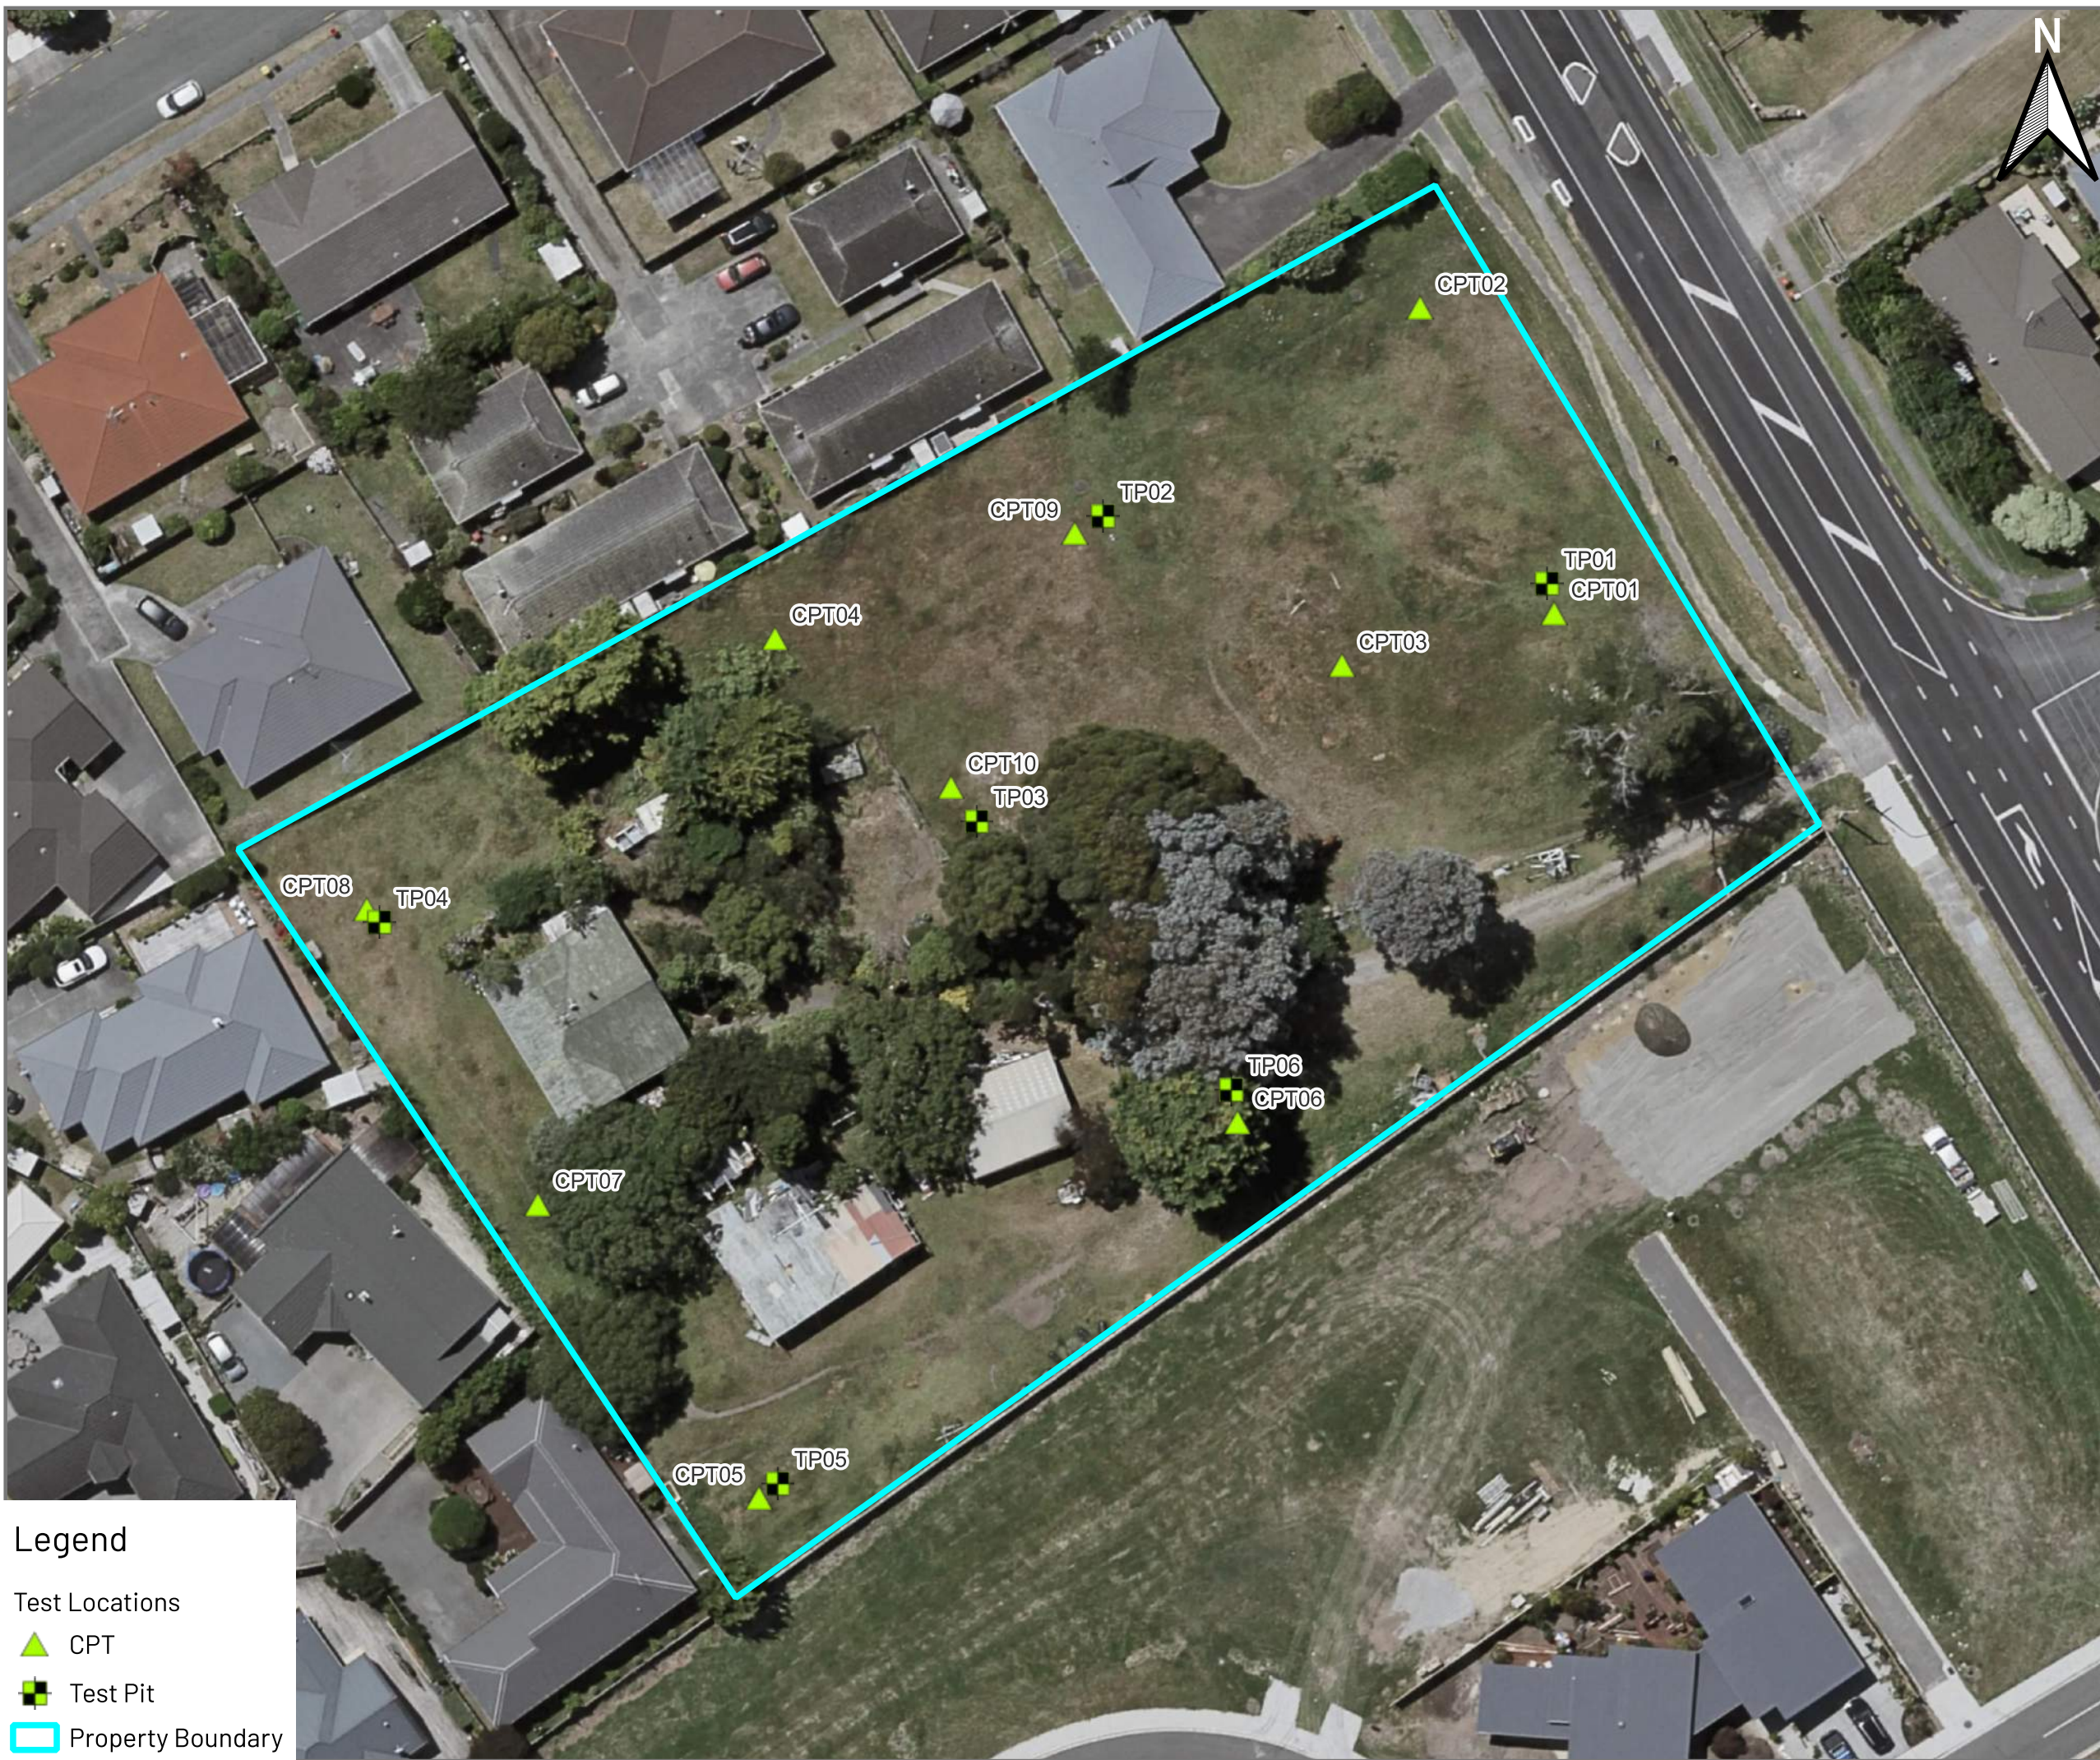
Sketch Title:  
Test Location Plan

- ▲ CPT
- Test Pit
- Property Boundary

- CPT05 was repeated due to early refusal with the second test achieving 12m.
- A DCP was undertaken at each pit location to refusal.
- The test locations are shown on Sketch 1 in Appendix A.
- A full copy of the Test Pit and CPT logs are included in Appendix C.

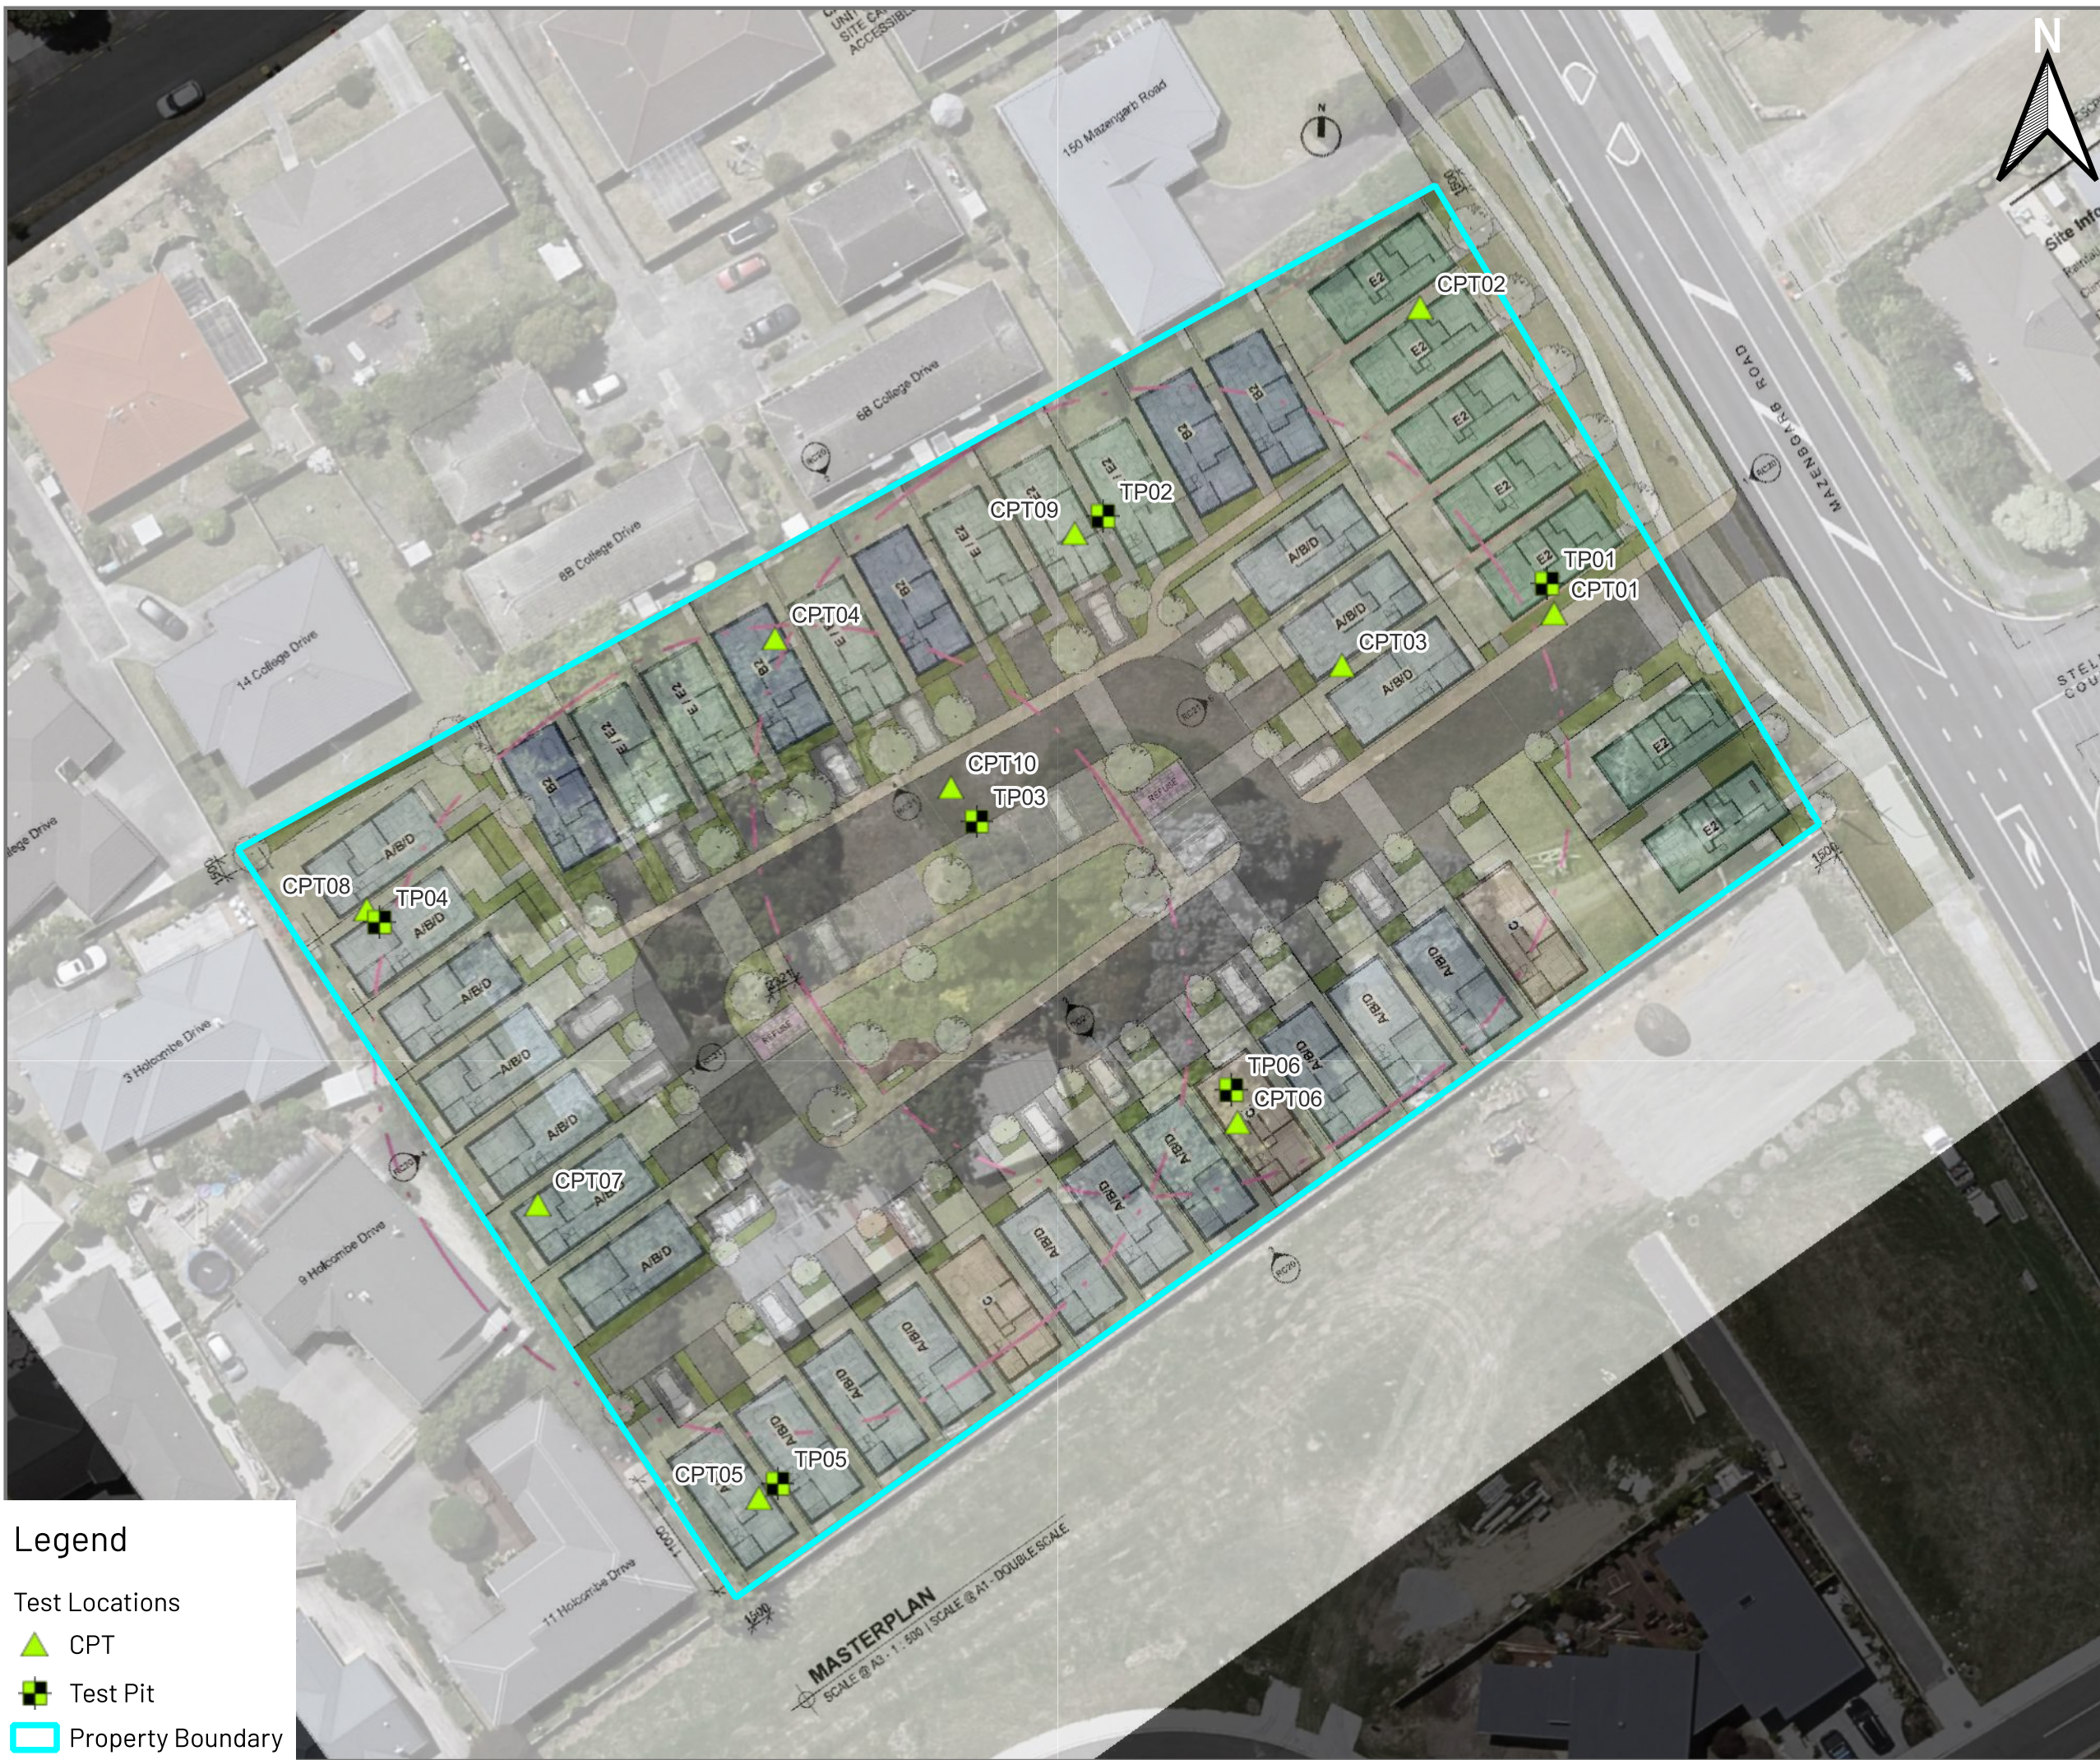
Sketch Title:  
Proposed Development Plan

- ▲ CPT
- Test Pit
- Property Boundary

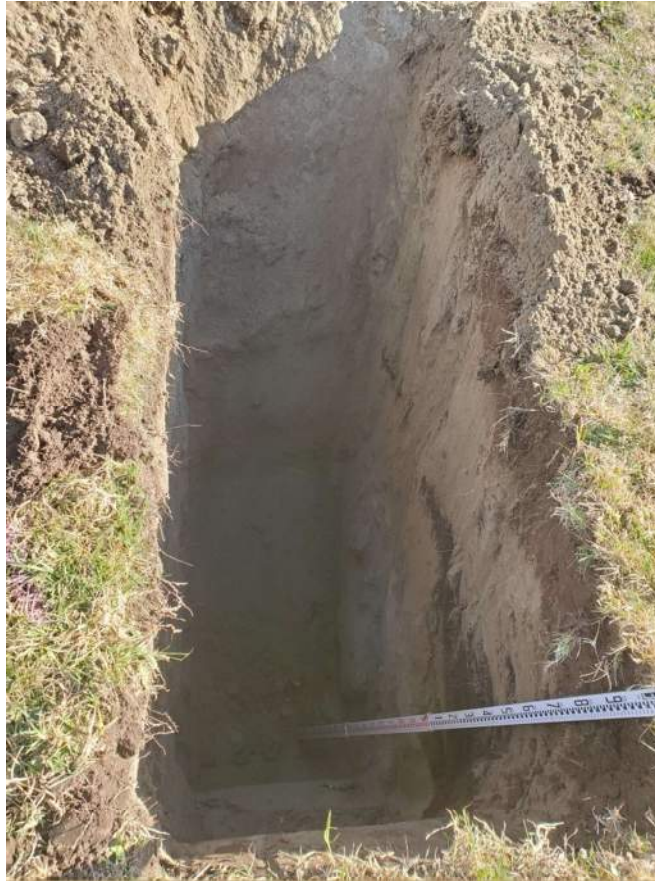
TP01 Pit

Depth Scale	Lithologic Description	Symbol	Samples	Vane Shear Test (Su)	Pocket Penetrometer	Manual DCP	Comments / Additional Notes
0	Ground Surface						
0	<b>TOPSOIL</b>						
	<b>Fine to coarse SAND</b> Light brown, loose, moist.						
	<b>Fine to medium SAND</b> With trace silt. Dark brown, loose to medium dense, moist. Silt is non-plastic.						
	<b>Fine SAND</b> Light brown, medium dense, moist.						
	<b>Fine to medium SAND</b> Grey, medium dense, moist.						
2	From 2.2m bgl - Medium dense to dense.						
	From 2.5m bgl - Dense.						
3	Test Hole Terminated at 3 m - Target depth.						
4							
5

**Coordinates obtained from mobile phone GPS.**  
**Elevation estimated from Cuttriss Consultants Topographic Survey.**  
**Groundwater was not encountered.**

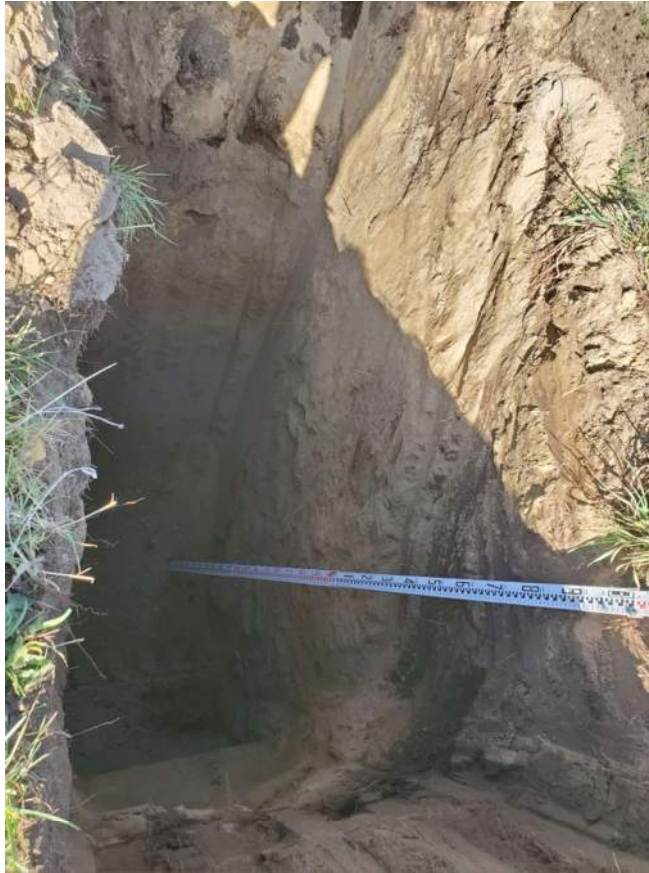
TP02 Pit

<b>Fine to medium SAND</b> With trace gravel. Dark brown, loose, dry to moist. Gravels are fine to medium, sub-round. (FILL?).

1	<b>Fine to medium SAND</b> With trace rootlets. Brown, loose, dry to moist.

<b>Fine SAND</b> Light brown, medium dense, dry to moist.

<b>Fine to coarse SAND</b> Grey brown, medium dense to dense, moist.

2	From 2.1m bgl - Dense.						
3	Test Hole Terminated at 3.1 m - Target depth.						
4							
5

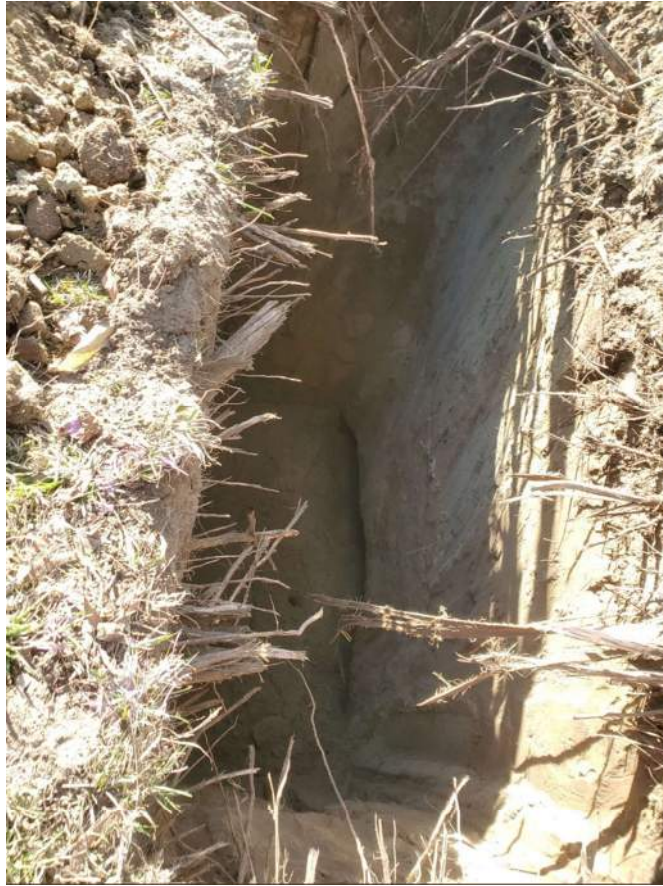
TP03 Pit

Depth Scale	Lithologic Description	Symbol	Samples	Vane Shear Test (S <sub>u</sub> )	Pocket Penetrometer	Manual DCP	Comments / Additional Notes
0	Ground Surface						
0	<b>TOPSOIL</b>						
0	<b>Fine SAND</b> With minor tree roots. Brown, loose to medium dense, dry.						
0	<b>Fine to coarse SAND</b> With trace rootlets. Light brown, medium dense, dry to moist.						
1	From 1.2m bgl - Medium dense to dense.						
2	From 1.8m bgl - Dense.						
2	From 2.0m bgl - Moist.						
3	<b>Fine to coarse SAND</b> Grey, dense, moist to wet.						
3	Test Hole Terminated at 3.2 m - Target depth and pit wall collapse.						
4							
5

**Coordinates obtained from mobile phone GPS.**  
**Elevation estimated from Cuttriss Consultants Topographic Survey.**  
**Groundwater was not encountered.**

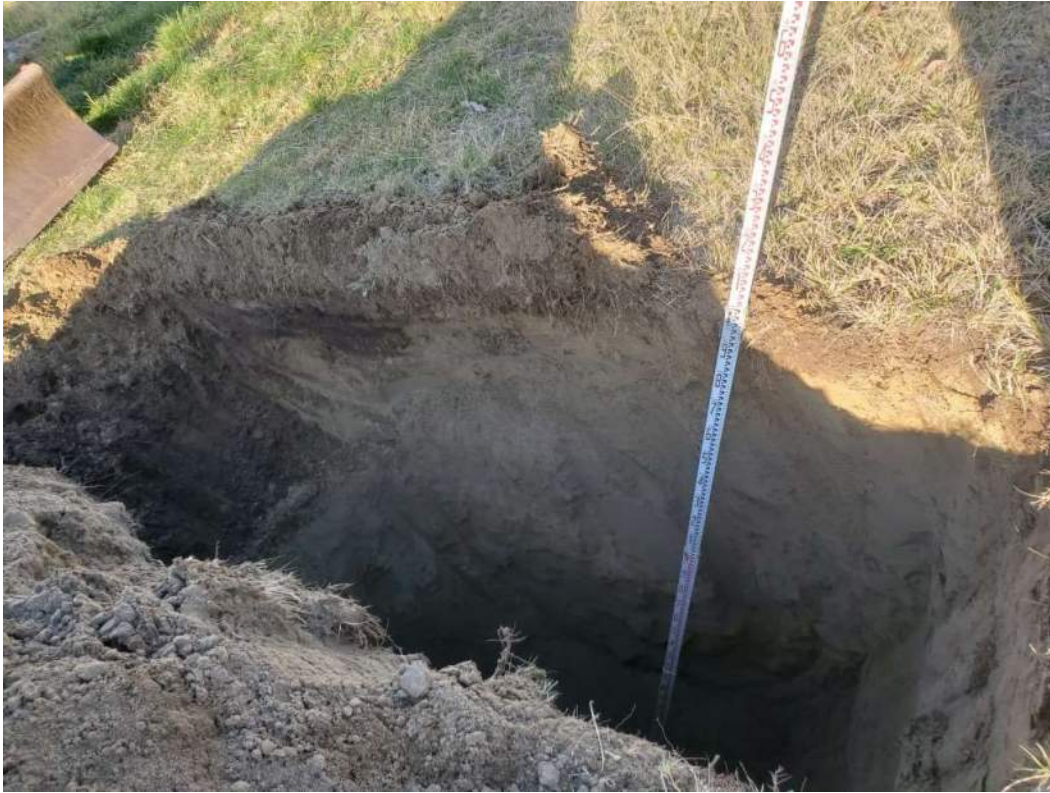
TP04 Pit

Depth Scale	Lithologic Description	Symbol	Samples	Vane Shear Test (S <sub>u</sub> )	Pocket Penetrometer	Manual DCP	Comments / Additional Notes
0	Ground Surface						
0	<b>TOPSOIL</b>						
0	<b>Fine to medium SAND</b> Light brown, loose to medium dense, moist.						
1	<b>Fine to coarse SAND</b> Light brown, loose, moist.						
1	From 1.1m bgl - Medium dense.						
2	From 2.0m bgl - Dense.						
3	Test Hole Terminated at 3 m - Target depth.						
4							
5

**Coordinates obtained from mobile phone GPS.**  
**Elevation estimated from Cuttriss Consultants Topographic Survey.**  
**Groundwater was not encountered.**

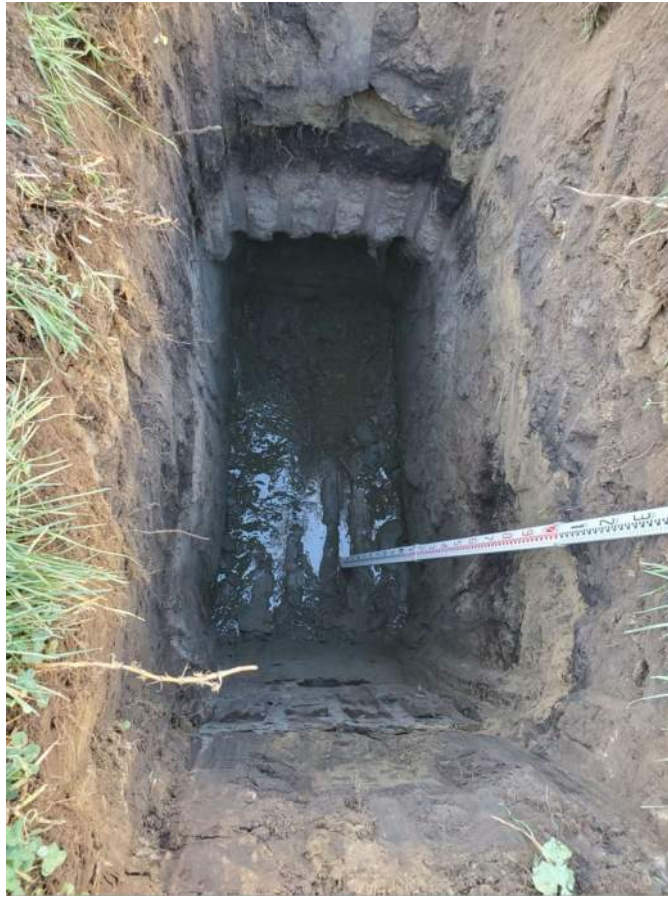
TP05 Pit

Depth Scale	Lithologic Description	Symbol	Samples	Vane Shear Test (Su)	Pocket Penetrometer	Manual DCP	Comments / Additional Notes
0	Ground Surface						
0	<b>TOPSOIL</b>						
	<b>Fine to coarse SAND</b> Light brown, loose, moist.						
	<b>Sandy SILT</b> With trace gravel and rootlets. Dark brown, stiff, moist. Non-plastic. Sand is fine to medium. Gravels are fine, sub-angular.						
	<b>Fine to medium SAND</b> Dark brown, medium dense, moist.						
1	<b>Silty fine SAND</b> Grey, moist. Silt has low plasticity.						
	<b>Fine to coarse SAND</b> Grey, medium dense, moist.						
	From 1.8m bgl - Strong organic smell.						
2	From 2.5m bgl - Saturated. Organics in base of pit (bark).						
3	Test Hole Terminated at 2.6 m - Refusal on organic material (possible log).						
08 Jul 2024							
3							
4							
5

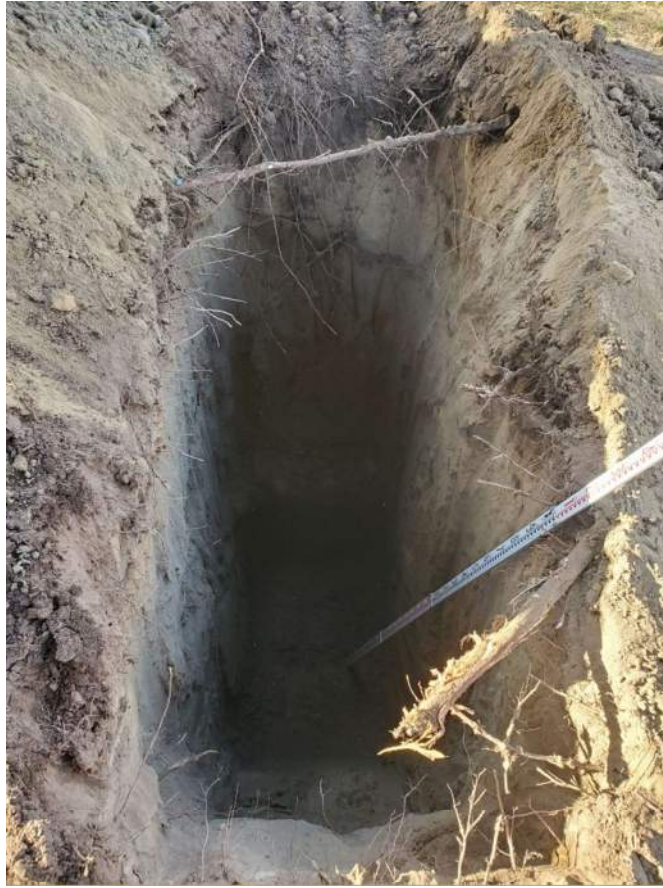
TP06 Pit

Depth Scale	Lithologic Description	Symbol	Samples	Vane Shear Test (S <sub>u</sub> )	Pocket Penetrometer	Manual DCP	Comments / Additional Notes
0	<b>Ground Surface</b> <b>Fine SAND</b> With trace tree roots. Grey brown, loose to medium dense, dry.						
	<b>Fine SAND</b> Light brown, medium dense to dense, dry.						
1	From 1.1m bgl - Dense.						
	<b>Fine to coarse SAND</b> Grey, dense, moist.						
2							
	From 3.0m bgl - Wet.						
3	Test Hole Terminated at 3.1 m - Target depth and pit wall collapse.						
4							
5

Coordinates obtained from mobile phone GPS.  
 Elevation estimated from Cuttriss Consultants Topographic Survey.  
 Groundwater was not encountered, however some seepage was observed in the base of the pit.

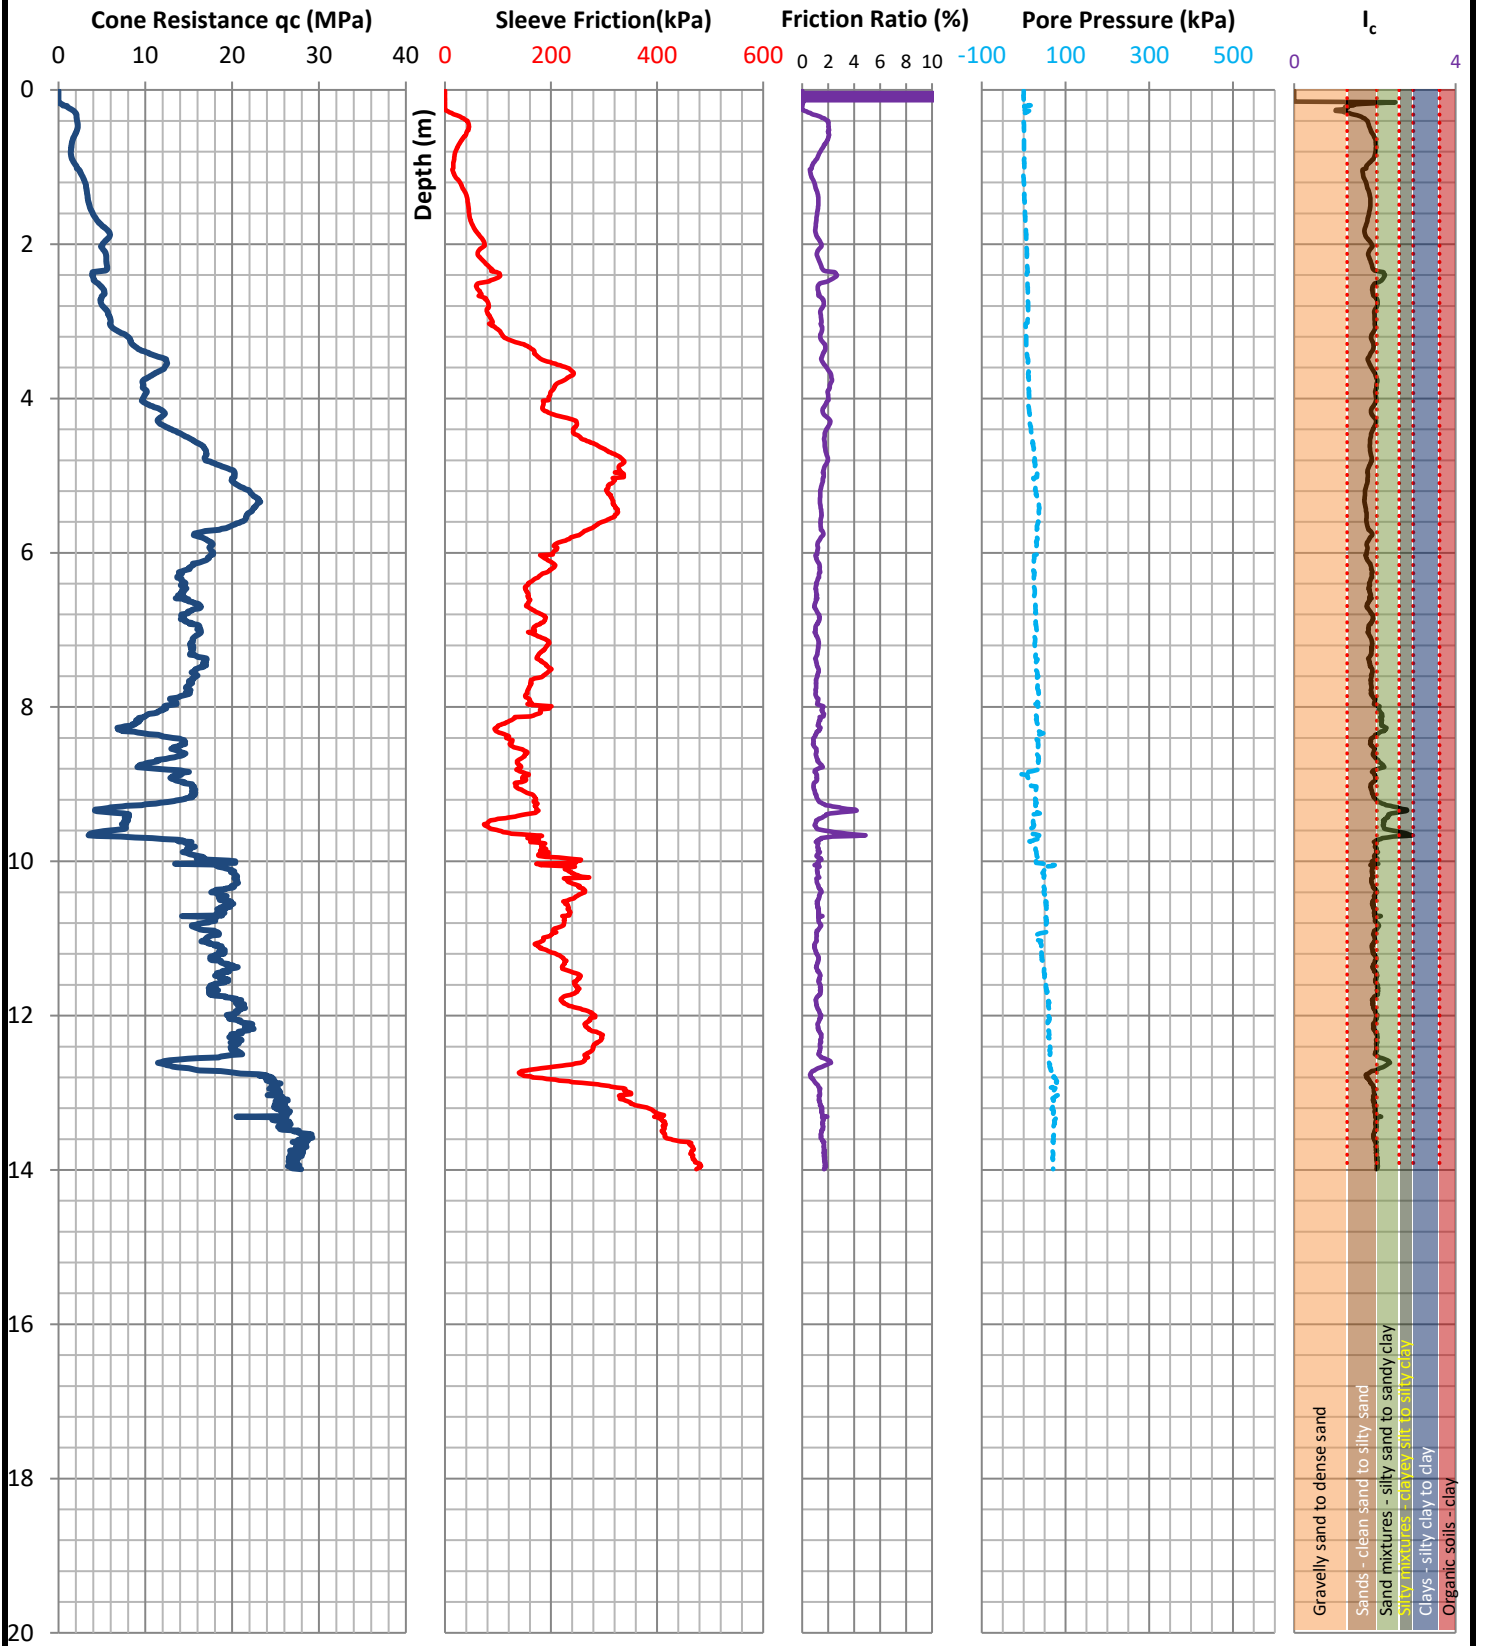
Soil Behavior Type Index  $I_c$

Holes collapsed 3.5m to 4.5m.  
No GW observed

Cone type: 15 sqr cm piezocone
