Appendix 10
Geotechnical and Liquefaction
Assessment

Geotechnical Assessment and Liquefaction Analysis Report

Kapiti Island Gateway, Maclean Park, Paraparaumu Beach

MINZ Reference: **200133-RP-001[A]**

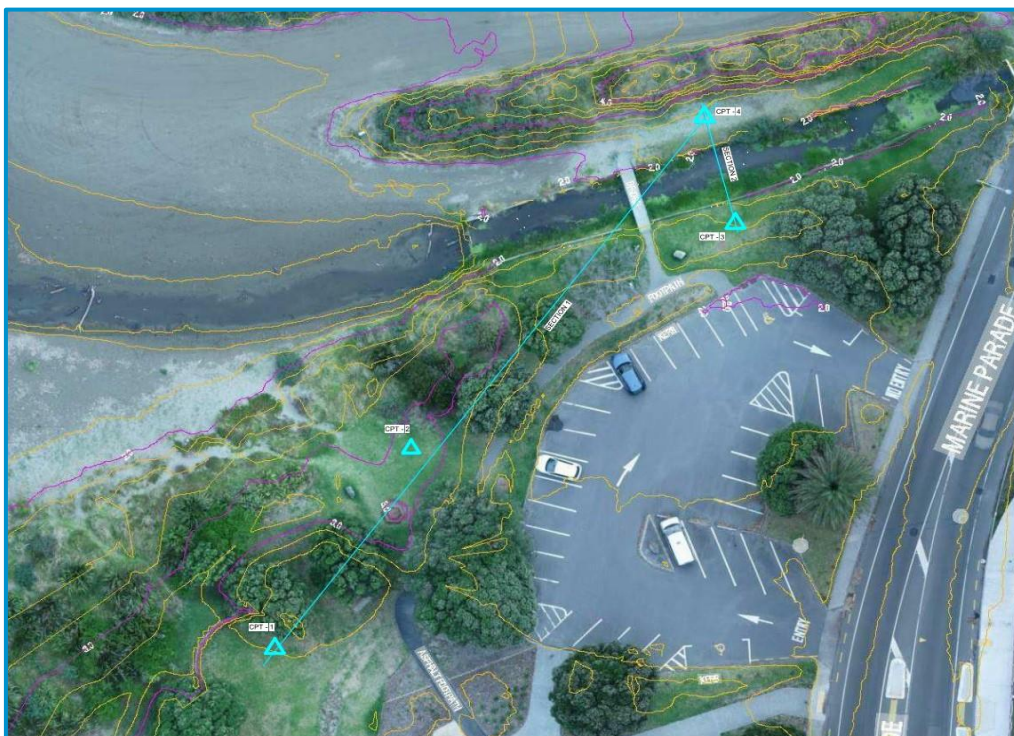
Figure 3: Geotechnical Cross Sections – Overview (see also Appendix E)

Two geotechnical cross sections have been drawn for the site. The cross sections are provided in Appendix E. Figure 3 provides the overview plan for the cross sections, and Figure 4 provides cross section 2.

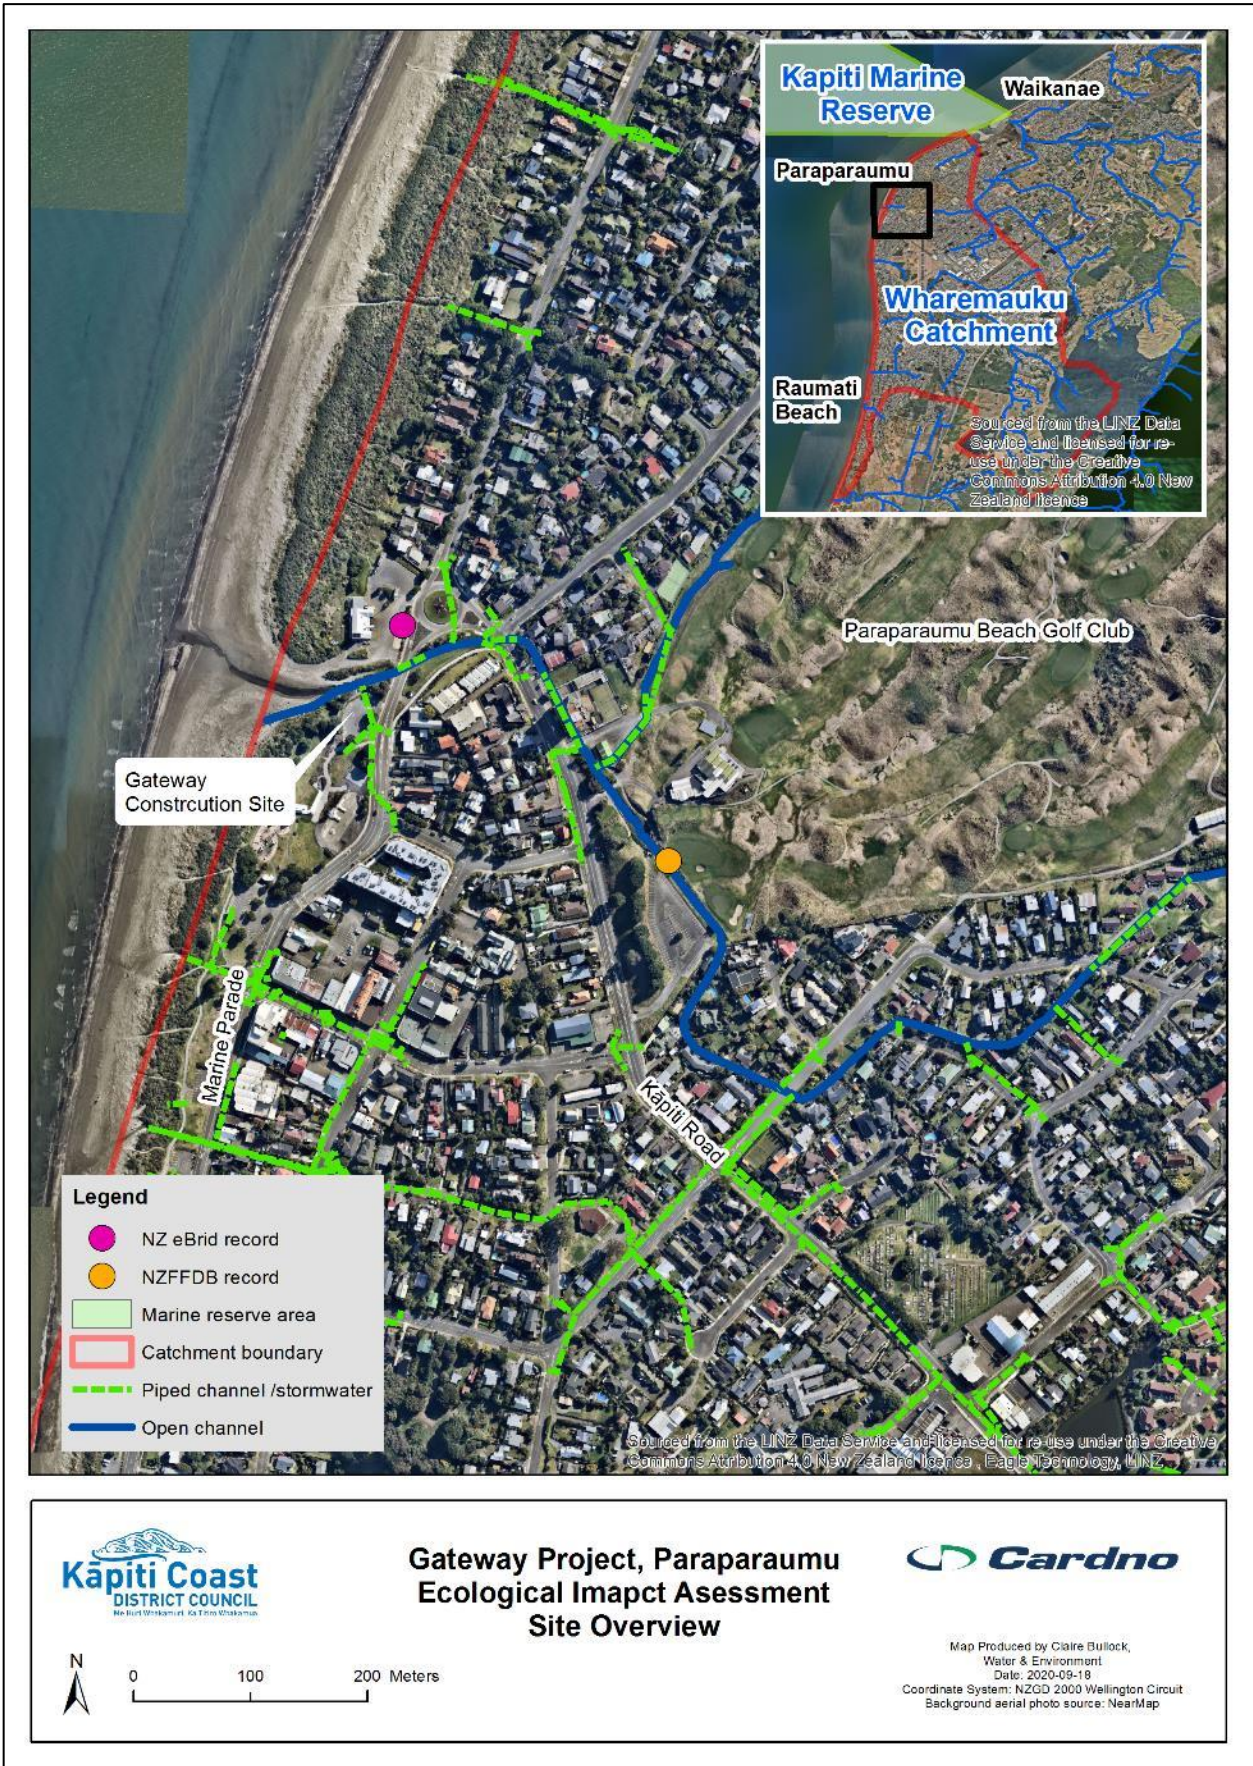
Figure 2-1 Map of the Tikotu stream catchment showing the proposed works site at the Kāpiti Road and Marine Parade intersection, Paraparaumu.

The Tikotu Stream is part of the Wharemauku catchment. The Wharemauku has a catchment of approximately 22 km² which consists of pasture, scrub and some patches of native forest in the upper catchment, and densely populated urbanised area in the lower catchment (Figure 2-1). Historically, the Wharemauku Stream, which begins in the foothills of the Tararua Mountain range, flowed into the Tikotu Stream before discharging into the Tasman Sea at Marine Parade, Paraparaumu. However, due to residential development in the 1970's the connection between the Wharemauku Stream and Tikotu Stream was blocked, resulting in the Tikotu Stream servicing a smaller largely stormwater-fed urban/residential catchment (catchment PP09 approximately 1.6 km² in area) (TDE, 2019). The Tikotu Stream has limited areas of riparian vegetation and a highly modified channel (straightened and incised) (TDE 2019). The mouth of Tikotu Stream is located at the northern end of MacLean Park on the western side of Marine Parade. The stream mouth is approximately 1.5 km south of the Kāpiti Marine Reserve (MacDiarmid et al, 2012) (Figure 2-1).

Two recent 2020 NZFFD records recorded four native fish species upstream of the proposed work site (Figure 2-1, Table 3-4); inanga (*Galaxias maculatus*) and longfin eel (*Anguilla dieffenbachii*), which are classified under the “At Risk-Declining” (Dunn et al. 2018); and shortfin eel (*Anguilla australis*) and common bully (*Gobiomorphus cotidianus*) which are classified as “Not Threatened. In addition to the NZFFD records, FENZ (Leathwick et al. 2008) predicted the presence of gambusia (*Gambusia affinis*) within the affected reach which are classified as “Introduced and Naturalised”. Considering the NZFFD records, there is a high probability for the four native species to occur within the Tikotu Stream worksite.

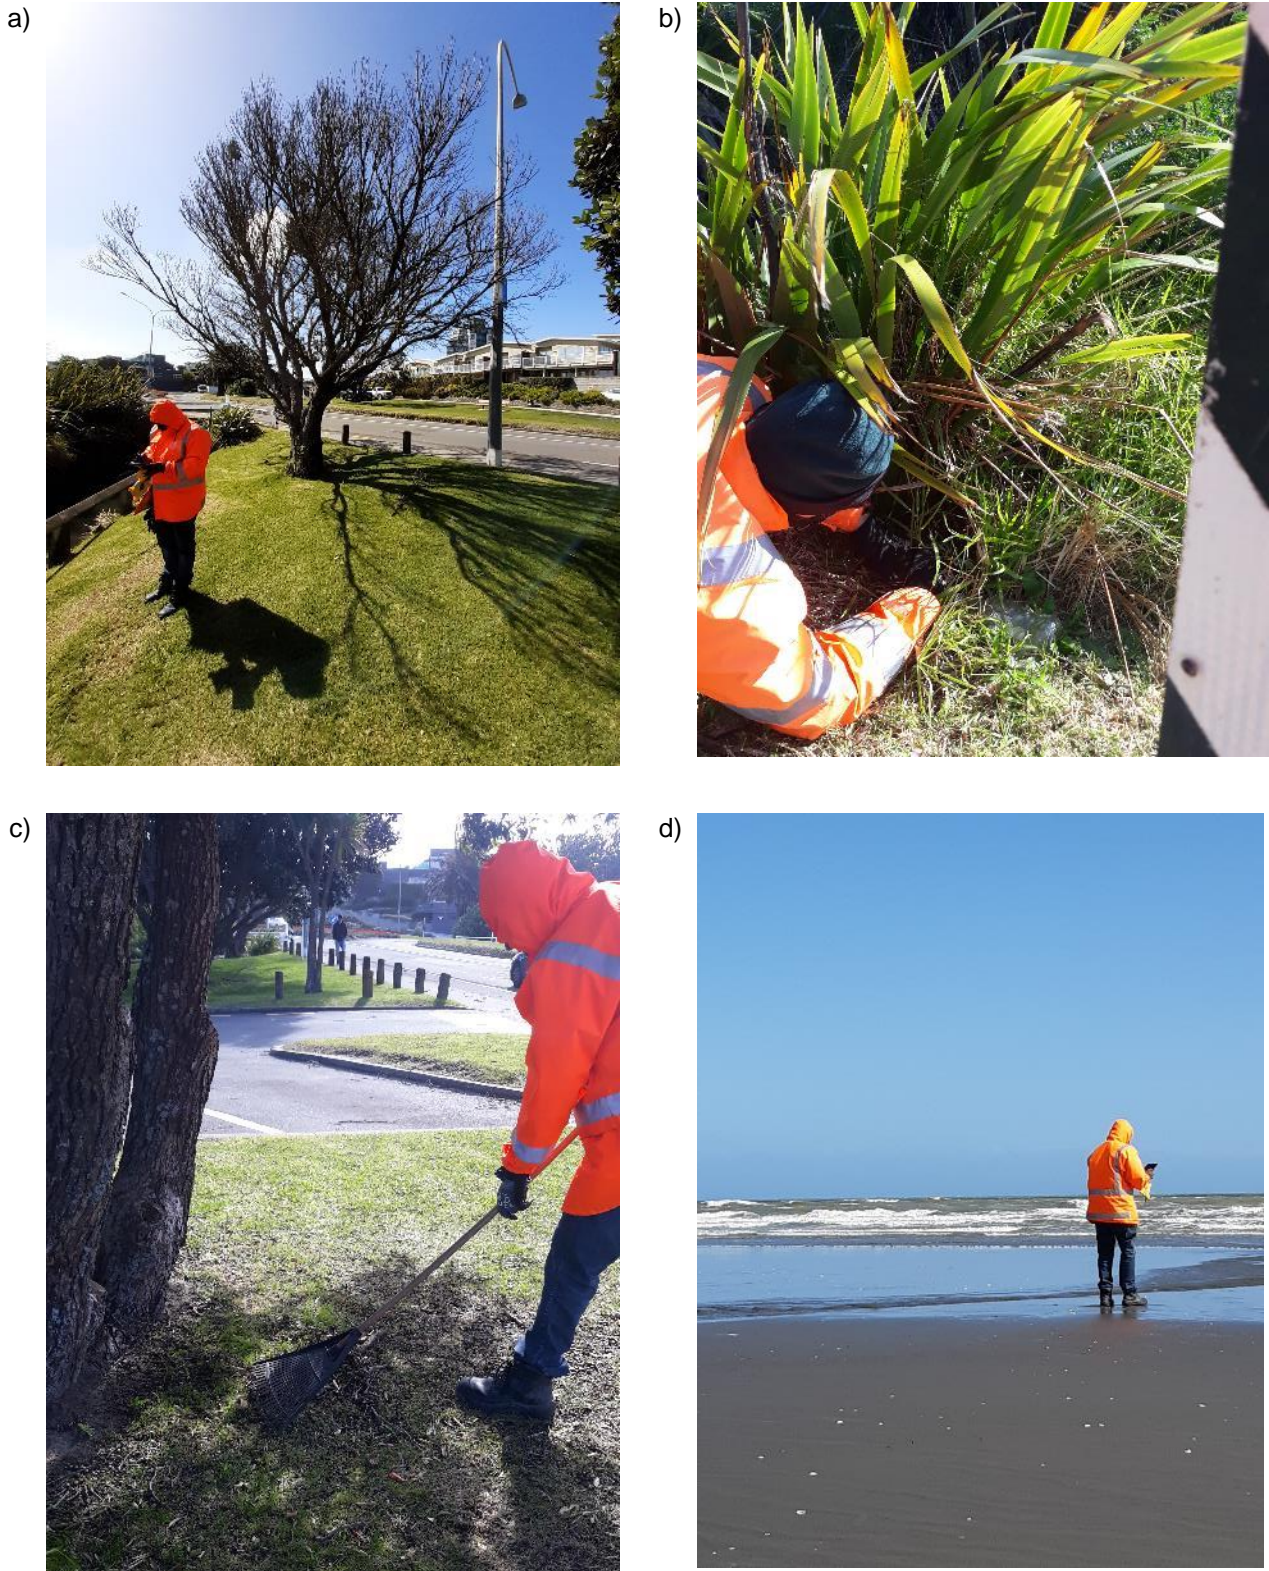
Figure 2-2 Views of the fauna habitat survey conducted by Cardno ecologists: (a) stream habitat survey, (b, c) lizard survey, and (d) marine habitat survey.

A field-based visual assessment was conducted on 15 September 2020 to describe the habitat values of the Tikotu Stream adjacent to the proposed Gateway Project. This included general stream morphometrics (e.g. depth and width), stream habitat type, substrate type, bank cover and riparian vegetation (Figure 2-2a).

Potential lizard habitat within and adjacent to the proposed footprint was assessed on 15 September 2020 with a Visual Encounter Survey (VES; Lettink and Monks, 2016) that involved searching for lizards between 9:28 am and 10:27 am by a suitably qualified and experienced ecologist. Lizard searching involved raking areas of mown grass and the rank grass in the remnant dune areas, examining crevices and holes in trees, poking sand and soil out from beneath carpark furniture, examining the curbing, rock walls and memorial rocks for signs of lizard droppings or skins, and scanning the canopy for arboreal lizards (Figure 2-2b and c).

A visual assessment was undertaken to assess the ecological values of Tikotu Stream mouth where it flows into the receiving marine environment. This included searching for the presence of potential marine habitats such as salt marshes, sea grass beds, intertidal reefs, subtidal reefs, mudflats and shell hash (Figure 2-2d).

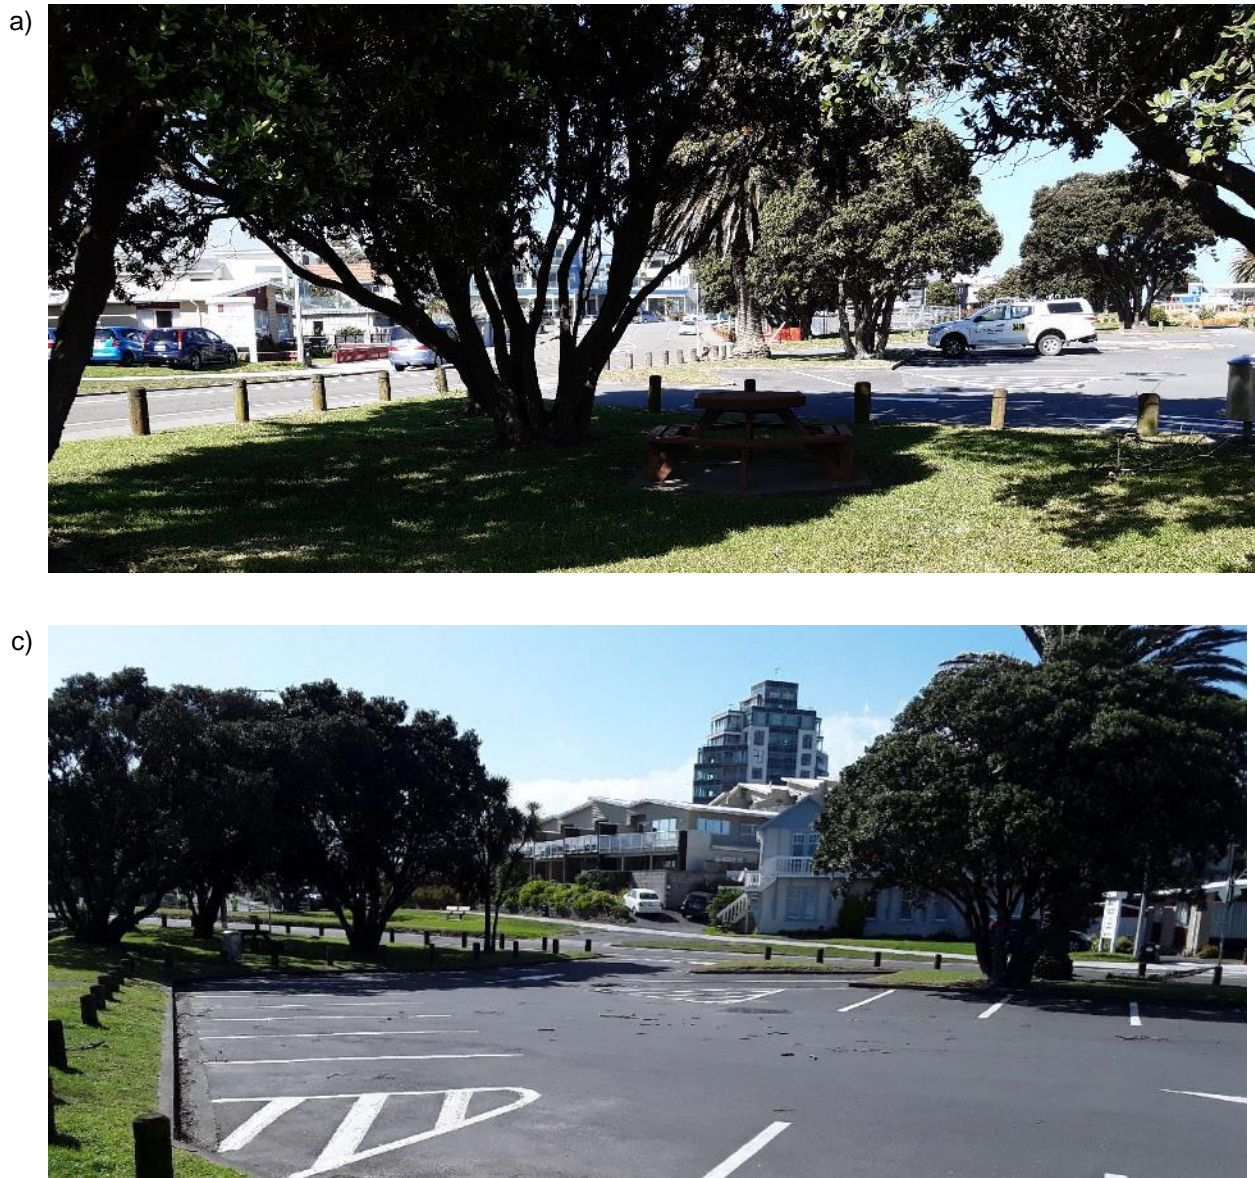
Figure 3-1 Site photos showing the built environment at the proposed construction site and its immediate surrounding: (a) looking south from the true left bank of the Tikotu Stream, and (b) the parking area under the footprint of proposed worksite.

The proposed Gateway building construction area is located within MacLean Park and the footprint comprises a tar sealed carpark, bounded by concrete kerbs and surrounded by mown grass with widely spaced planted trees. The carpark connects to Marine Parade on the eastern side, and there are several pedestrian paths. The planted trees are pohutukawa (*Metrosideros excelsa*) but there also is one phoenix palm (*Phoenix canariensis*) and the location of these in relation to the proposed development, are shown in Figure 3-2. Tikotu Stream flows from east to west, on the northern side of proposed construction area. The stream enters the coastal environment just past the park area. A small sand dune is located along the western margin of the proposed construction area between the park area and the beach (Figure 3-1 and Figure 3-2).

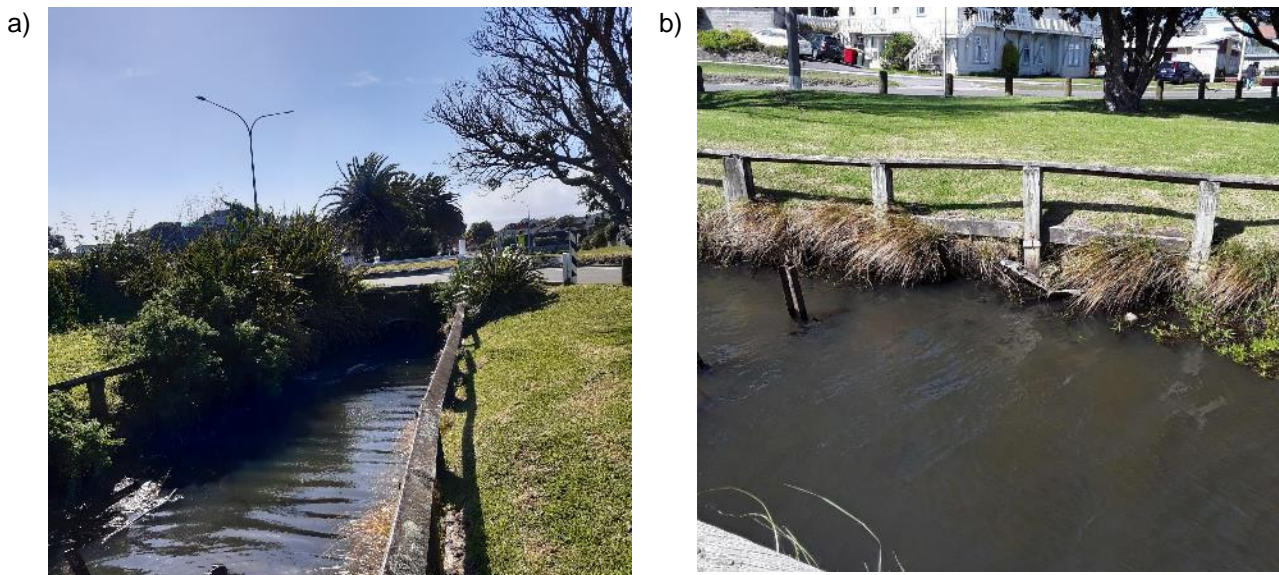
Figure 3-3 a) looking upstream, Tikotu Stream from the pedestrian bridge; b) looking from the true left (north) bank across the stream just upstream of the pedestrian bridge. .

entire reach consisted of a pool habitat with sand substrate. The bank along the entire reach consisted of wood retaining walls while most of the bank is covered by mowed grass. There was no riparian vegetation cover except for the flax and scrub at the upstream end of the reach exiting the culvert beneath Marine Parade (Table 3-2 and Figure 3-3).

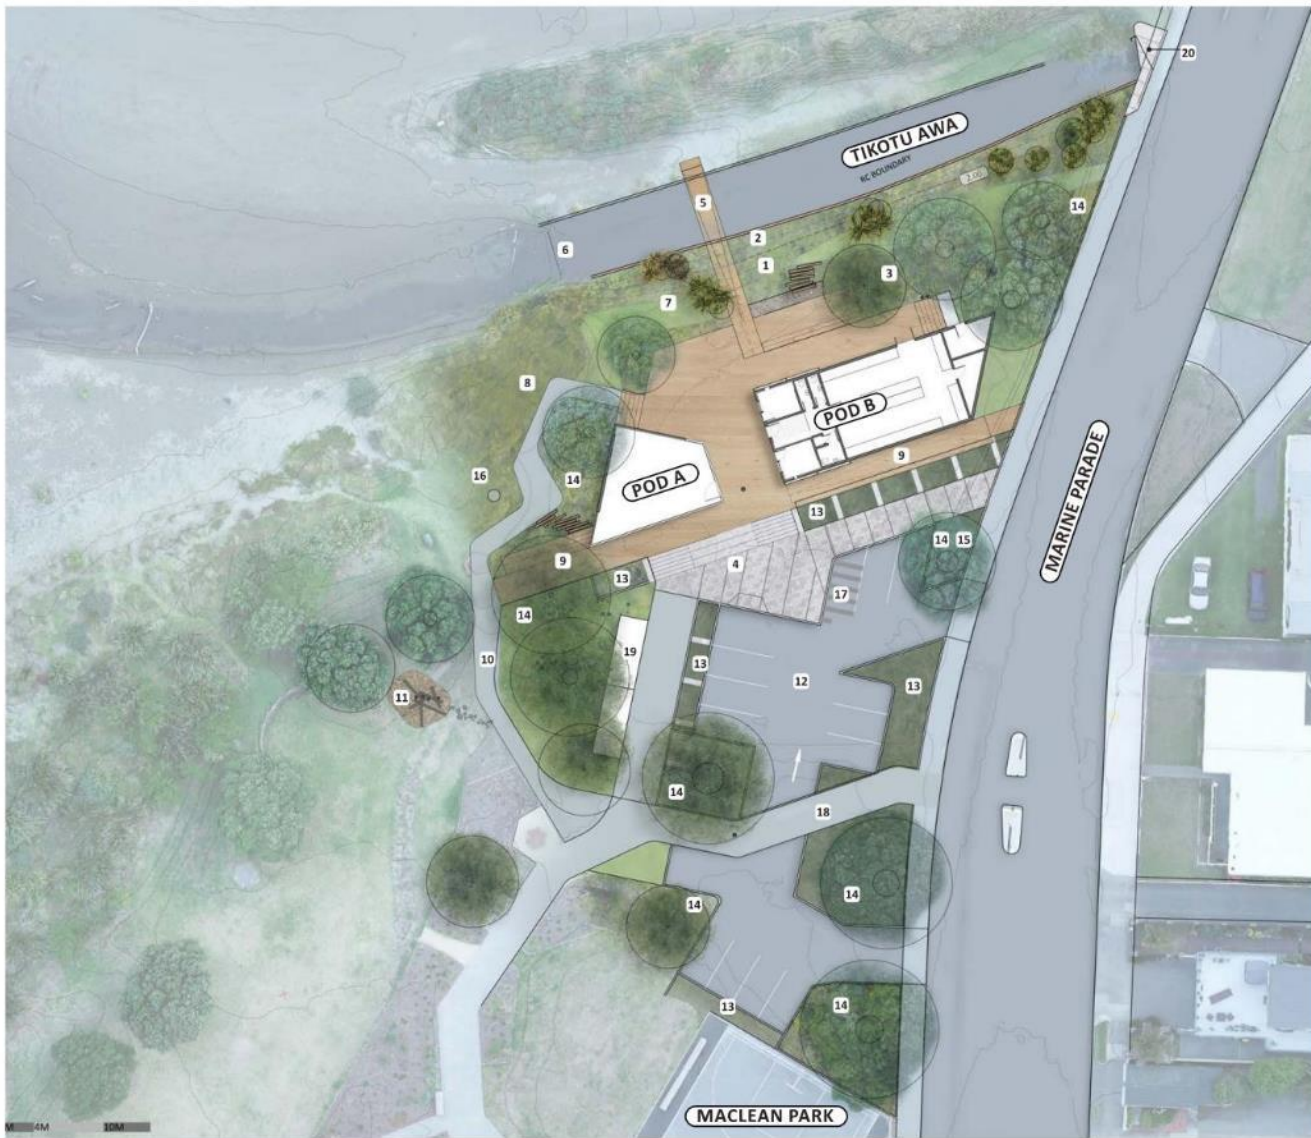
FINISHES | 1:400 @ A3

- CONCRETE PAVING
- ASPHALT PAVING
- DRIFTWOOD PATH
- LIMECHIP PAVING
- PLAY SURFACE
- LAWN
- RAIN / RIPARIAN GARDEN
- COASTAL GARDEN
- STREAM EDGE PLANTING

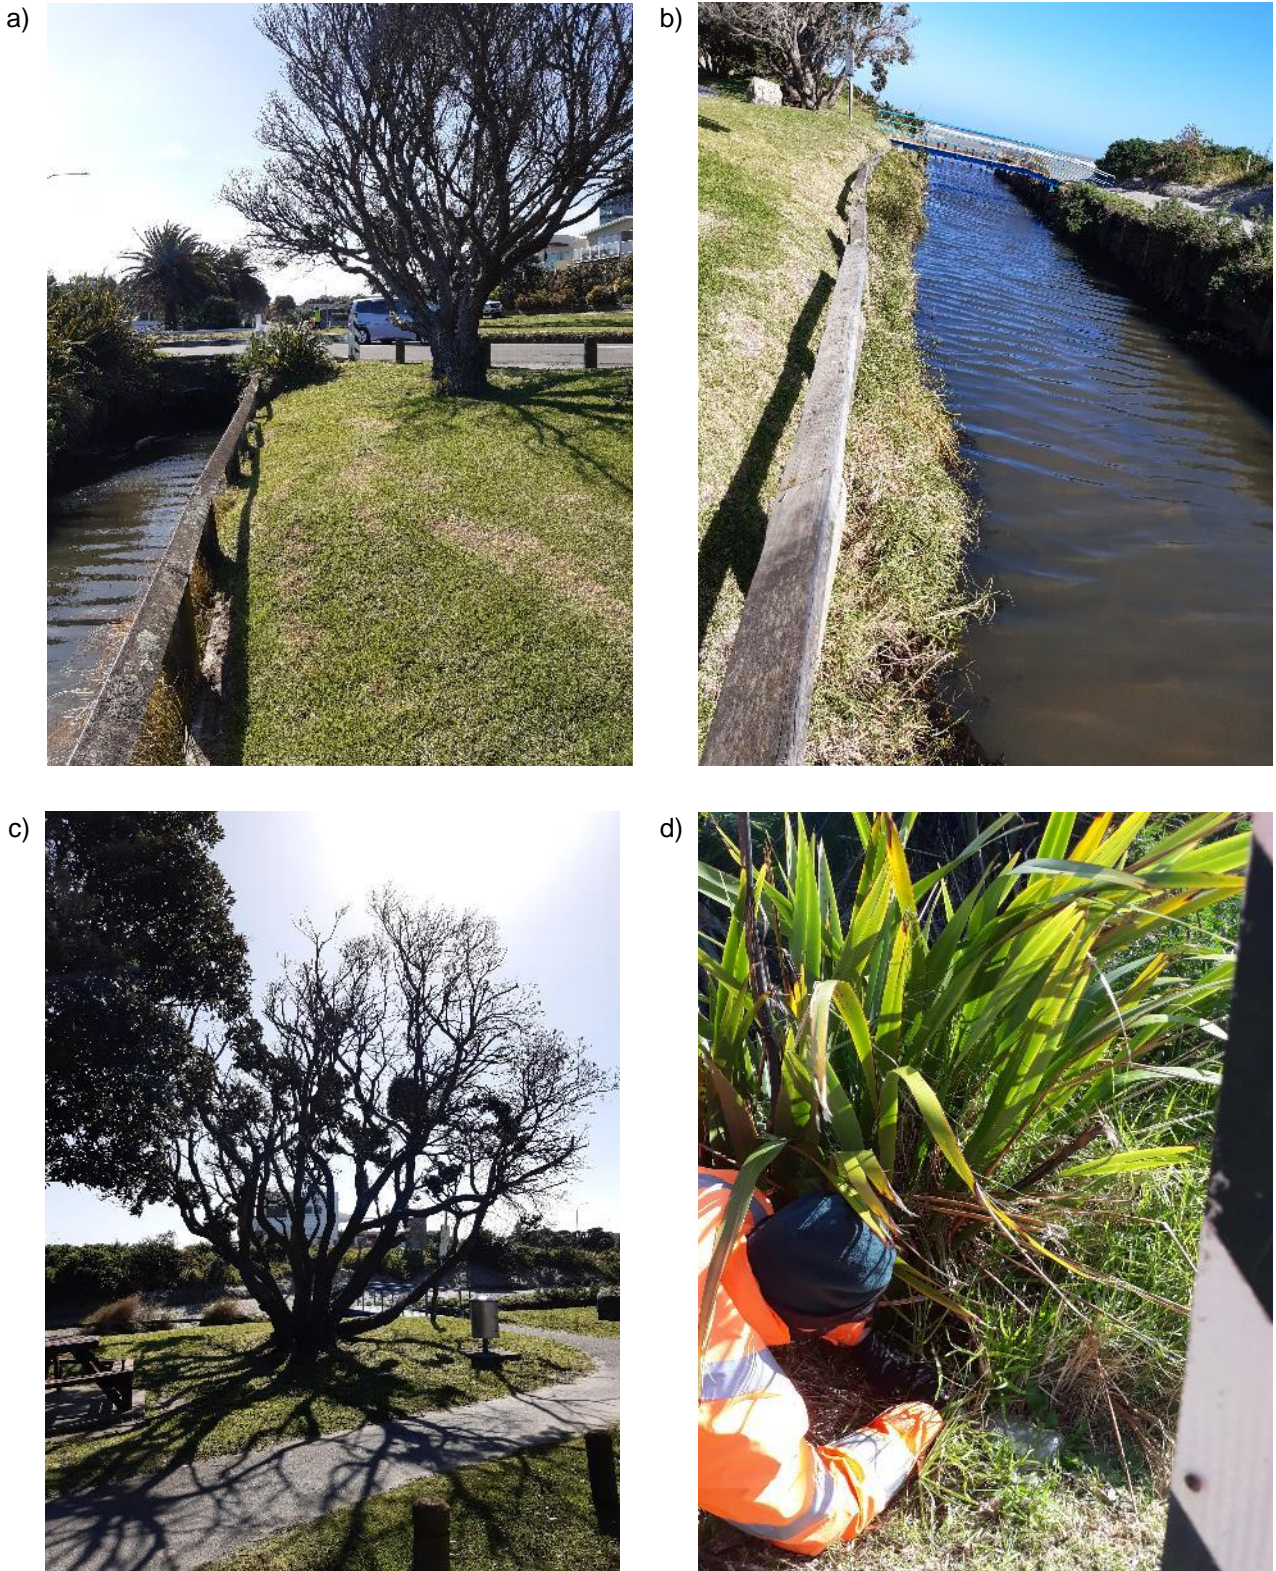
Figure 1. Upstream and downstream view of Tikotu Stream taken from....., (a,b). One of the pohutukawa trees that is in poor health, (c). searching for lizards or signs of lizards in potential habitats (d).

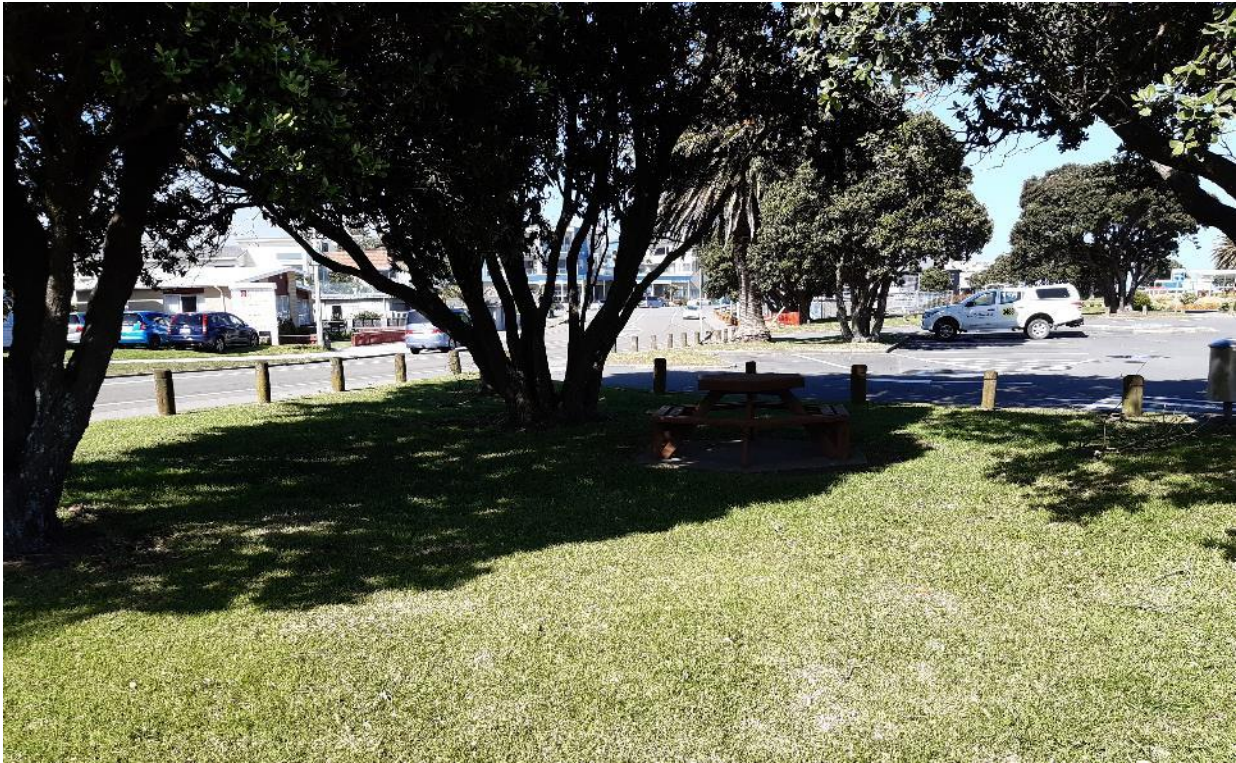
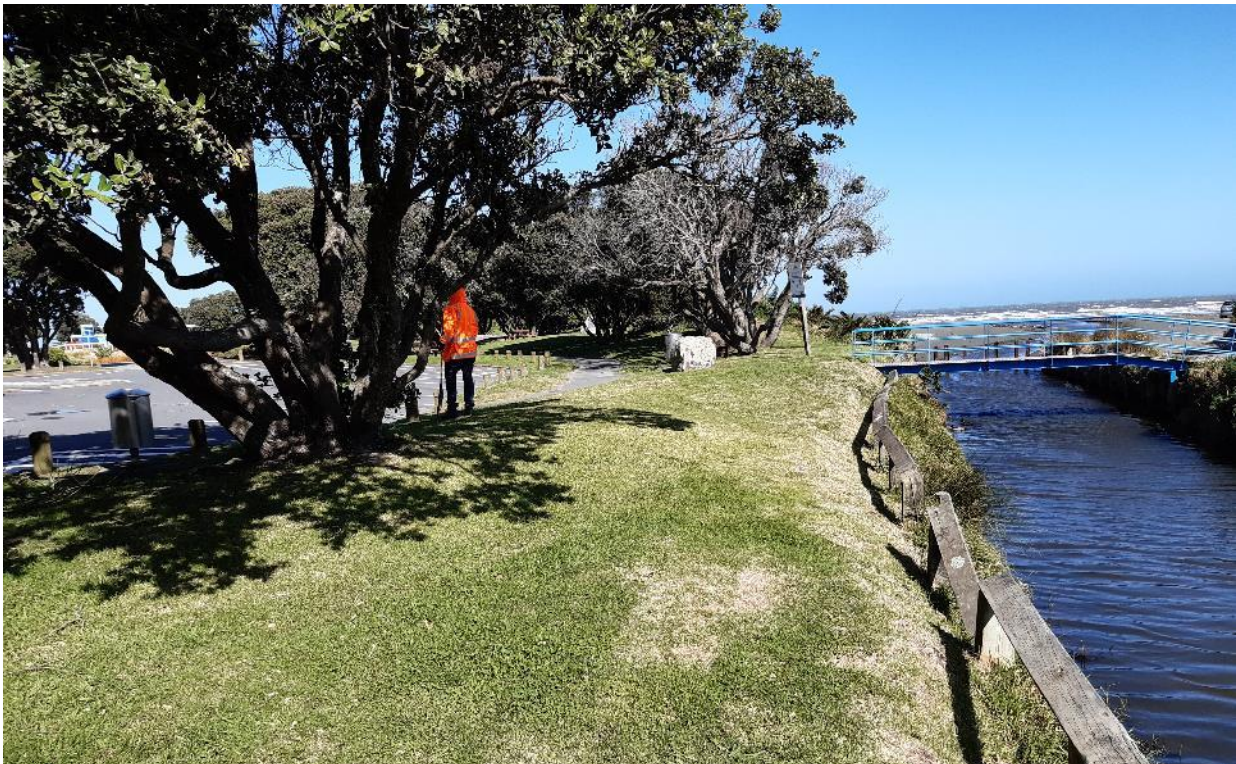
Figure 2. Assessment of bird and lizard habitats, (a,b).

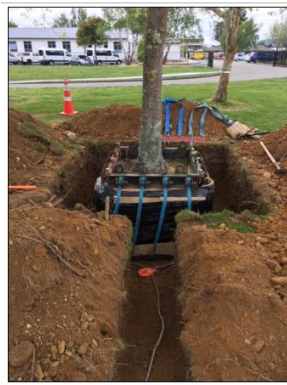
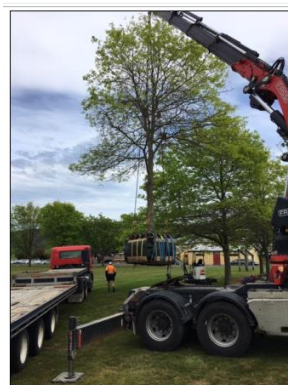
The tree will then be lifted with a Hiab crane into its new location. When the tree is planted in its new location, underground anchors and guys will be fixed across the root balls to ensure stability and minimise the risk of the trees becoming unstable.

Quality planting mix will be used as back fill around the root ball of the trees, the mulch will be applied over the entire root zone to the edge of the canopy which will assist in moisture control.
