INFRASTRUCTURE REPORT

KAPITI COUNTDOWN SITE

160 KAPITI ROAD

M A	Maven Associates	Job Number 109022		Rev B
Job Title	160 KAPITI ROAD PARAPARAUMU	Author	Date 02.7.2021	Checked
Title	Infrastructure Report	CA		BB

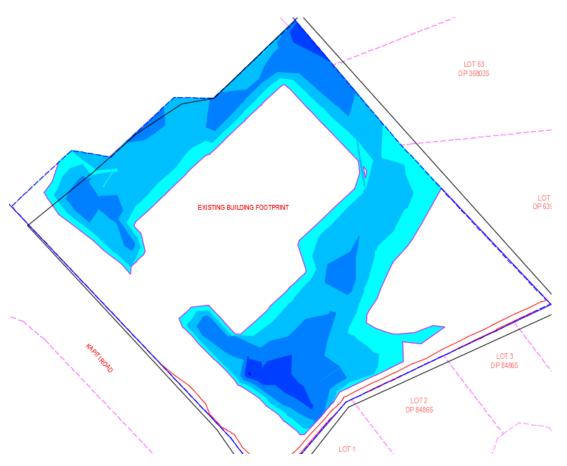
Figure 2.1 Existing Flood Plain Extent

Modelling shows that there is 1,140m³ of ponding on site at a 6.10m RL, **Refer C201**. The proposed site contains the same flood volume of 1,140m³ at the RL 6.10 with this volume being split between surface ponding and underground storage **Refer C202**. The general ponding depth throughout the carpark is 150mm with a max of 230mm depth in an isolated non-public area around the back of the site. There is plenty of raised areas for pedestrian egress from the carpark in a 100year event. The carpark can contain roughly 340m³ of flood storage and the additional 900m³ volume can be contained within underground flood storage tanks located within the carpark **Refer C410**. Only flooding within the Countdown site has been considered due to the available resources and flood data.

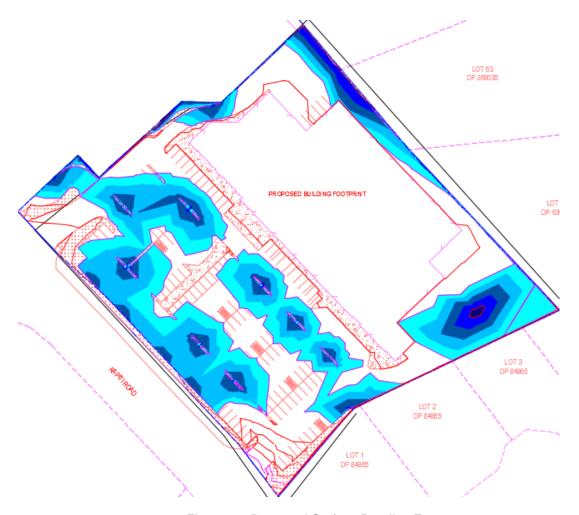
Figure 2.2 Proposed Surface Ponding Extent

The proposed site will allow for ponding around the building and in the carpark without affecting the new building finished floor level. A preliminary general freeboard of 300mm has been provided above the top water level of RL 6.1m. The proposed minimum FFL of new buildings on site is therefore RL 6.4m. It is noted that the 100 Yr. ARI flood event has a top water level of RL6.1m. The design of the carpark contains the ponding up to RL 6.1m to allow for some storage ponding to a safe depth (typically maximum 150mm) within the sealed carpark and to a max of 230mm around the back of the building in a non-public area. Additional stormwater storage will be underground on-site using storage tanks (APD Tanks or similar).

Flooding within the carpark will be to a max depth of 150mm (apart from an isolated non-public low-risk area around the back of the building where it is 250mm deep). Additional underground flood storage can be provided using stormwater tanks (APD or similar) to maintain the existing potential flood volume within the site. The new development will not cause any additional flooding effects upstream or downstream.

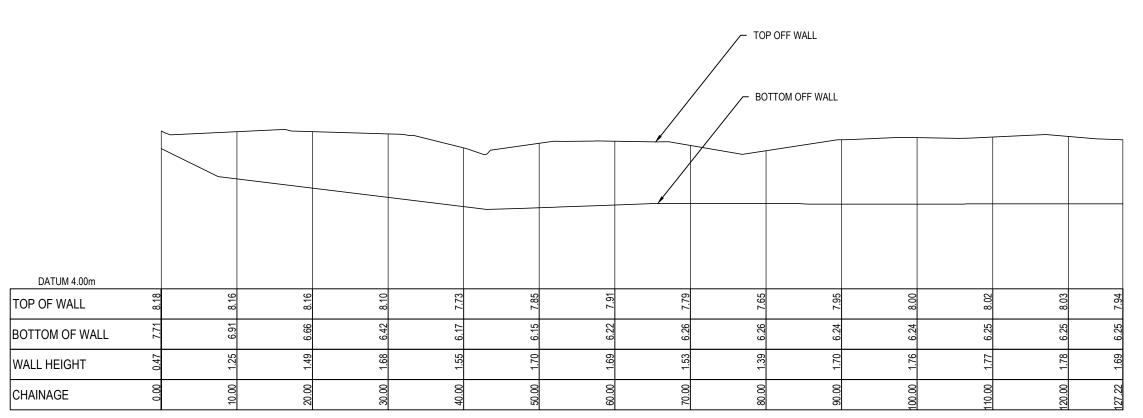
SOUTH EAST BOUNDARY RETAINING WALL SCALE: HORI 1:1000 VERT 1:200

PROPOSED SOUTH-EAST
RETAINING WALL
LONG SECTION

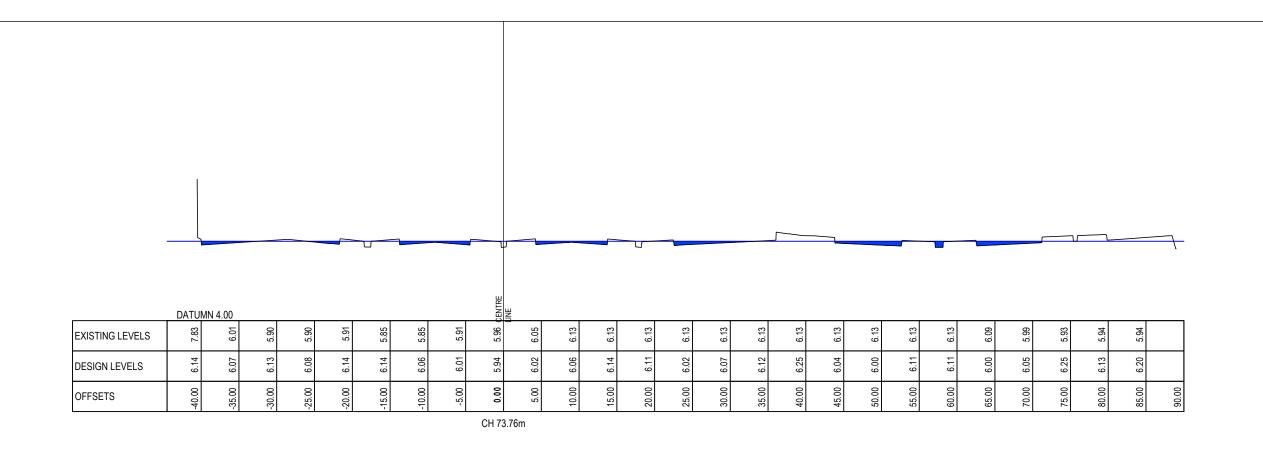
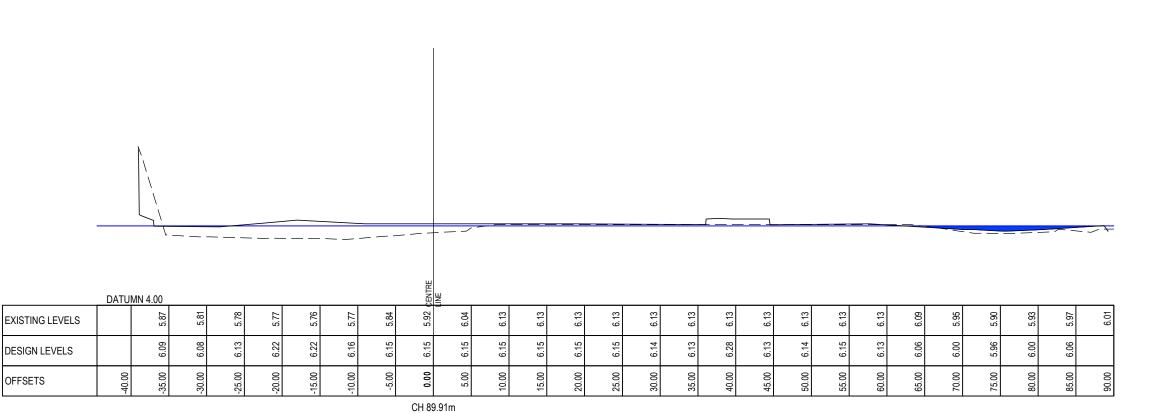
NORTHWEST TO SOUTHEAST OF SITE CROSS SECTIONS

STORMWATER
FLOODING
CROSS SECTIONS

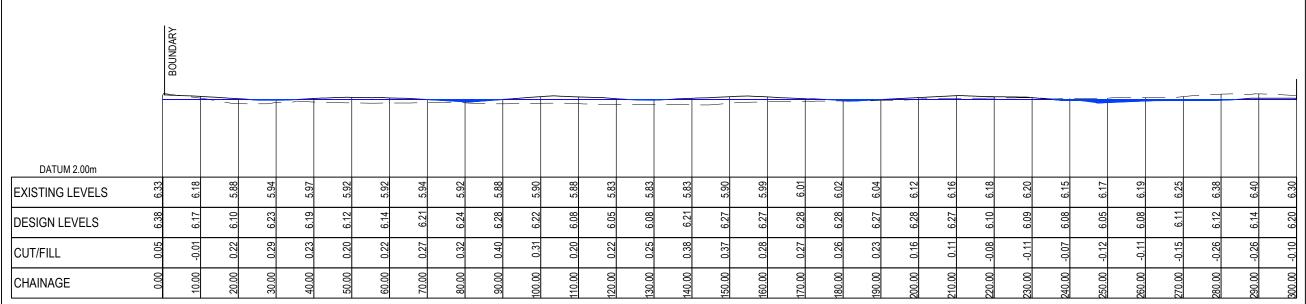
PROPOSED TRUCK ACCESS PATH (1 OF 2) SCALE: HORI 1:1250 VERT 1:250

TRUCK
ACCESS
LONG SECTION

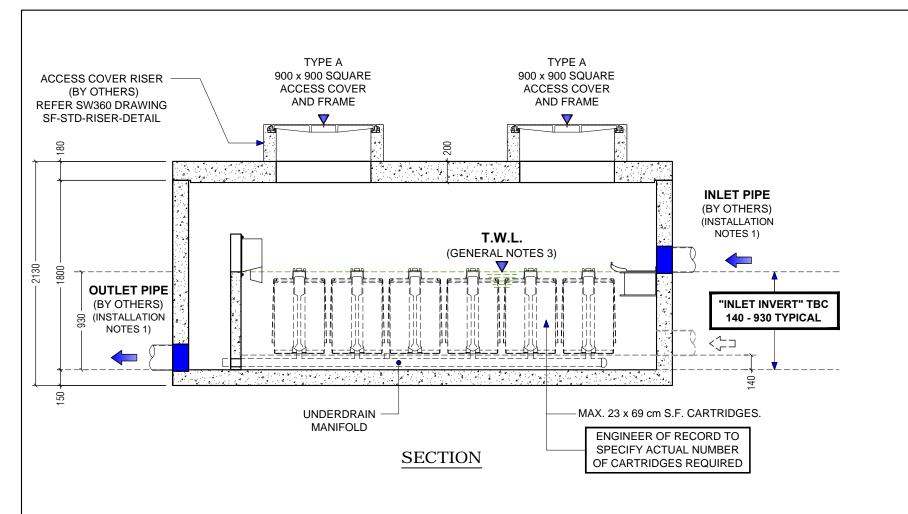
PLAN LAYOUT

STORMFILTER TREATMENTCAPACITY IS A FUNCTION OF THE CARTRIDGE SELECTION AND THE NUMBER OF CARTRIDGES. THE STANDARD VAULT STYLE IS SHOWN WITH THE MAXIMUM NUMBER OF CARTRIDGES (23). VOLUME SYSTEM IS ALSO AVAILABLE WITH MAXIMUM 23 CARTRIDGE. STORMFILTER PEAK TREATMENT CAPACITY IS 32.66 L/s. IF THE SITE CONDITIONS EXCEED THIS AN UPSTREAM BYPASS STRUCTURE IS REQUIRED.

CARTRIDGE HEIGHT (cm)	69		46		30 (LOW DROP)	
RECOMMENDED HYDRAULIC DROP (mm)	930		700		540	
SPECIFIC FLOW RATE (L/s/m2)	1.40	0.70	1.40	0.70	1.40	0.70
CARTRIDGE FLOW RATE (L/s)	1.42	0.71	0.95	0.475	0.63	0.315

Required treatable flow rate (Qwq)	24.48 L/s	Calculated using Rational method Qwq = C x iwq x A (L/s)
Cartridge size/height	69cm	Recommended hydraulic effect is 770mm, for lower hydraulic effect option please contact Stormwater360
Media	Perlite	Other media options are available, please contact Stormwater360
Design treatment flow rate per cartridge (Qcart)	1.42 L/s	
No. of cart required (nCart)	18	Calculated - Qwq/Qcart (Rounded up to whole number)
Design StormFilter treatment flow (QSF)	25.56 L/s	Calculated - Qcart x nCart
Is QSF > Qwq?	Yes	
StormFilter model required	Contact Stormwater360	Please refer to drawing for footprint and size

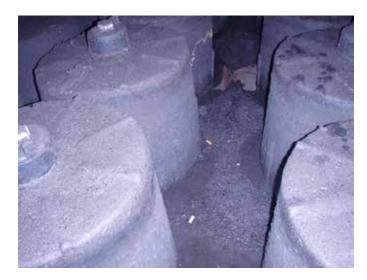
- 1. If applicable, set up safety equipment to protect and notify surrounding vehicle and pedestrian traffic.
- Visually inspect the external condition of the unit and take notes concerning defects/problems.
- 3. Open the access portals to the vault and allow the system vent.
- 4. Without entering the vault, visually inspect the inside of the unit, and note accumulations of liquids and solids.

- 5. Be sure to record the level of sediment build-up on the floor of the vault, in the forebay, and on top of the cartridges. If flow is occurring, note the flow of water per drainage pipe. Record all observations. Digital pictures are valuable for historical documentation.
- 6. Close and fasten the access portals.
- 7. Remove safety equipment.
- 8. If appropriate, make notes about the local drainage area relative to ongoing construction, erosion problems, or high

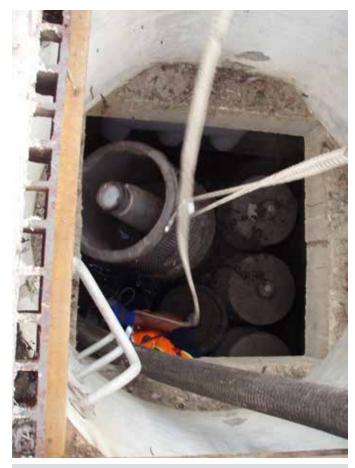
A. This activity will require that maintenance personnel enter the vault to remove the cartridges from the under drain manifold and place them under the vault opening for lifting (removal). Unscrew (counterclockwise rotations) each filter cartridge from the underdrain connector. Roll the loose cartridge, on edge, to a convenient spot beneath the vault access.

Using appropriate hoisting equipment, attach a cable from the boom, crane, or tripod to the loose cartridge. Contact Stormwater360 for suggested attachment devices.

Important: Take care not to damage the manifold connectors.

This connector should remain installed in the manifold and could be capped during the maintenance activity to prevent sediments from entering the underdrain manifold.

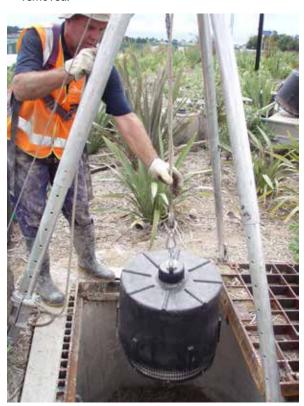
- Enter the vault using appropriate confined space protocols.
- B. Unscrew the cartridge cap.
- C. Remove the cartridge hood hood and float.
- At location under structure access, tip the cartridge on its side.

- Important: Note that cartridges require unscrewing from their threaded connectors. Take care not to damage the manifold connectors. This connector should remain installed in the manifold and capped if necessary.
- D. Empty the cartridge onto the vault floor. Reassemble the empty cartridge.
- E. Set the empty, used cartridge aside or load onto the hauling truck.
- Continue steps a through e until all cartridges have been removed.

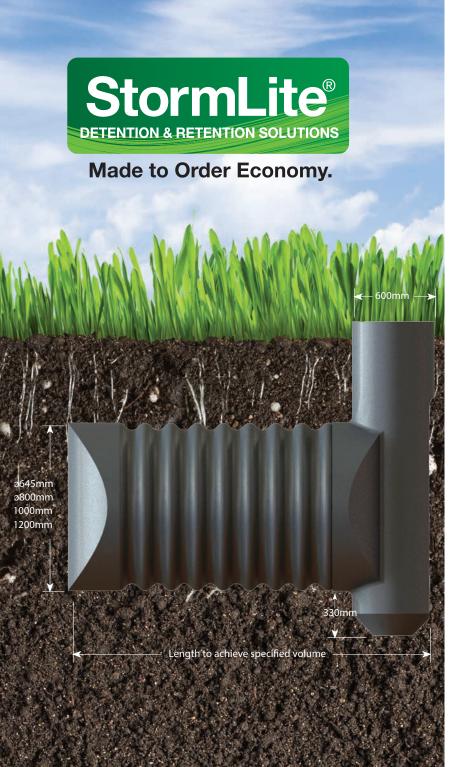
Our 1200
diameter tanks are
made from a potable
grade polyethylene, which
means they can be
used for drinking
water.

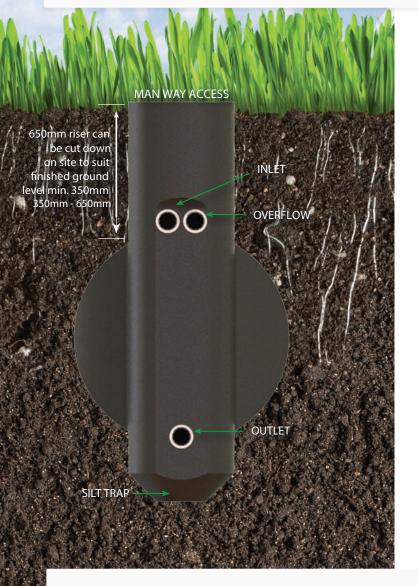
At around 250 kilograms, a 5000 litre StormLite® water tank is a mere fraction of the weight of concrete tanks. This means it can be moved around site with only a small digger. Designed strong, StormLite can go under driveways, carparks, and grass. Tell us your volume requirement, and our make-to-order service will ensure your StormLite tank adheres to council regulations, while making your drainlayer's job a breeze. Make the affordable choice, with made to order economy. Call APD now on (09) 263 7741.

StormLite tanks are made from tough polyethylene corrugated pipe which won't corrode and can be recycled.

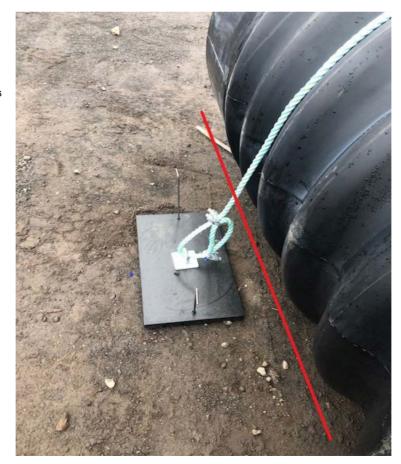
Pads to be laid length ways along tank. Past the edge of tank and secured firmly with pegs supplied

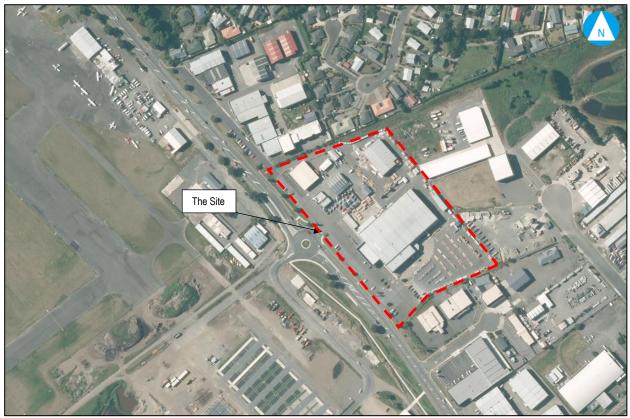
Figure 1: Plan view of the site

The western boundary of the site is marked by Kapiti Road which trends in a north-west south-east direction from State Highway 1 to Paraparaumu Beach. East of this road is the Kapiti Coast Airport and other commercial developments. The east and south of the site continues into the industrial zone and north of the site borders a residential zone.

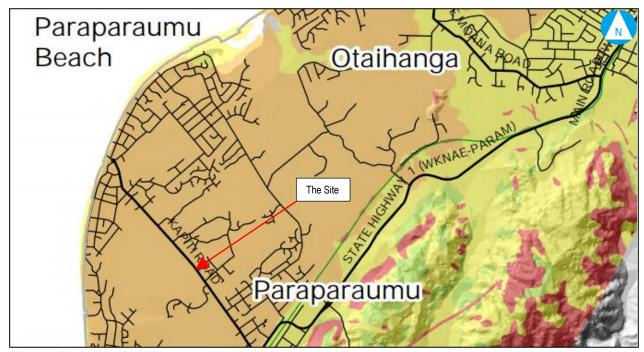
Figure 2. Earthquake Risk Map

The Kapiti Coast Combined Earthquake Risk map (Figure 2) from the Kapiti Coast District Council website shows the site to be located in a moderate to high risk zone pertaining to ground shaking, liquefaction, and earthquake induced slope failure.

(Kapiti Coast Combined Earthquake Risk, Scale 1:50,000 source: www.kapiticoast.govt.nz)

The Soil and Rock Consultants Geotechnical Study W18029 found that the site is in a moderate to highrisk zone pertaining to ground shaking, liquefaction and earthquake induced slope failure. There may be shallow based groundwater present. The report concludes that with a suitably engineered foundation following specific geotechnical investigations the site is suitable for the proposed development. It is envisaged that a detailed design of secondary earthworks and footing preparation for the new building will be necessary at building consent stage. Secondary earthworks have not been factored into the above volumes as the building design is not known at the time of this report.

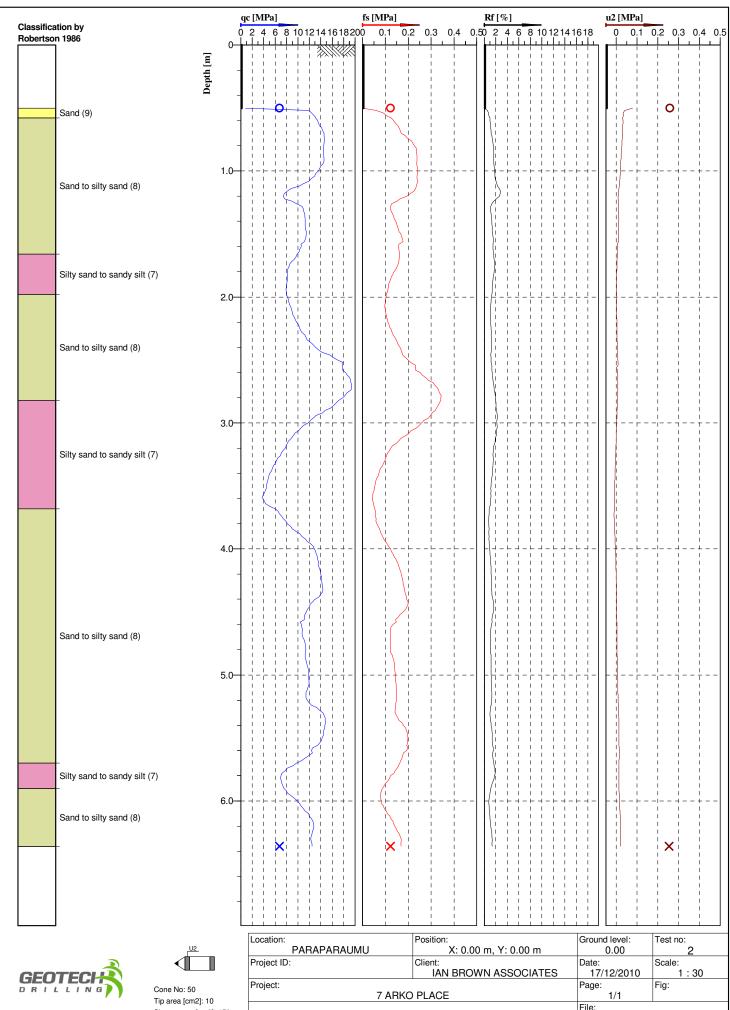
Location:	Position:	Ground level:	Test no:
PARAPARAUMU	X: 0.00 m, Y: 0.00 m	0.00	2
Project ID:	Client:	Date:	Scale:
	IAN BROWN ASSOCIATES	17/12/2010	1:30
Project:	Page:	Fig:	
7 ARKC	1/1		
	File:		
	PARA	2.CPT

Sleeve area [cm2]: 150
