OIR: 2324/809

**Request for Information under the Local Government Official Information and Meetings Act 1987 (the Act) (the LGOIMA)**

## Section Inspection - 8/07/2022 - KSWP003634

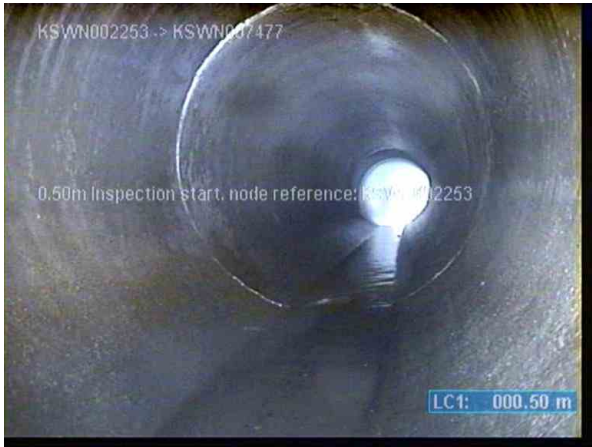
KSWP003634\_1ba1942e-786e-4d32-a0ef-3e5e99191770\_20220708\_155106\_788.jpg, 00:00:18, 0.50m  
Inspection start, node reference: KSWN002253

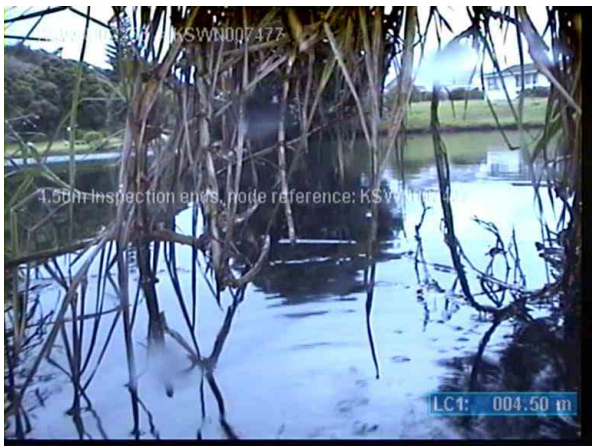
KSWP003634\_e8054480-66f1-423c-82c9-a92725071798\_20220708\_155606\_909.jpg, 00:02:28, 4.50m  
Inspection ends, node reference: KSWN007477

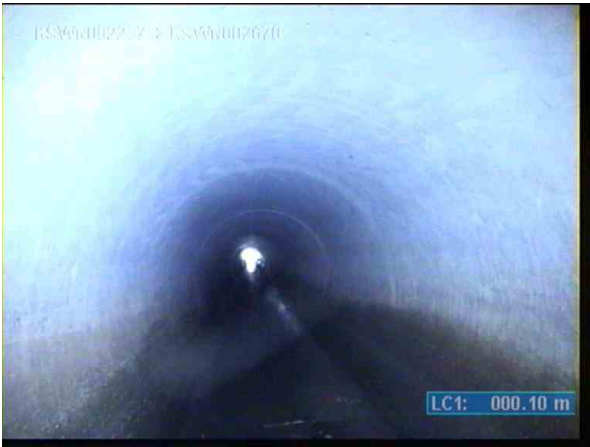
KSWP003713\_8fcaed6d-e316-4503-bd38-4c2f453a4dee\_20220811\_131533\_459.jpg, 00:00:10, 0.10m (48.10m)  
Inspection start, node reference: KSWN002237

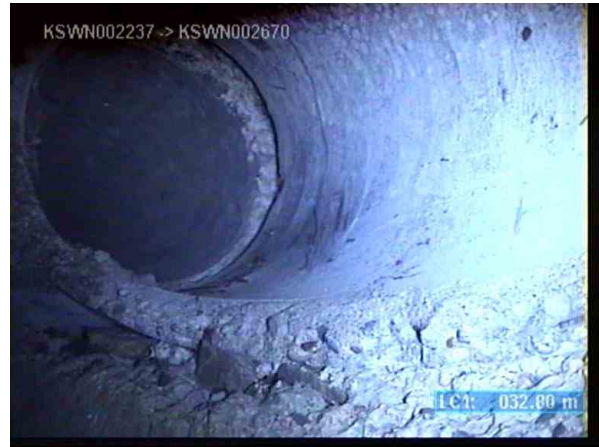
KSWP003713\_ba39b8cc-c631-4d6d-bf67-e948ee438793\_20220811\_131924\_634.jpg, 00:03:14, 32.80m (15.40m)  
The lateral is open at 9 o'clock / Ok

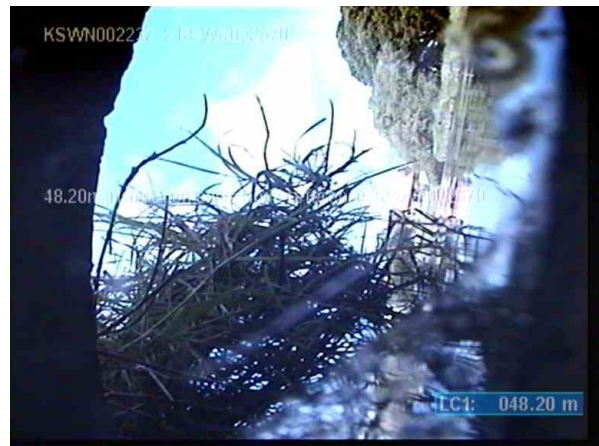
KSWP003713\_08170dd5-a2ee-498c-b1cb-0e14d6ec21e9\_20220811\_132210\_981.jpg, 00:05:25, 48.20m (0.00m)  
Inspection ends, node reference: KSWN002670

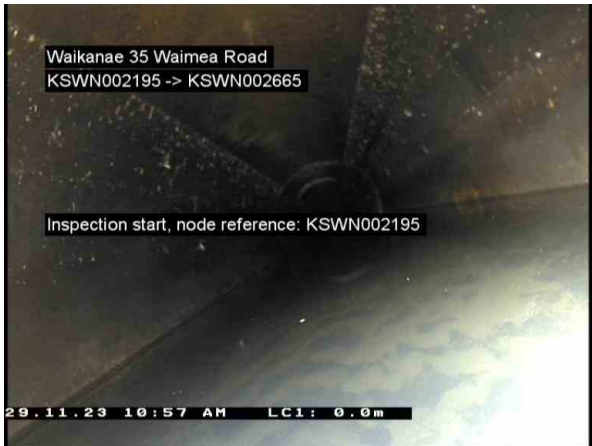
42\_KSWP003751\_195.jpg, 00:00:00, 0.00m (15.40m)  
Inspection start, node reference: KSWN002195

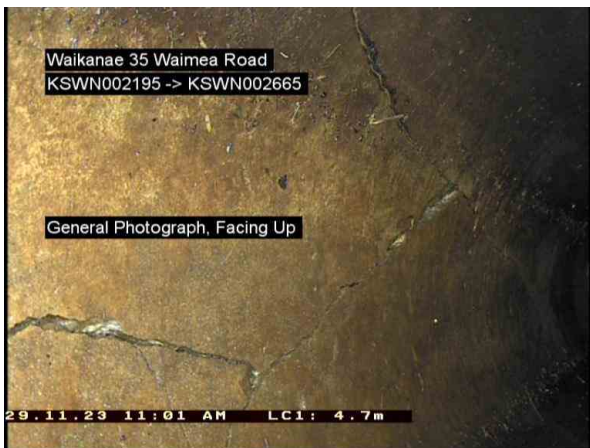
42\_KSWP003751\_201.jpg, 00:03:48, 4.70m (10.70m)  
General Photograph, Facing Up

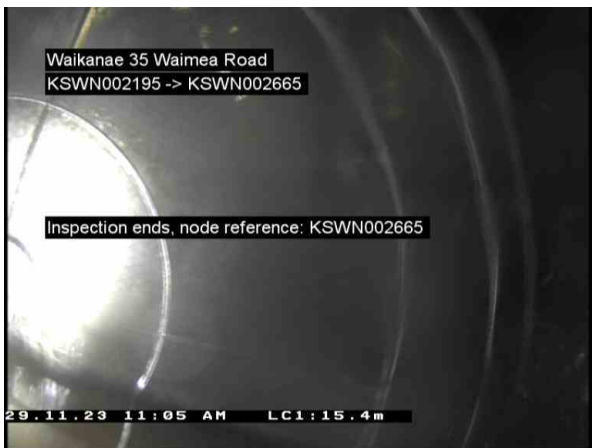
42\_KSWP003751\_205.jpg, 00:06:46, 15.40m (0.00m)  
Inspection ends, node reference: KSWN002665

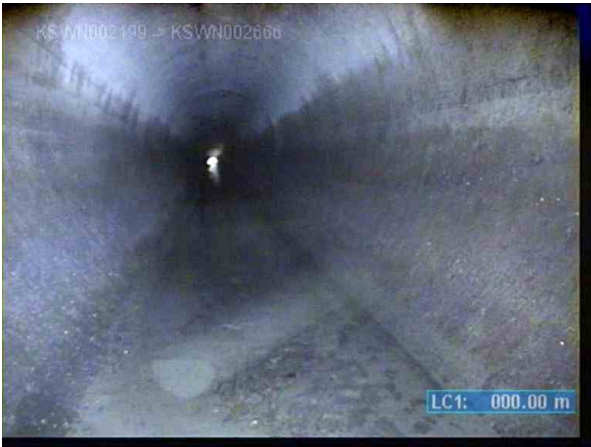
KSWP003760\_7677c142-fac2-4d80-89f4-e9575e26f6a4\_20220729\_130055\_240.jpg, 00:00:12, 0.00m (55.40m)  
Inspection start, node reference: KSWN002199

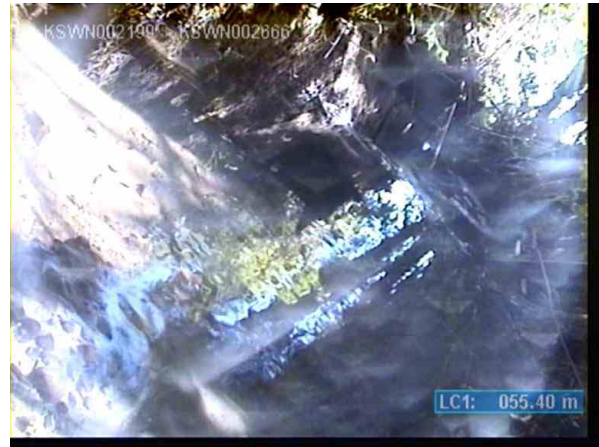
KSWP003760\_eb9b8076-ced0-4af8-a24e-2047390a5156\_20220729\_130513\_621.jpg, 00:04:25, 55.40m (0.00m)  
Inspection ends, node reference: KSWN002666

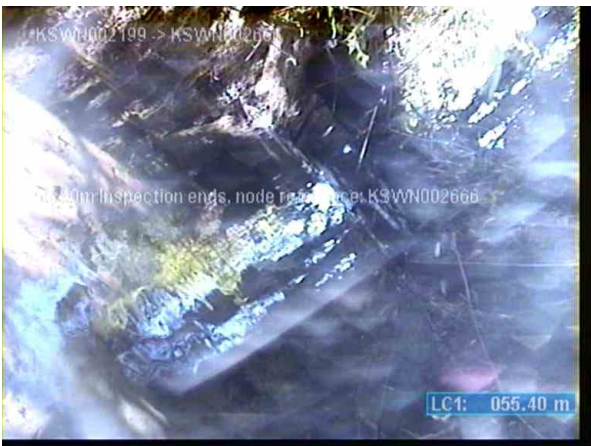
KSWP003760\_8a078897-305d-4a67-b1bc-06dc3754d98b\_20220729\_130517\_633.jpg, 00:04:25, 55.40m (0.00m)  
Inspection ends, node reference: KSWN002666

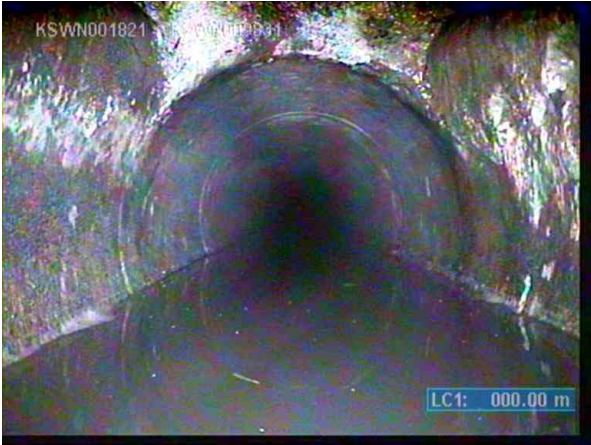
KSWP003815\_55591706-00c2-44c2-bdff-3145507a1a94\_20220701\_134803\_749.jpg, 00:00:10, 0.00m  
Inspection start, node reference: KSWN001821

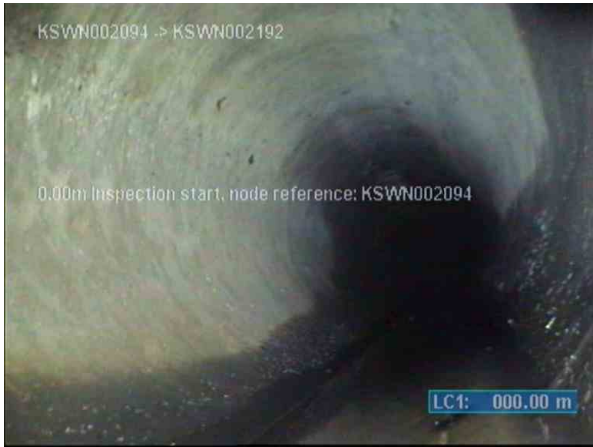
KSWP003817\_224e464b-ab95-4ae6-aa2d-987a188d07f9\_20220812\_112800\_348.jpg, 00:00:17, 0.00m (56.00m)  
Inspection start, node reference: KSWN002094

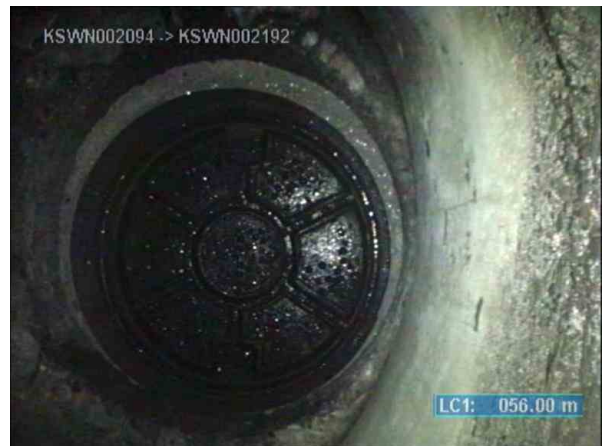
KSWP003817\_a4fb2681-563a-48bd-83bd-c1cc76266e3d\_20220812\_114139\_453.jpg, 00:12:14, 56.00m (0.00m)  
Inspection ends, node reference: KSWN002192

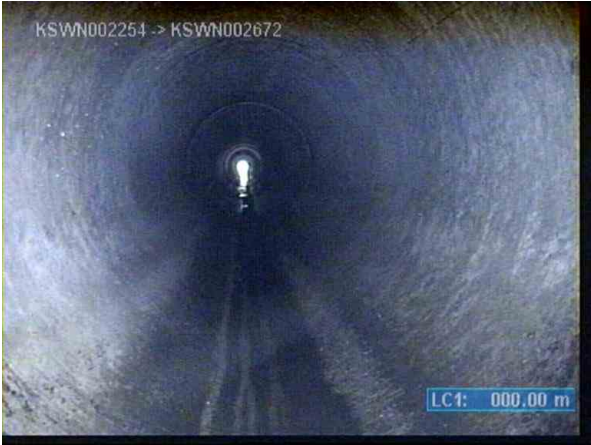
KSWP004512\_78f79a2c-7a30-477a-bdf6-03125de5751b\_20220711\_125340\_084.jpg, 00:00:12, 0.00m  
Inspection start, node reference: KSWN002254

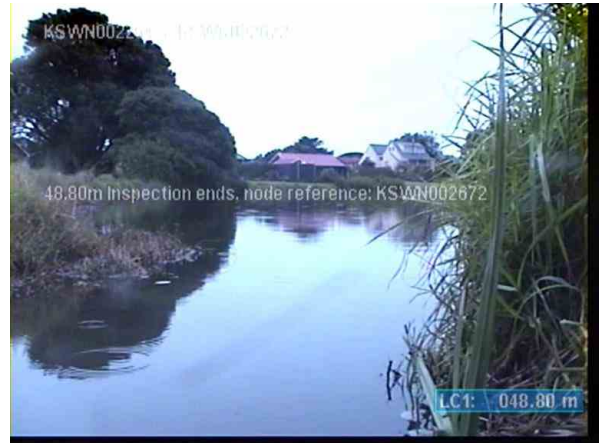
KSWP004512\_087bebea-fdb2-4655-9c99-90565d25f838\_20220711\_125923\_108.jpg, 00:05:40, 48.80m  
Inspection ends, node reference: KSWN002672

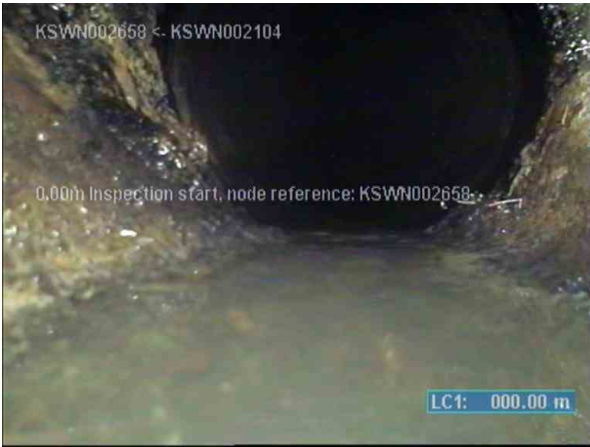
KSWP004528\_e003fdb0-c8ea-45e4-96ca-35ff473e65db\_20220809\_111906\_286.jpg, 00:00:12, 0.00m (48.70m)  
Inspection start, node reference: KSWN002658
